### ***Trench 1 (The Lower Dam): Results Summary***

(Figs. 3-6; Pl. 1-3)

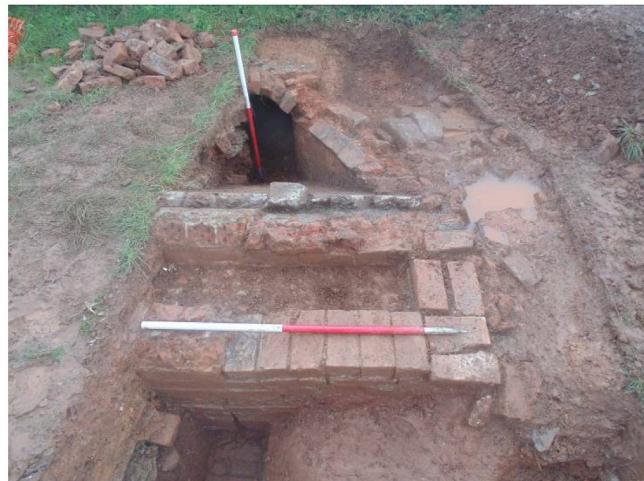
PI. 1: General of excavated structures in Trench 1 from N (scale=2x1m)

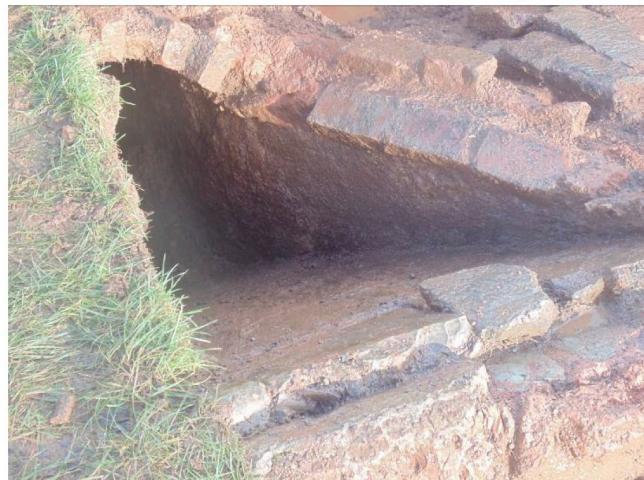
PI. 2: View of spillway (120) & upper culvert (123) from SW

**2.3.12 The spillway:** The south end of the upper culvert meets the spillway, which is a triangular structure, its southern side being a vertical brick wall (122), about 2.40m long and over 1m high, against the waters of the lake. It is two bricks thick, with alternate courses of headers and stretchers and 11 courses visible on its southern face. The extant top lies between 51.20m aOD. It is bonded with the angled side wall (118) which narrows the spillway to meet the tunnel, and all the brickwork is set in a hard reddish mortar flecked with white. The spillway's south wall (122) defines the edge of the lake and determines its level; immediately behind it, there is a slope downwards towards the tunnel, with small sloping slabs of Mort Slate set in the same reddish mortar (121). This was only visible at the top of the slope and was overlain by the large, tooled lias limestone slabs (120) that form the present surface of the spillway. These slabs have been set on a hard, grey mortar flecked with coal and there is a bituminous coating extant over the lower part of the slope. Where they meet the floor of the culvert there is a step down. Above the side wall (118) there are several angled bricks (117) that formed the springing for an arch over the spillway. These are bonded with a hard, coal-flecked, grey mortar, as are the bricks at the south end of this wall into which an iron spike has been set. A remnant of the arch remains over the north end of the spillway (123) using the same, hard grey mortar.

2.3.13 The fabric of the spillway shows two periods of construction, defined by two very different mortars. Both the lias slab surface of the spillway and the arch over it appear to be rebuilds or repairs of the original structure. It is indeed possible that the original spillway was an open feature, in which the cascade of water from the lake was visible until it entered the culvert.

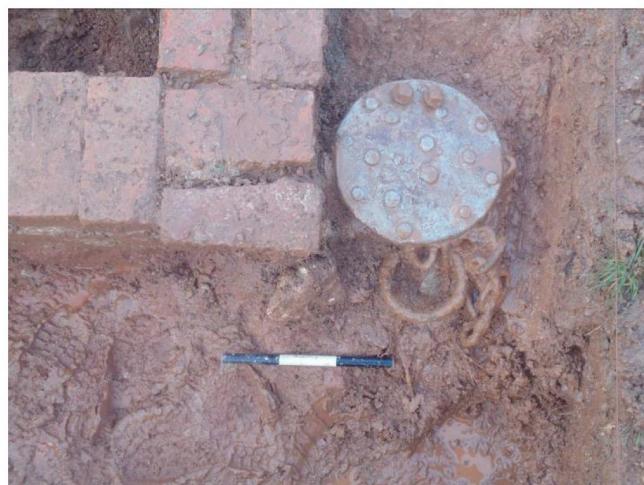
PI. 3: Lead plug (sf. 6) as found; view from S (scale=0.30m)

**2.3.22 The lead plug (sf. 6):** Lying on the top of the clay bank (129), just east of the end wall of the narrow chamber, was a heavy circular lead plate up to 310mm in diameter. It was

25mm thick and had been pierced for numerous heavy lead rivets, which had fixed a thick, leather washer to it, of which traces remained beneath the flattened top of the rivets. An iron staple was bolted through one side of the plate, attaching it to a long chain and ring. The chain was folded up beneath the plate, which had been laid down leather side up. This object was clearly a plug that would drain the lake when removed and somewhere the drain hole may be intact, probably leading into the lower culvert. When the plug was removed and lost is not clear. It seems simply to have been left lying on the bank where it later became covered with the debris spread during the construction of the present outfall chamber.
