HALSWELL HOUSE, SOMERSET

A Structural History 1536-1689

Dissertation in Building History

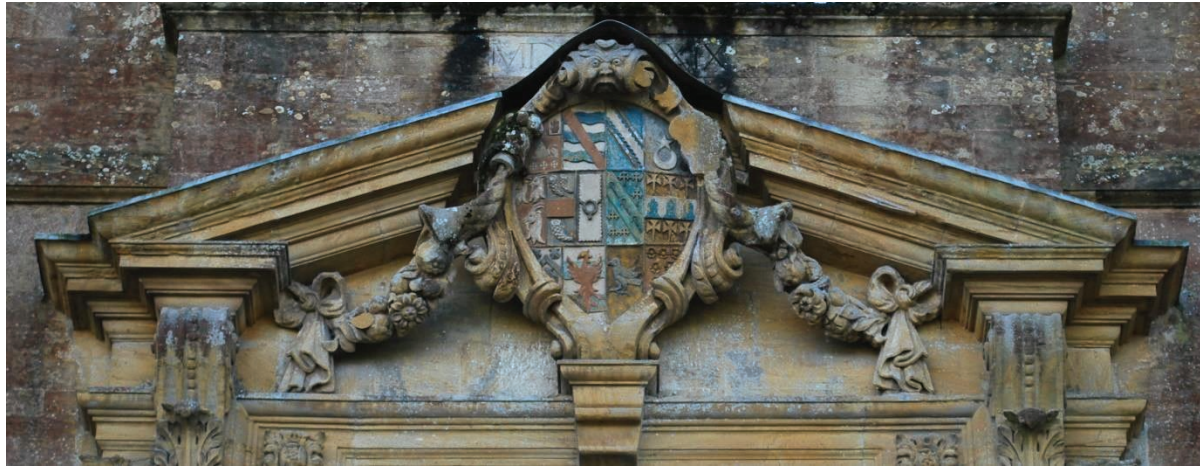
Fig. 0.3. Heavily quartered armorial and date stone of 1689, first floor, north façade.

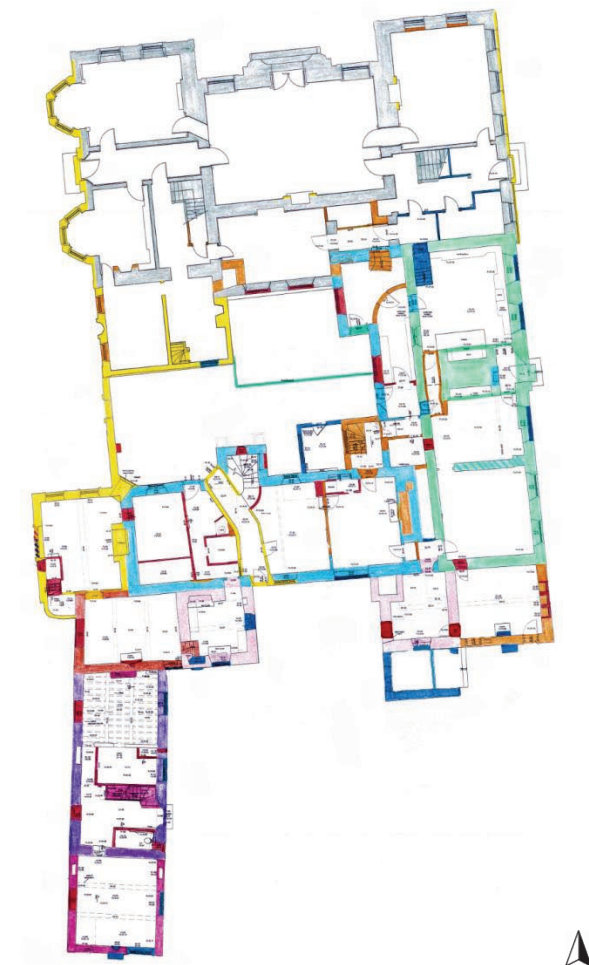
Plan 1.1.

The plan used is the 2015 house plan for the ground floor. The important phases are c. 1536 in light green, c. 1590 in light blue and 1689 in grey. A classical skin of 1754, in yellow, is applied to some of the earlier structure in grey. Full yellow was constructed in 1754. Where door openings have not changed these areas are not coloured, where new openings have been made those openings are coloured with the date of that insertion. Windows display either no change from construction, surround changes only, or full loss of historic material in the area. Staircases have also been date coloured.

Colour Key: c. 1536 – 1550, c. 1590, c. 1610, early-seventeenth century, late-seventeenth century, 1689, 1754, 1766, 1771, c. 1772-1899, c. 1900-1926, after 1950.

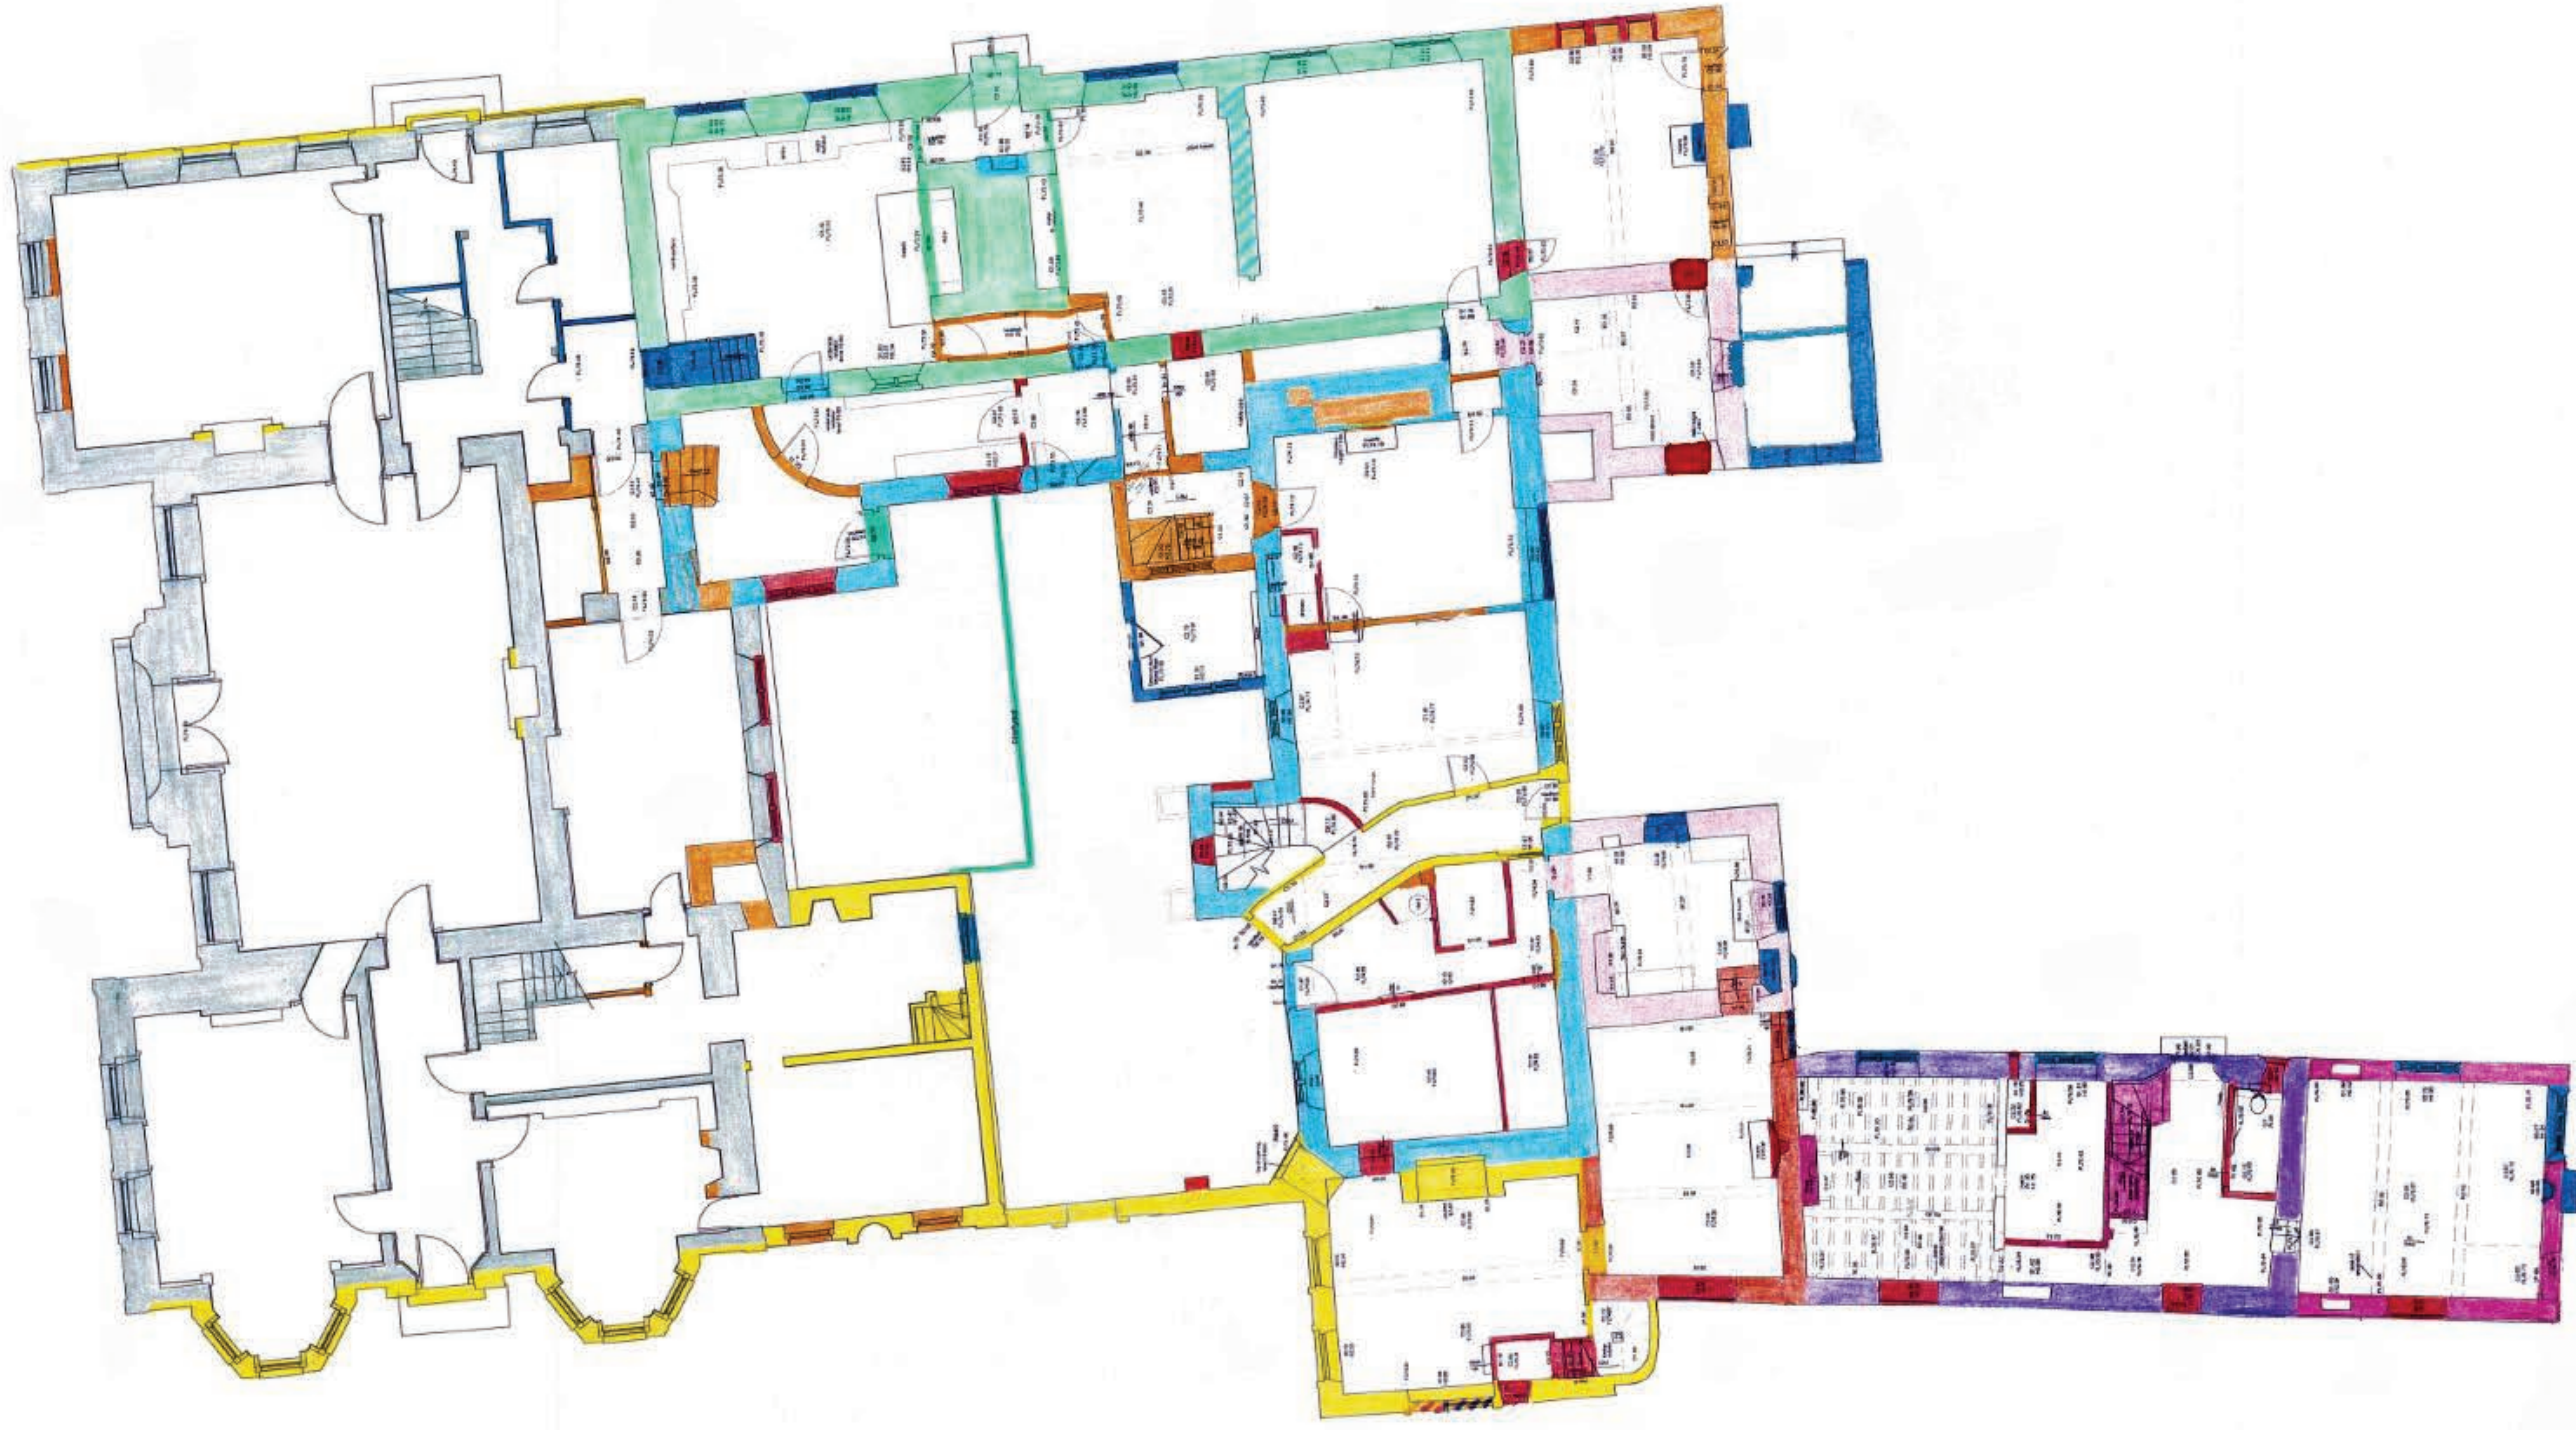
Plan 1.

Colour Key: c. 1536 – 1550, c. 1590, c. 1610, early-seventeenth century, late-seventeenth century,

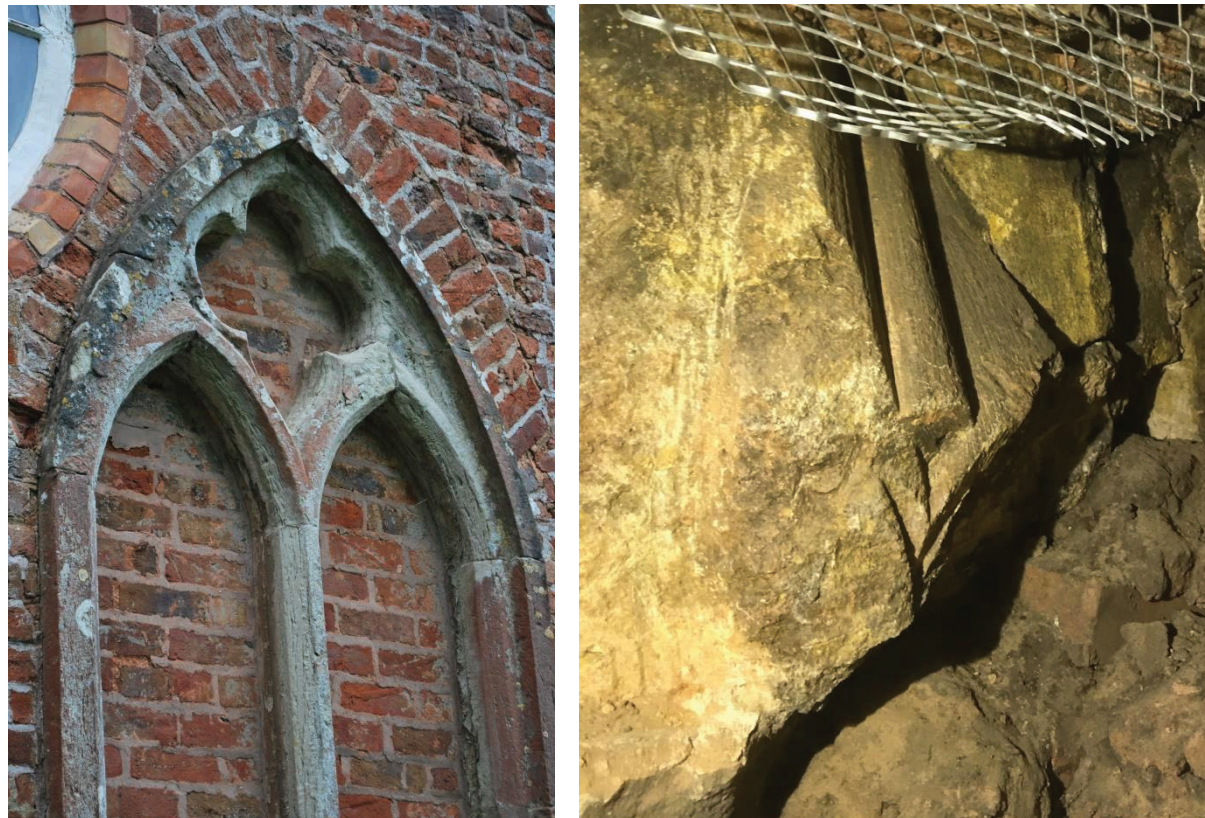
Fig 1.8. One of a set of six late thirteenth-century double-lancet gothic windows, re-used in the west wall of the Gatehouse building.

Fig 1.9. A section of van vault embedded inside the chimney of the ground-floor Servant's Hall at the south of the Baroque Wing.

seventeenth century, see fig. 1.10. Though it must fall outside the scope of this study a series of windows rearranged within it warrants mention. They are a set of six double-lancet gothic windows, see fig. 1.8, which have been dated by Neil Rushton of the Churches Conservation Trust to c. 1270⁶⁰ and by archaeologist James Brigers to 'medieval'.⁶¹

Within the rubble that makes up the interior of a chimney at the south of the Baroque Wing there is a piece of masonry which is part of a stone fan-vaulted ceiling, see fig. 1.9.

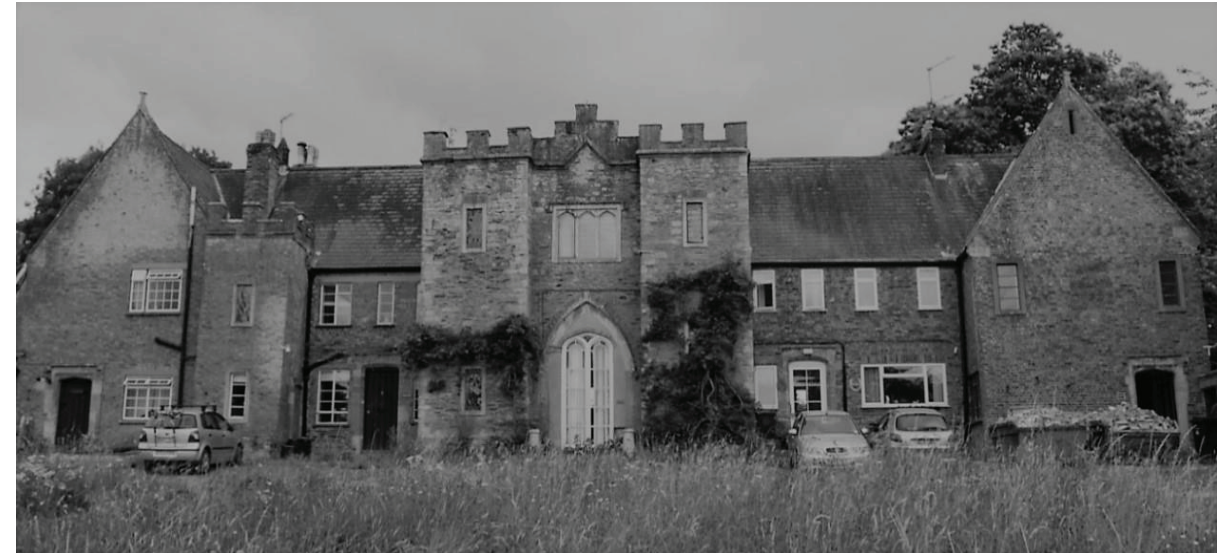
Fig. 1.10. The Gatehouse, Halswell, much changed but containing six thirteenth-century windows, four seventeenth-century doors and two early sixteenth-century mullioned windows one of which matches a surviving window in the c. 1536 phase of the manor.

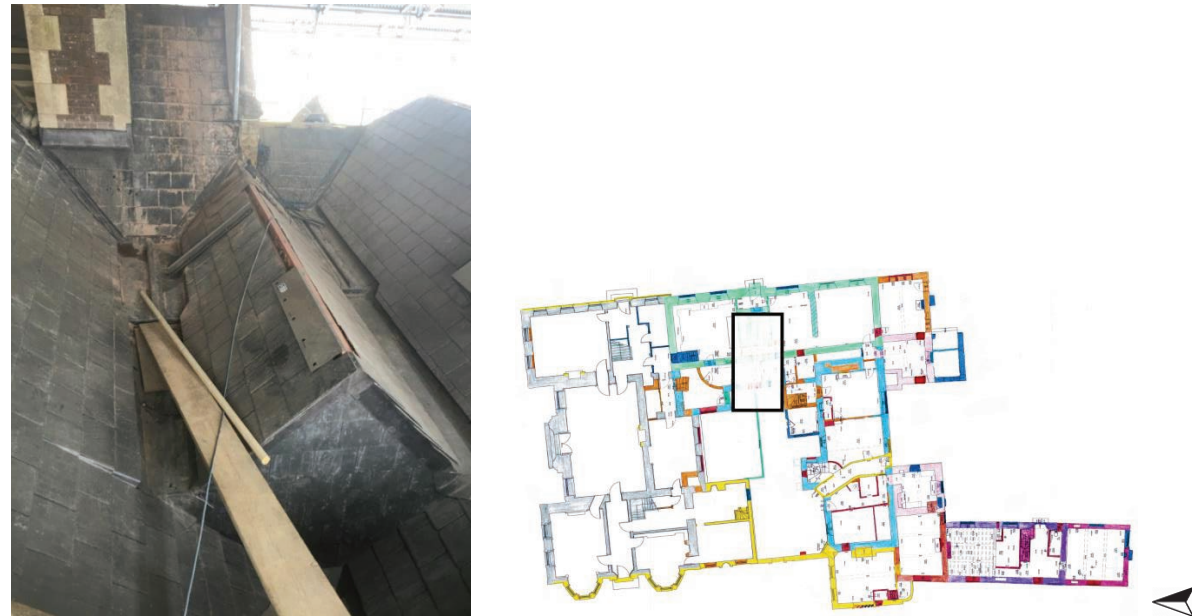
Fig. 2.1. The roof west of the Hall chimney.

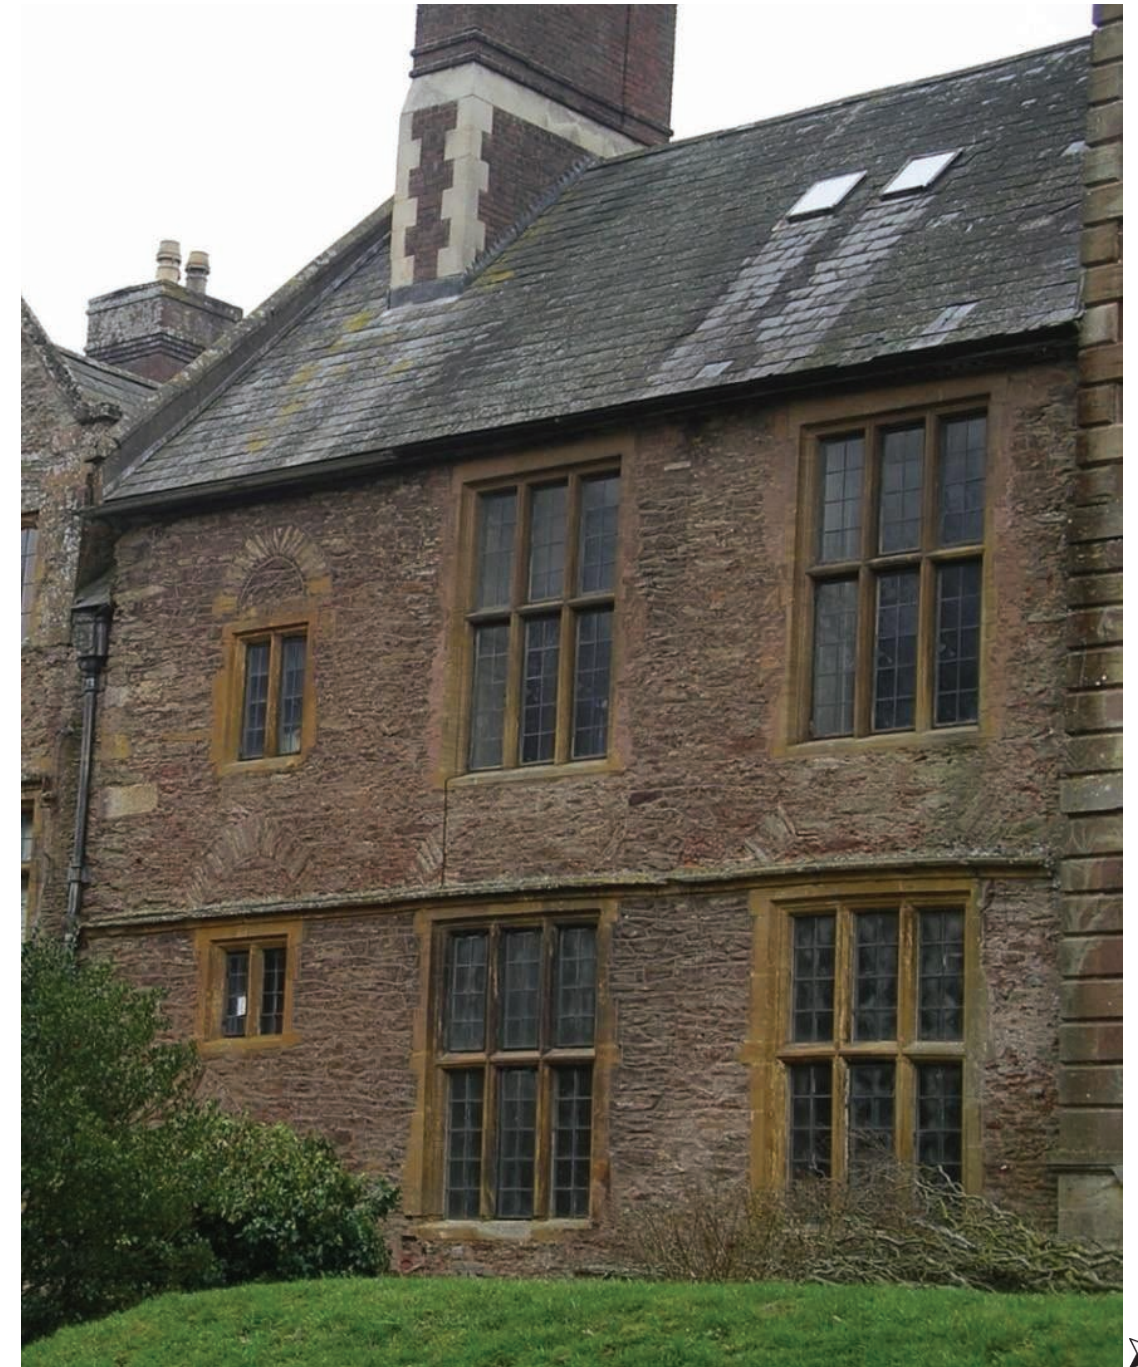
Fig. 2.2. Hall block, east façade, which sits between a slightly later building to its south and the 1689 Baroque Wing to its north.

rebated chamfered mouldings and a relieving arch above the string course, above this, another similar window which shows some evidence that it once had a hood mould which has been removed. The two pairs of six-light mullion windows are early twentieth-century replacements, dateable to between 1924 and 1926.⁶⁴ The chimney casing above roof level was added in c. 1926, replacing a late Victorian red brick chimney of slightly smaller proportions, which itself replaced much earlier chimneys.⁶⁵ There is a rebate of approximately 25cm. between this block and the building to its south. The two rooms to the south on plan 2.3 correspond to a phase that appears to have been built consecutively with the Hall.

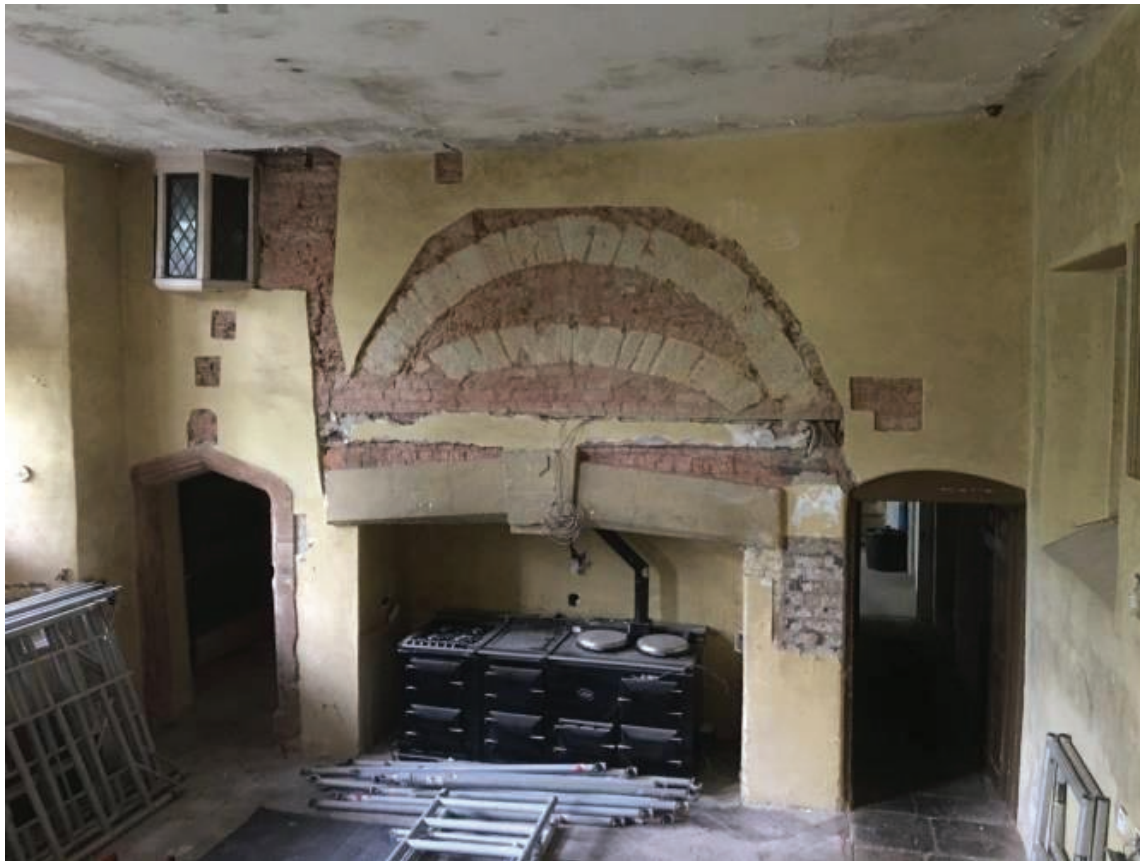
Fig. 2.5. Hall interior with oriel window to a, now, small chamber above the entrance porch, the contents of the corresponding area opposite remain unknown.

In the ground-floor entrance porch, which is only 2 metres high, there is a protruding layer of wall material directly opposite the east door, inset with a niche. The area would benefit from invasive investigation. A stairs from this position would be lit well from both ends with a high window above the east door illuminating a high staircase lobby the same height as the Hall. This would also illuminate the high internal oriel window in the Hall; the west window on the first floor lighting its top end where it becomes a spiral stairs, see figs. 2.5 and 2.16.

The external east doorway does not appear to have been moved or tampered with. The door opens inward and has a deep corresponding rebate in the wall to accommodate the open door within the inner porch. The chimneystack wall on the Hall side has had structural restorations in the twentieth-century, see fig. 2.5.

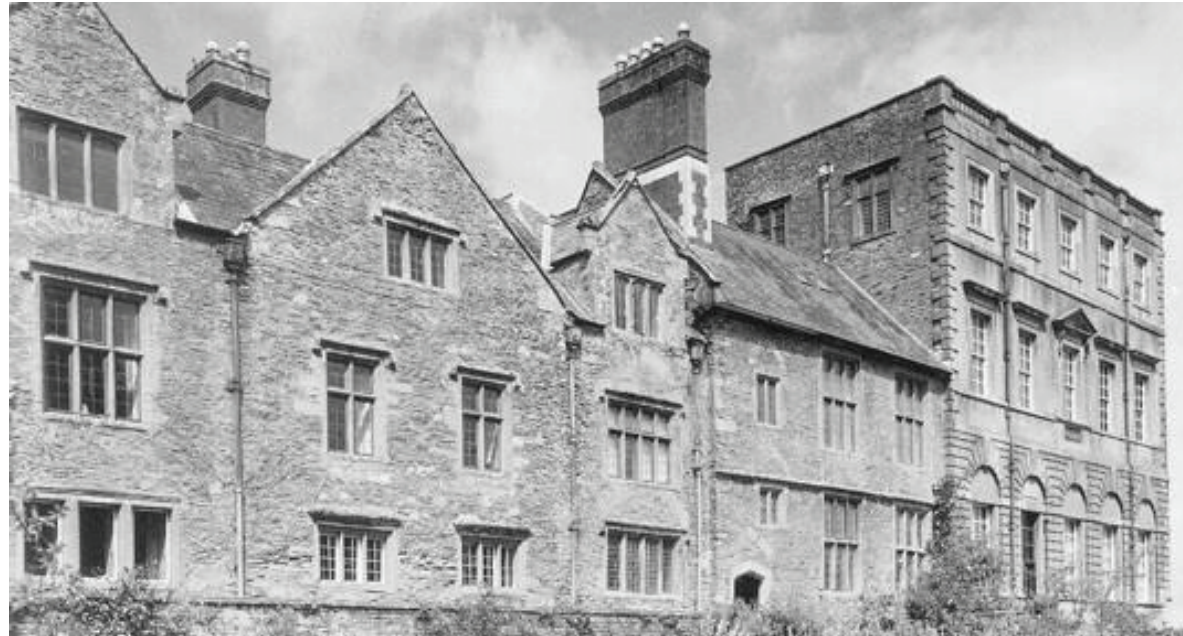
Fig. 2.6. East façade, c. 2000, re-fenestrated in 1926.

⁶⁵ The chronology of this transformation, of windows and chimneys, is illustrated by a series of photographs, see figs. 2.6, 2.7 and 2.26.

The two smaller windows at the southern end of the Hall's east façade and the east door beneath them, see fig. 2.6, do provide valuable dating evidence, as do two once external windows to its west wall and a pair of early sixteenth-century door surrounds with ribbed four-centred arches on the ground floor.

The two-bay section has c.1536 fenestration only to its ground floor. Above these wooden mullions are later classical stone mouldings. The single-bay section to its north retains an original, probably c. 1536, window to the attic, see fig. 2.6, a mullioned window with high four-centred arches to its three lights, the only such example in the manor house itself.⁷¹ This single-bay section has high relieving arches to the ground and first-floor windows, the

Cartwright (d. 1758) could not have been responsible for the eighteenth-century addition to the south-east corner of the old manor house, see figs. 2.7 and 3.28. The map clearly records that this corner did not contain a structure in 1771. Its exterior was remodelled by c. 1900, see fig. 2.6; however the interior first-floor room does contain dateable plasterwork from the late-eighteenth century. Its light relief is typical of the Adamesque classicism of the 1790's.

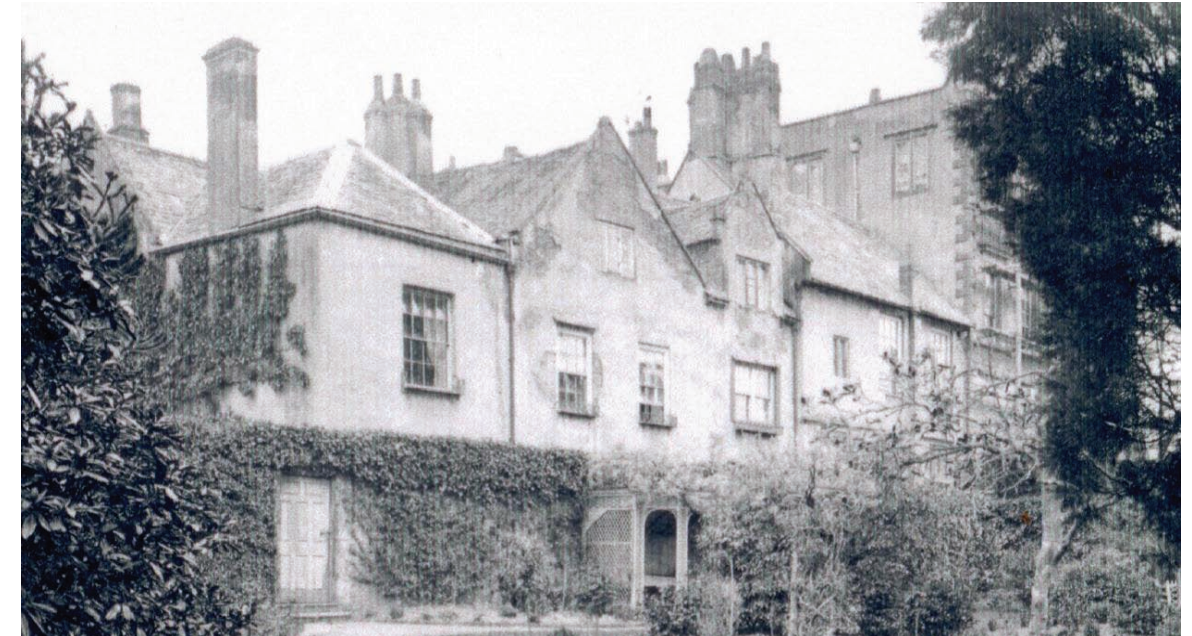
Fig. 2.7. East façade c. 1898. The first floor with Georgian sash windows. The ground floor is obscured by an eighteenth-century redbrick garden wall, defining the service floor at that date.

This Hall building differs quite significantly in arrangement and scale to all the other sixteenth-century buildings that are grouped around it and contains architectural decorations which pre-date those elsewhere within the house, with the exception of the two oak windows in the Buttery, see fig. 2.3. It contains the two grandest sixteenth-century rooms at Halswell, both with pairs of six-light mullioned windows to the east. These four windows are early twentieth-century replacements, taking the place of eighteen-century sash windows which were installed in most of the original openings below attic level, see fig. 2.7.

The 1920s ground-floor windows in the Hall are in their original positions as evidenced by their relieving arches above and their internal deeply splayed sills with early mortar remnants. Those on the first floor have been modified in the eighteenth and twentieth centuries so have lost dateable material though the over-sized nature of the Georgian sashes, see fig. 2.7, may indicate continuity with the openings sizes.

⁷² The single-bay section of the building to its south is constructed of eighteen-century red brick, faced in rough stone and given a mullioned window gable between c. 1898 and 1908 when dated photographic records illustrate the changes, see figs. 2.7 and 2.26.

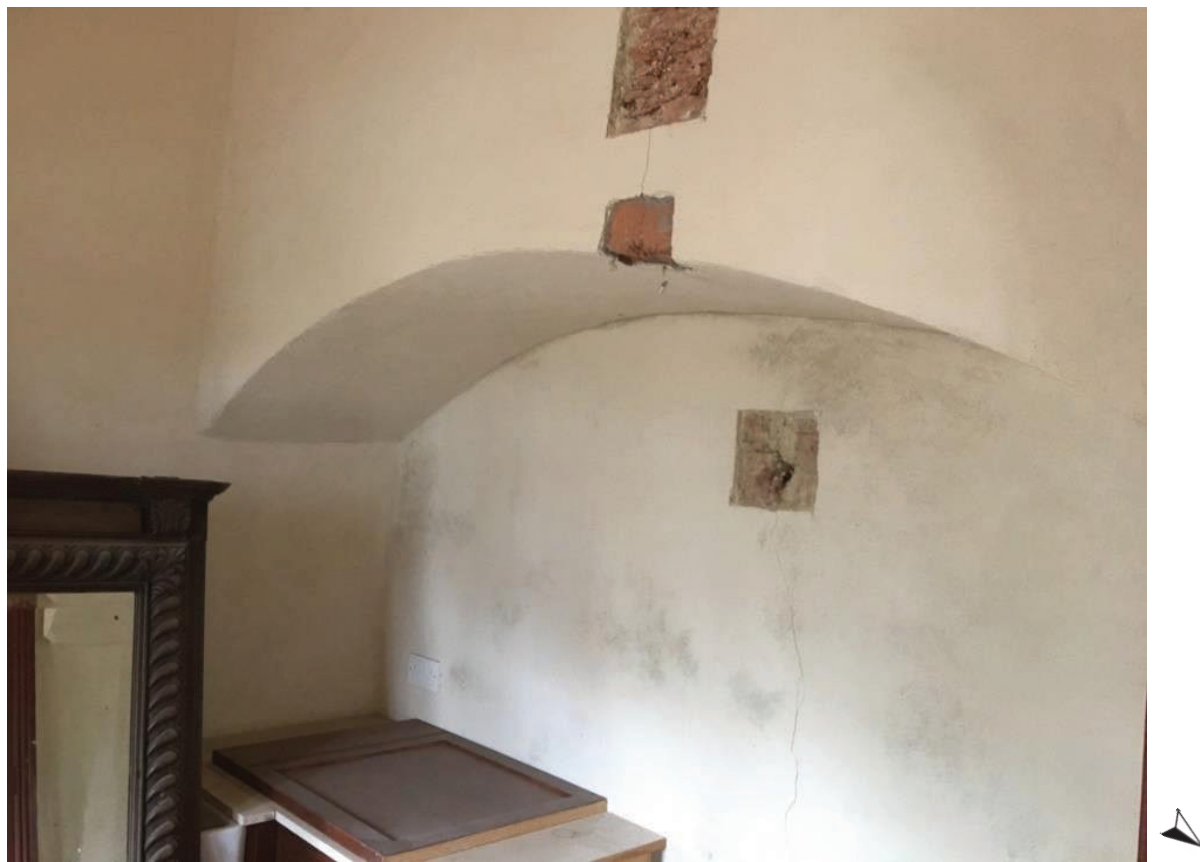
Fig. 2.12. First-floor chamber at south-east of the Hall.

ground-floor corridor. There is some suggestive evidence for this straight first-floor corridor within the chimneystack. The east chamber has a large arch to its west wall, see fig. 2.12, which corresponds to the ceiling height of the west chamber, and acts as the necessary spanning arch for this passage and the stair cavity below connecting the north chimneystack with the south chimneystack and its gable wall.

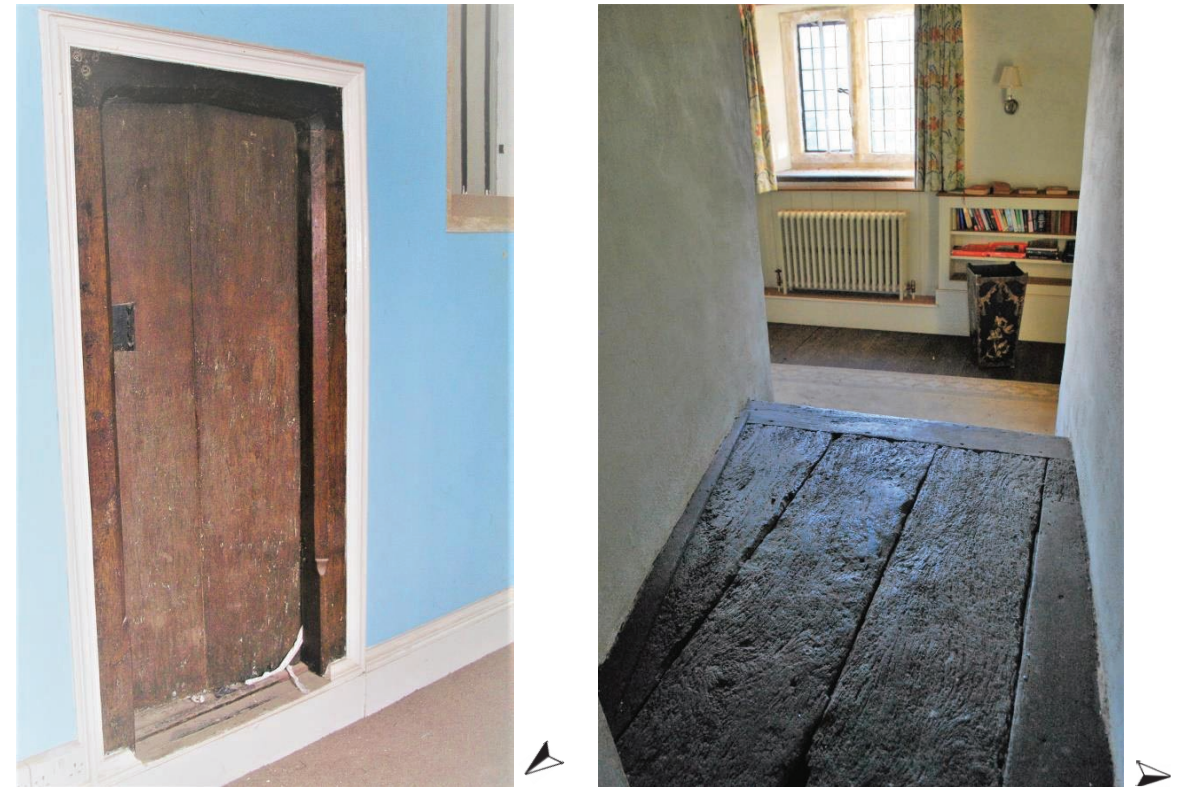
Fig. 2.13. Late sixteenth-century door on the first floor leading out of the earlier Hall building.

Fig. 2.14. Early elm floorboards in the attic above the Hall. The termination of the boards illustrated corresponds to the wall plate of the Hall's attic, where its west wall met the roof structure. The doorway opening must be of c. 1590 when a corridor was added, visible beyond.

From the western first-floor chamber, visible through the rectangular door on the right in fig. 2.11, it is suggested a spiral stairs continued from below to the attic also allowing access to the lower-level rooms in the building to its south. Inside the chamber is a once external window, see fig. 2.16. This space has a late sixteenth-century doorway with a flattened four-centred arch, see fig 2.13, leading to the c.1590 corridor extension.

Above this is another smaller chamber, also now a modern bathroom, but with clear indications of sealed openings to its north, south and west sides, further suggestive of a linking spiral staircase here. This west stairwell chamber rises upward to the attic and terminates behind a modern partition wall illustrated on the left in fig. 2.14, which bisects the sixteenth-century floor boards.

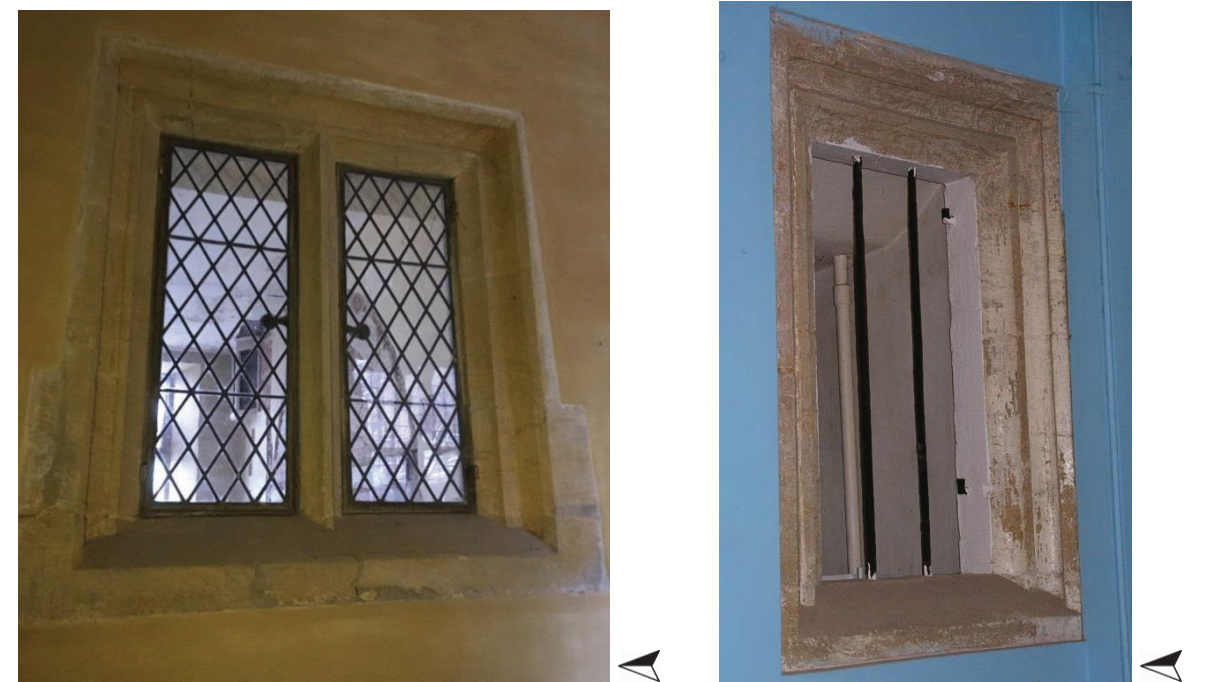
Fig. 2.15. West wall ground-floor window to Hall.

Fig. 2.16. West wall first-floor window to proposed stairs.

This western wall was originally external and still has two exposed small windows on the ground and first floors, see figs. 2.15 & 2.16, to the Hall and to the proposed staircase respectively. They are in a more perpendicular style and have fine hollow chamfered mouldings in excellent condition; in section the ground-floor window is similar to the two oak mullion windows in the Buttery, see fig. 2.3. The two small windows to the east of the Hall have rebated chamfered mouldings simply carved inside and out, see figs. 2.17 and 2.18. It is of note that these six windows are the only windows at Halswell which are not with ovulo-section mouldings.

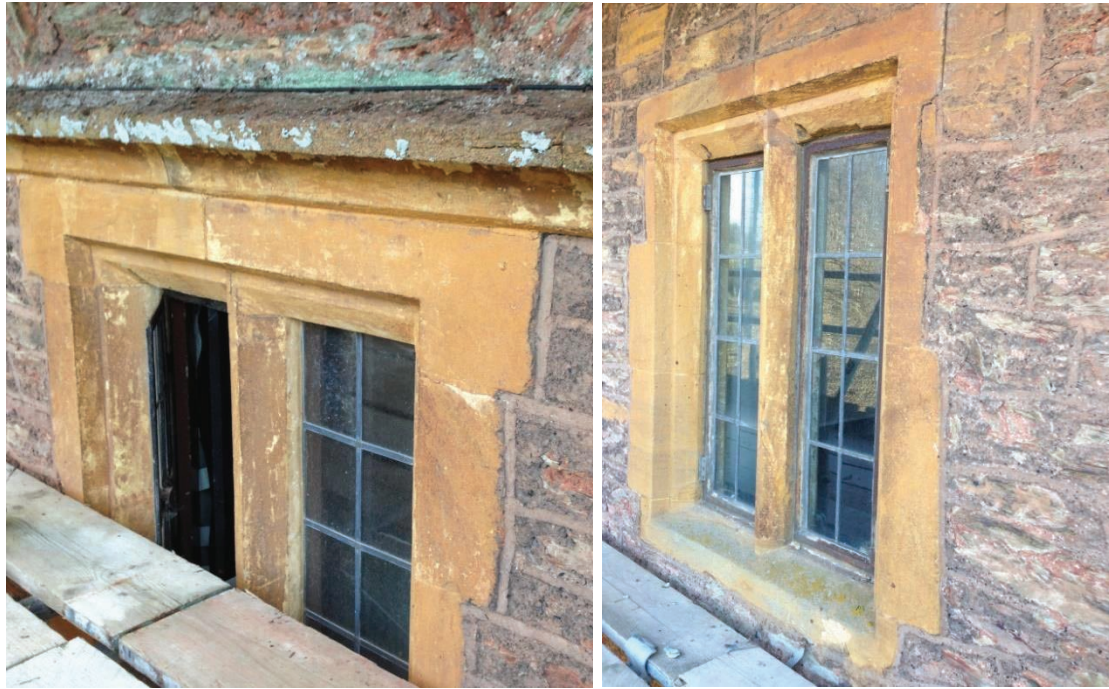
Fig. 2.17. East façade mid-level window, once lighting the stairs, now lighting a small chamber.

Fig. 2.18. East façade first-floor window.

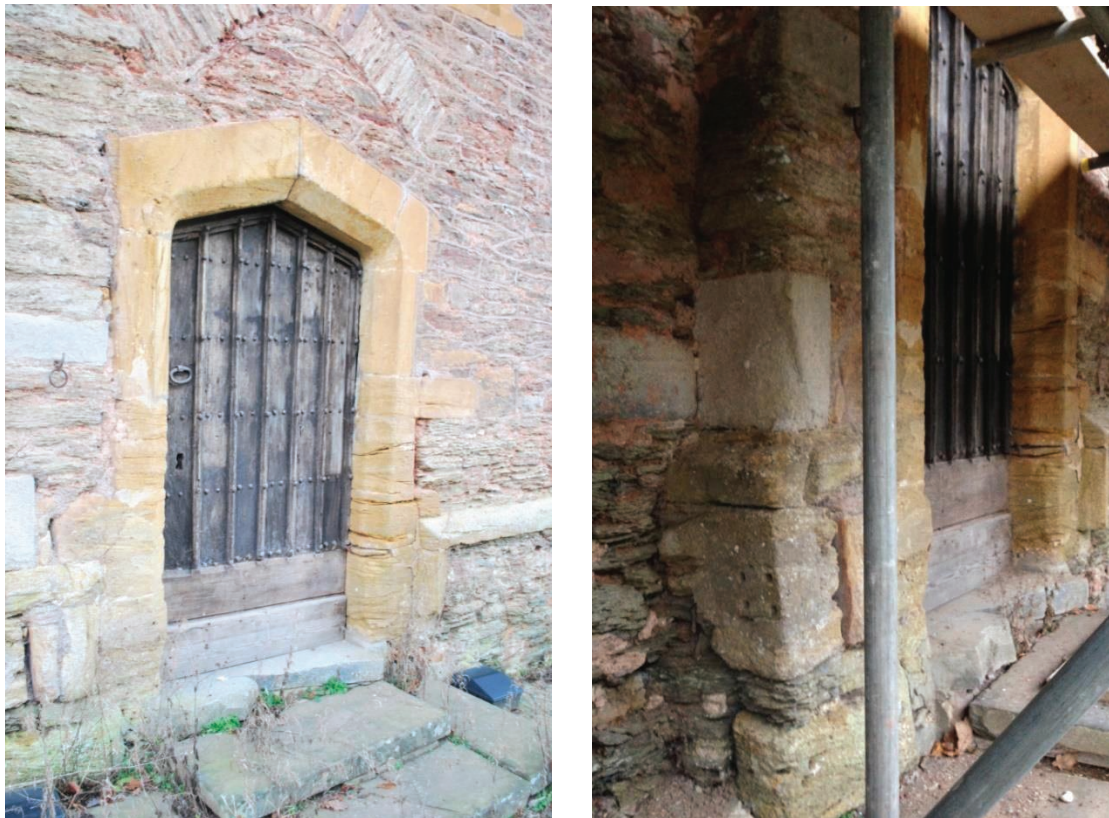
Fig. 2.19. External east door of the Hall building.

Fig. 2.20. East door with building join between the Hall and the Kitchen, the masonry indicates the Hall building was constructed first.

The east entrance door has a pronounced pointed arch, see fig. 2.19, as do the two door surrounds that flank it within the inner porch, leading north and south respectively, see fig. 2.21. These are the most pronounced high arches on the site, all other arched doors and windows having more flattened four-centred arches. Consequently these three door surrounds would seem to be the earliest surviving examples at Halswell.

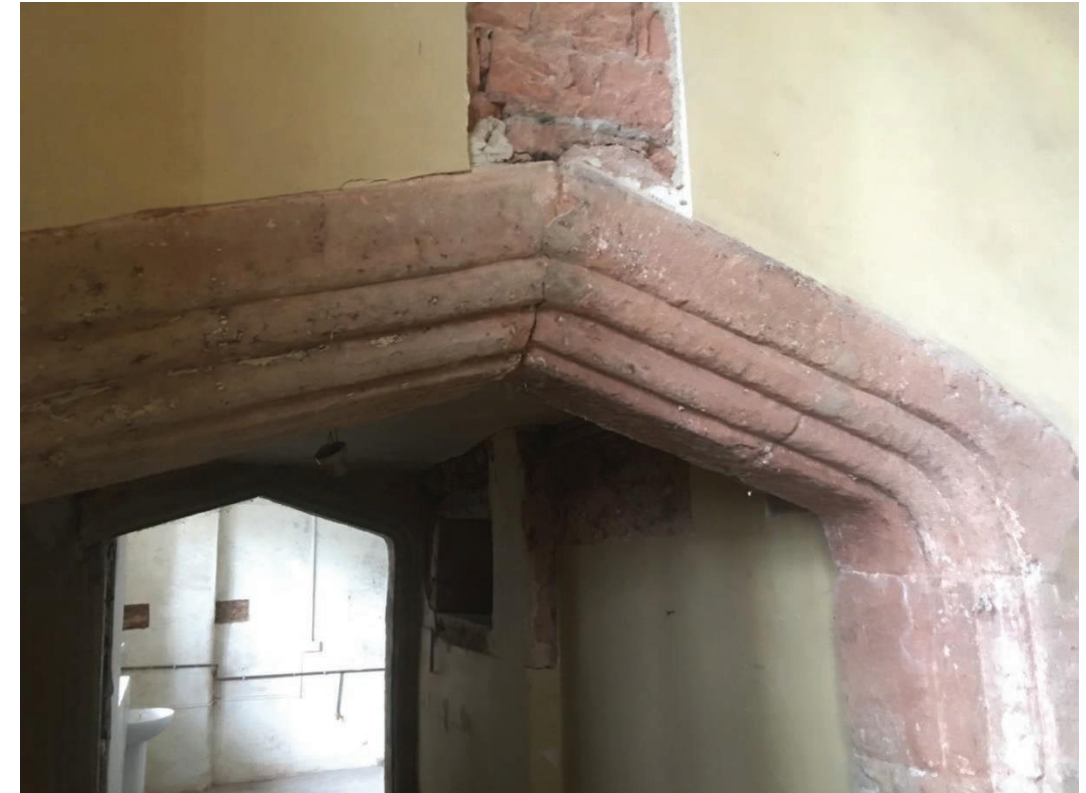
Fig. 2.21. Two similar four-centred arch door surrounds of red sandstone leading from the inner porch to the Hall and the Kitchen. Both doors are decorated only to their north, Hall-facing, sides with ironmongery to the undecorated south sides.

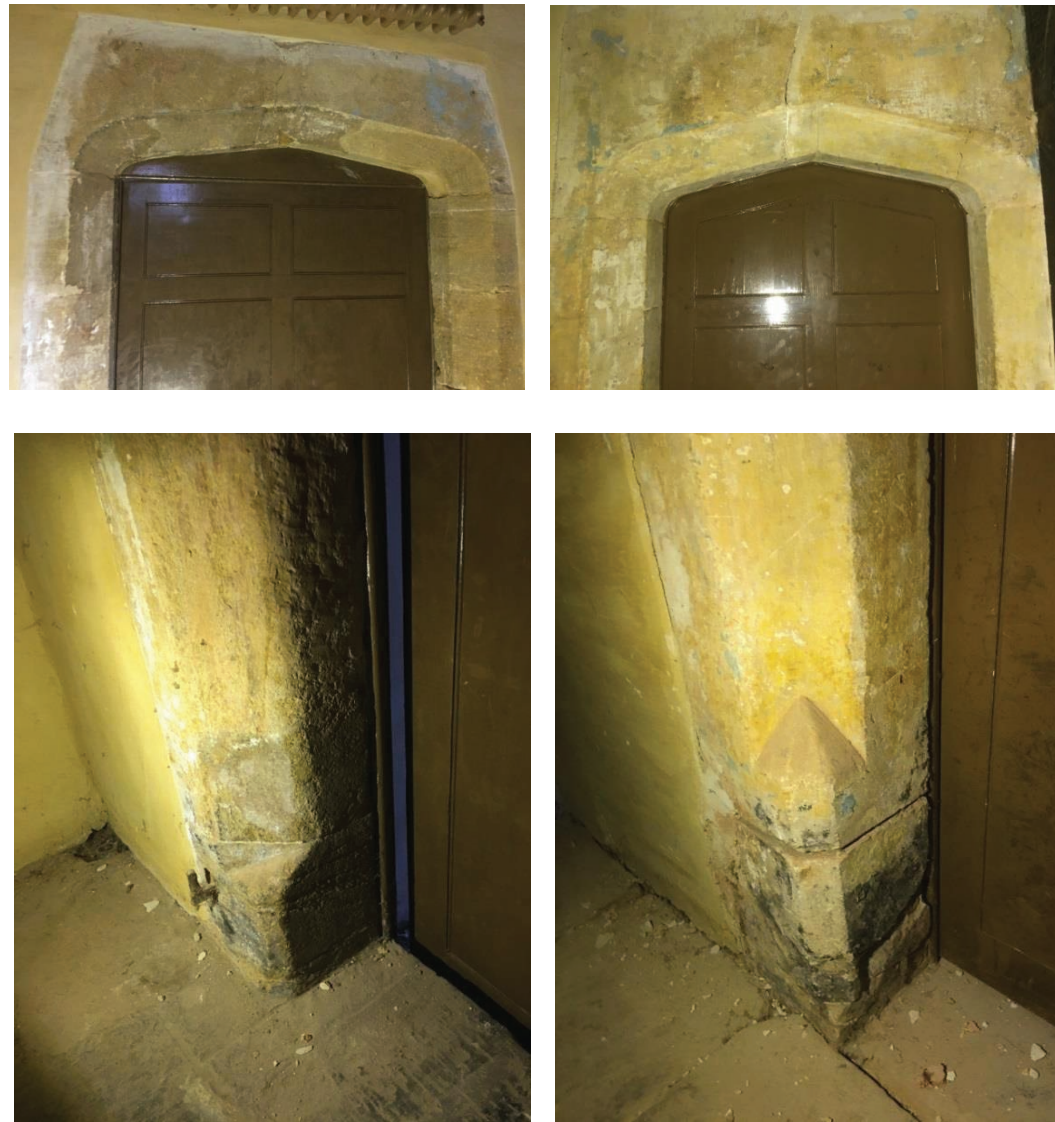
Figs. 2.22 and 2.23 (left). Ground floor: Hall west door, added c. 1590.

Figs. 2.24 and 2.25 (right). Ground floor: Kitchen west door, added c. 1590, possibly coinciding with a change of room use necessitating a door of equal status to the new internal Hall door.

Two further stone four-centred arch door surrounds are located in the west wall of the Hall and its neighbouring room, the proposed Kitchen. They have near-matching apexes to their flattened arches but differing chamfer decoration to their bases, see figs 2.22 – 2.25. The flattened-arch tops of these doors suggest they were inserted at a later date closer to the end of the sixteenth century, as does the position of the west door within the Hall, superfluous in a freestanding building with an internal porched doorway at the east. It is noteworthy that this west door is positioned exactly in the centre of the room's floor space and that the later sixteenth-century additional building created to the west terminates at the existing north wall of the Hall. Both occurrences lead to the conclusion that the Hall has not been truncated or at least not after c. 1590 when these proportionally complimentary additions were made.

earlier west walls of each room, see figs 2.22 – 2.25. This entrance gained some grandeur by creating a ceiling height to match that in the old Hall, possibly lit by two bays of mullioned windows. Further splendour was gained through the open balusters of the three-storey staircase which allowed light from all three floors of the southern gable to light both stairs and entrance hallway.

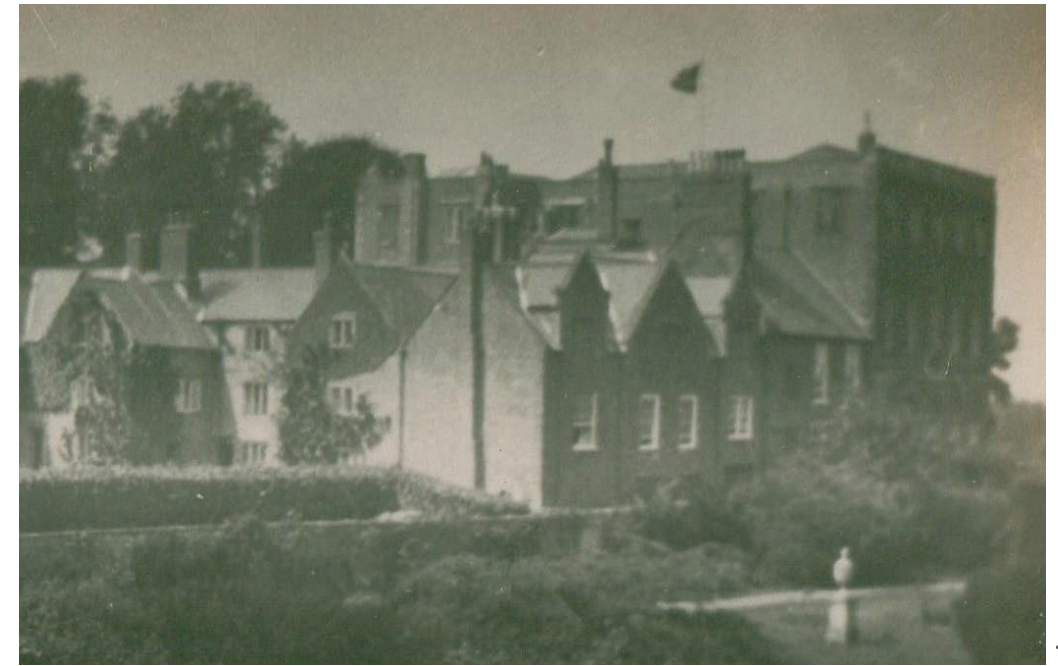
Fig. 2.26. Photograph c. 1908, the east range still with sash windows while mullioned windows had already replaced at least two sash windows in the south range.

Externally the entire east façade has the appearance of five stages of building, see figs 2.26 and 2.27: the 1689 wing to the north, next the Hall block, then the single-bay section with a full dormer window, to the south of which is a much wider two-bay gable and finally to the far south is a single-bay addition of the eighteenth century, remodelled c. 1900 to mimic the earlier single-bay section, this final section will be discussed in a different chapter.

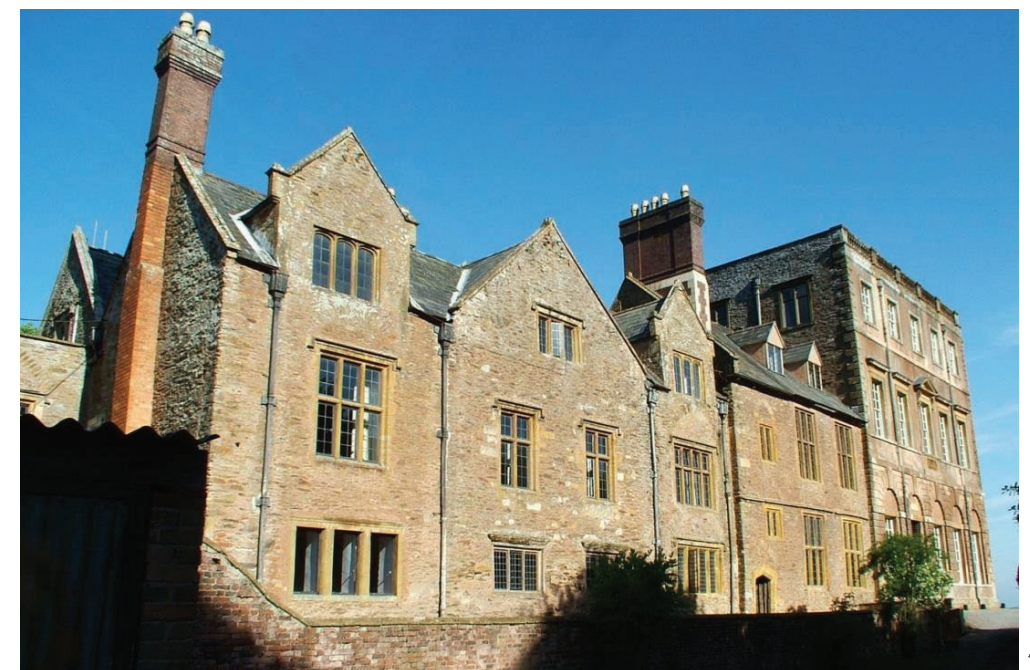
Fig. 2.27. c. 2006, east façade with new mullions of c. 1926.
