HALSWELL HOUSE, SOMERSET

A Structural History 1536-1689

Dissertation in Building History

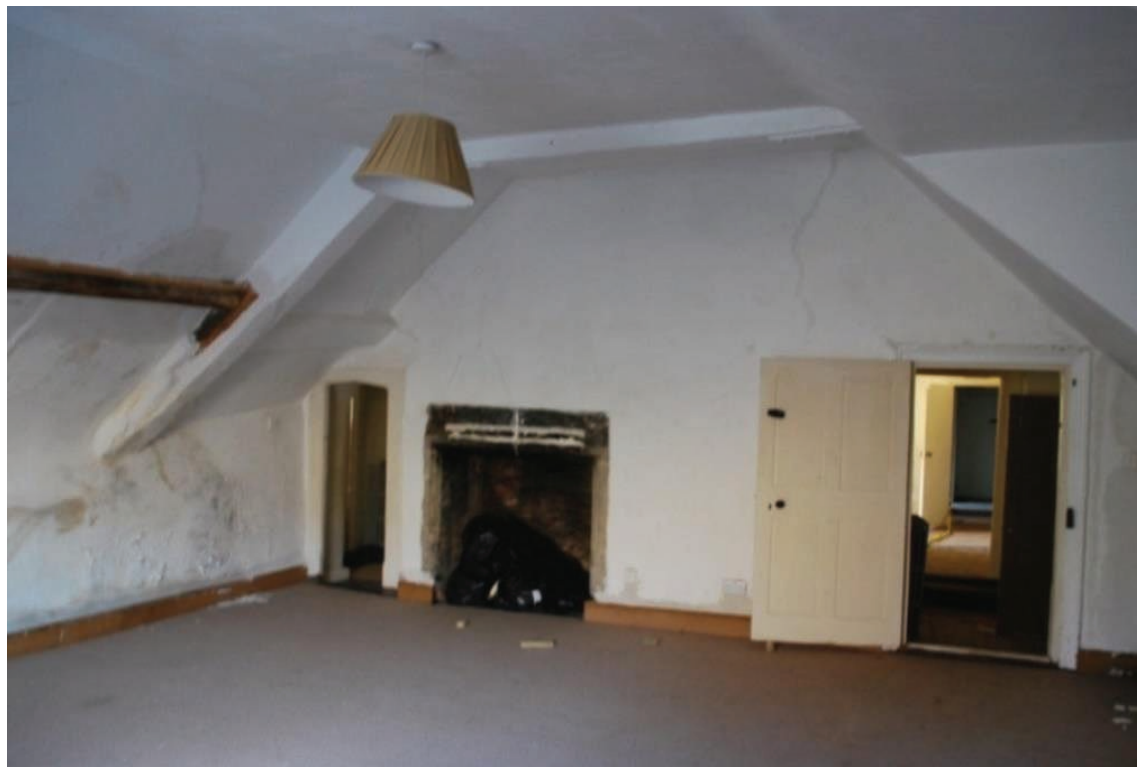
Fig. 2.30. The re-aligned attic of the two-bay section, looking west to the c. 1590 chimneystack and south range.

The roof structure of the older, eastern, two-bay section, though sagging and failing to a great extent compared to its neighbouring room opposite the chimney, is of the same build date as the roof to its west. When the c.1590 south range was built, following the line but not wall thicknesses of the earlier building, the new and old ranges were aligned and roofed as one continuous south range, however the weight of the older roof amended to lie across the new gable end was too much for the timbers to successfully carry.

The chimneystack wall is photographed again from inside the attic room in fig. 2.30. In that image the fireplace is seen inserted into this new c. 1590 stack, with new doors either side. The doorway on the left is visually datable to c. 1590 while the one on the right has only Georgian woodwork displayed. The failure of the amended roof structure above is visible here with iron bracing to the right; the replaced purlin to the left is associated with later structure built against that wall.

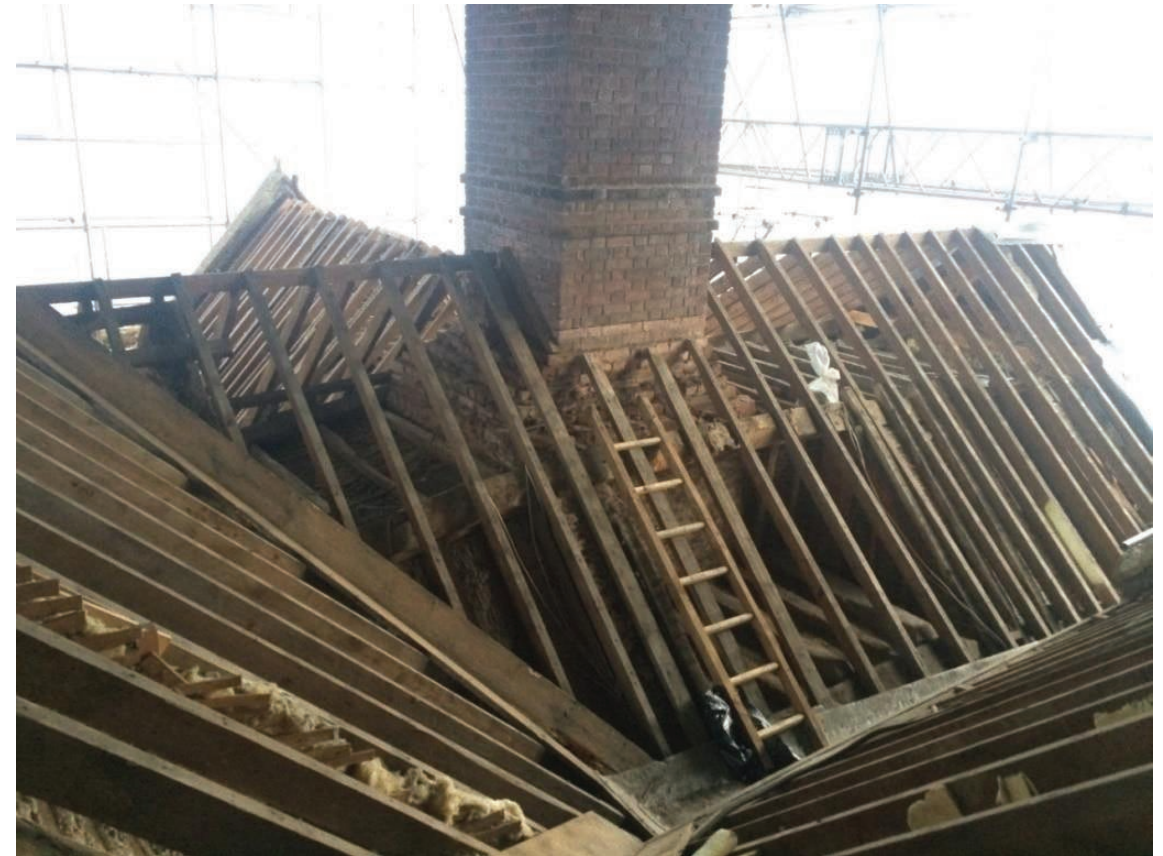
Fig. 2.31. The c. 1590 chimneystack at the east of that later range, see plan 2.6. The purlins supporting the ceiling of the new east facing gable on the earlier east range have sagged considerably from supporting the weight of the east range's older north to south roof alignment.

In fig. 2.31 the large chimneystack of the south range, otherwise hidden, has been exposed during re-roofing. The stack is built outside the west wall of the earlier east range building but buttresses to it, creating corridors through it at ground and first floor levels; a similar transit system to that believed to have been employed in the earlier Hall block. Immediately beneath the chimney in this illustration can be seen the horizontal oak framework of a small

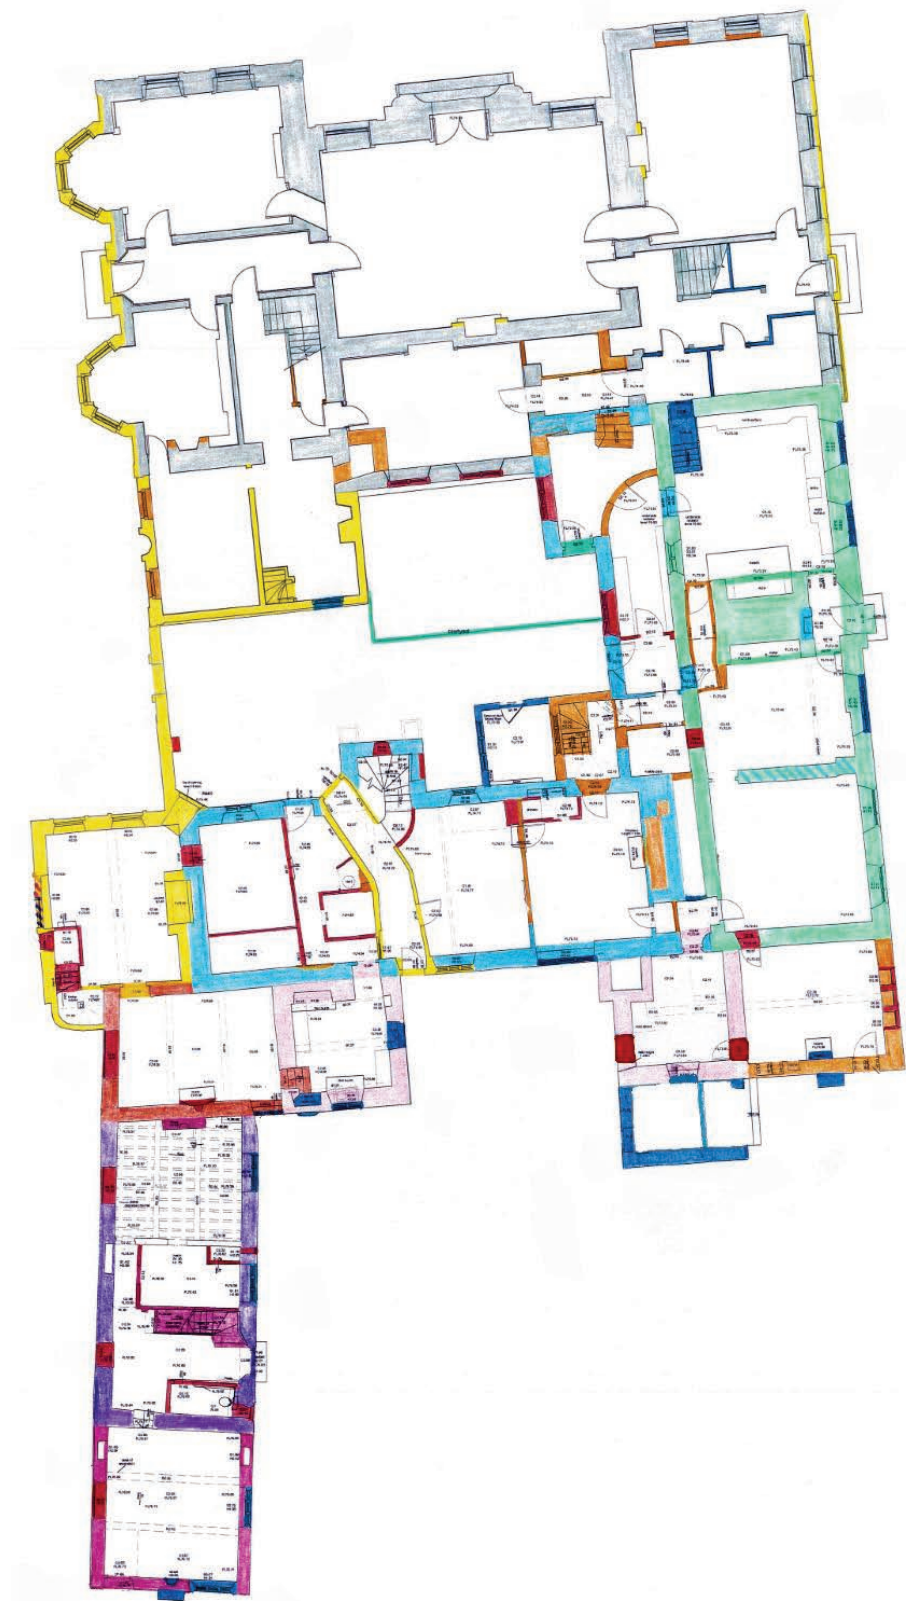
Plan 1.1.

Colour Key: c. 1536 – 1550, c. 1590, c. 1610, early-seventeenth century, late-seventeenth century, 1689, 1754, 1766, 1771, c. 1772-1899, c. 1900-1926, after 1950.

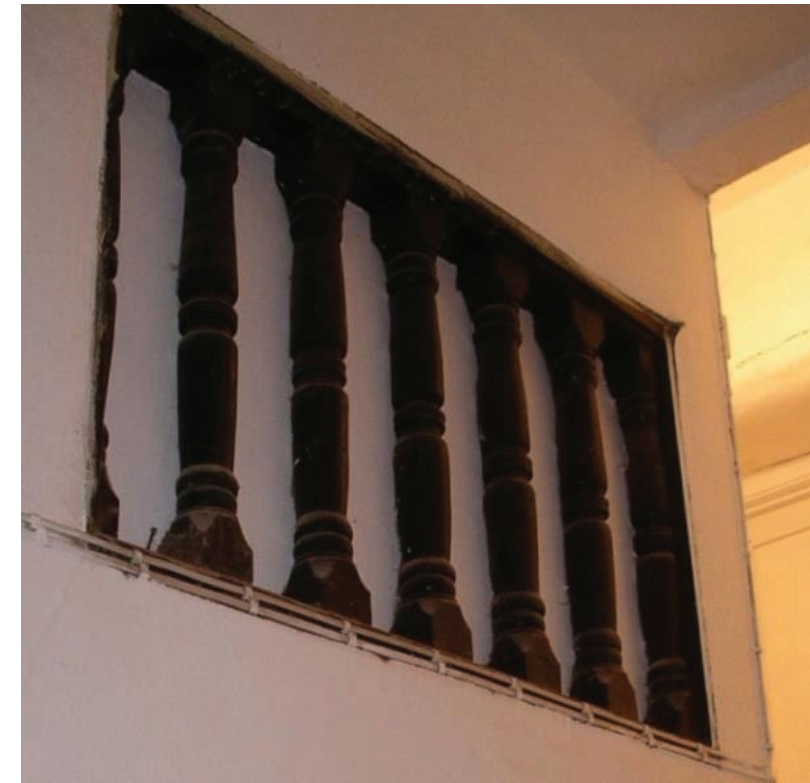
Fig. 3.1. One of four turned-oak baluster sections in situ at the south of the western extension.

The attic floor above can be accessed from either end of this level, via the external north stair tower or through a door with a finely carved flattened four-centred arch of c. 1590 in the north-east corner. That door leads directly onto a southward passage through the chimneystack, a mirror of the now in-filled service passage on the ground floor, and to the north is the staircase of c. 1590, see fig. 3.1, at the south-east junction of the two ranges built at this date.

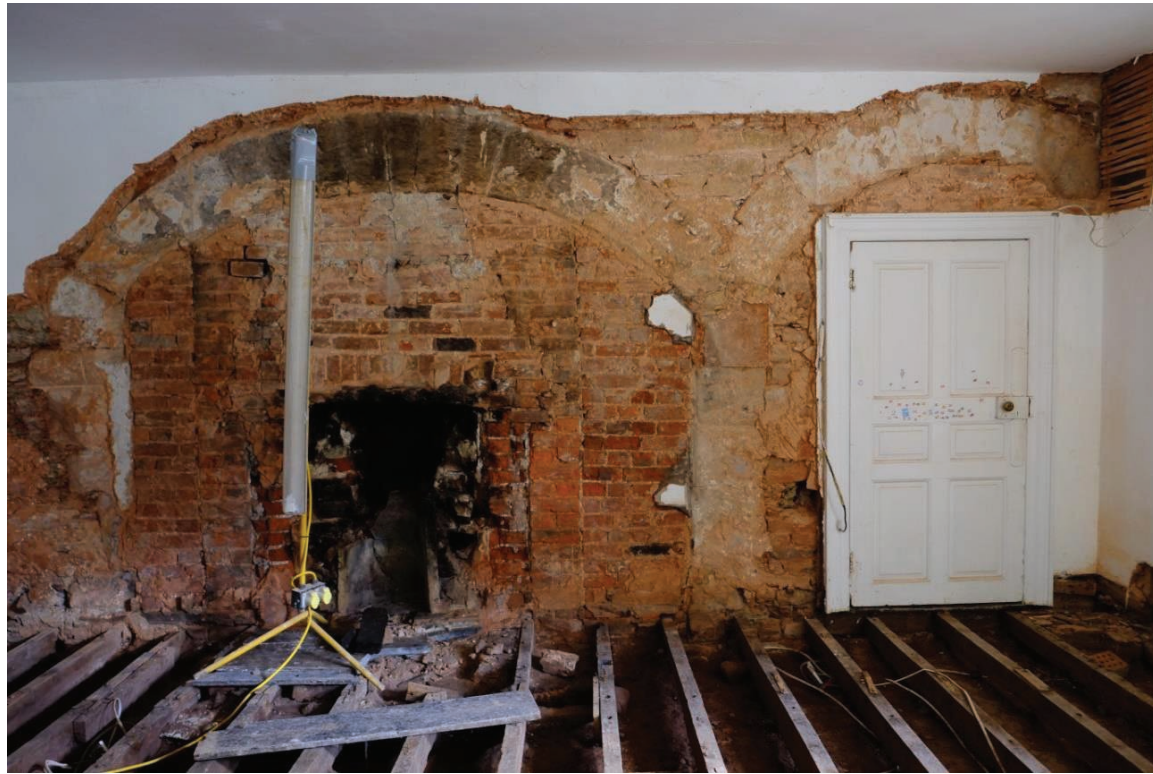
Fig. 3.2 The broad arch of the newly exposed sixteenth-century service fireplace with bread oven to its left and door arch to the right, leading to the service passage behind this fireplace and to the Buttery in the, now attached, two-bay gabled section to the east.

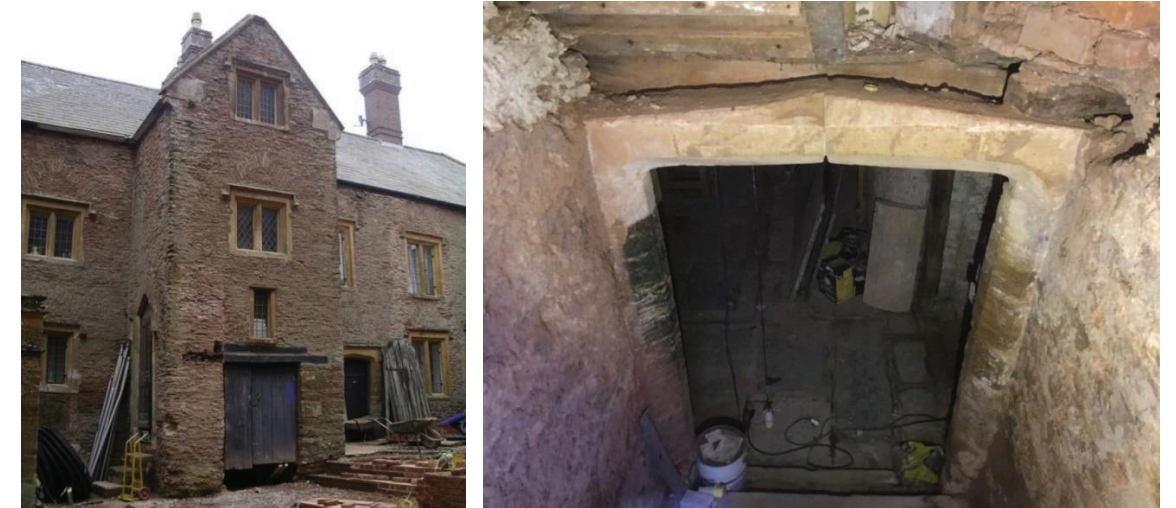
Fig. 3.3. South range, north elevation, c. 2008: stair tower with north cellar entrance and east entrance to floors above, to its west a four-centred arch door.

Fig. 3.4. A flattened four-centred arch door surround incongruously at the foot of the cellar stairs.

The room above the Cellar, with its restricted height and lack of heat source, is likely to have been service chamber. It may have been linked to the floors above by the external staircase tower to the north, which had two entrances. This tower shows no signs at the junctions of the wall to which it adjoins that it was added at a later date, the masonry suggests it was built contemporaneously with the south range. It had a large north-facing entrance probably decorated with a four-centred masonry arch leading to the Cellar below. This opening has for most of the twentieth-century been without an original door surround. The lintel was replaced with a rudimentary timber insert and the tower itself supported by a pier of twentieth-century buttressing, now removed. The area where its relieving arch would be expected has been reworked for a later window opening. At the foot of the stairs in the Cellar is a four-centred arch door surround that is unnecessary in its current location and appears to have been repositioned here from the ground-floor stair tower entrance, presumably being replaced by the wooden lintel in the twentieth-century, see figs. 3.3 and 3.4.

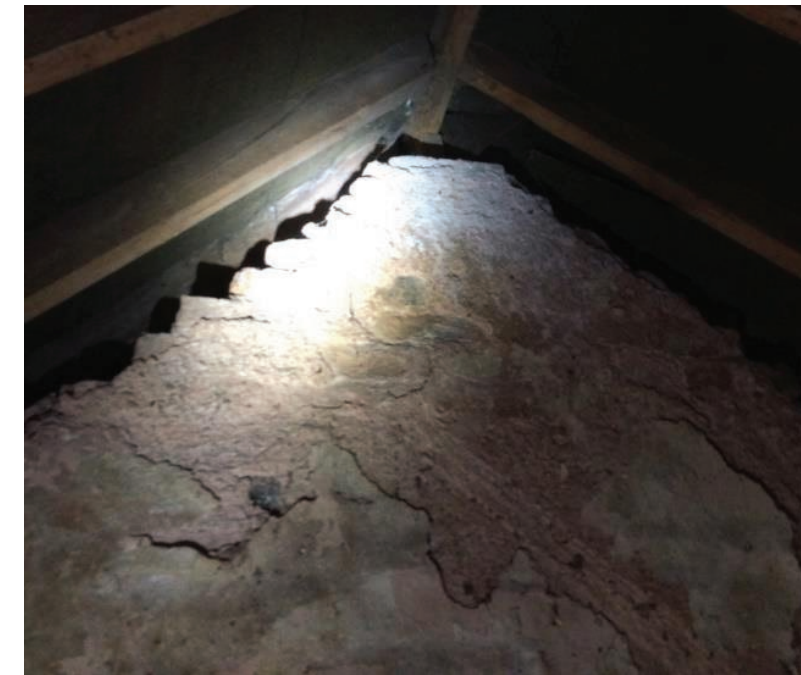
Fig. 3.5. The original plastered western gable of the c. 1590 south range, from the interior, east side.

This c. 1590 defunct west gable in fig. 3.5 is plastered rough stone suggesting that this space was inhabited. In this western section of the south range most of the roof timbers have been replaced. The thin rafters visible in fig. 3.5 date from the re-roofing of c. 1926. Evidence of

access to or a light source for this room seems lost through these modifications; however it is noteworthy that the attic space in the eastern portion of this range, which still remains intact, has attic level windows to its south side, originally dormers.

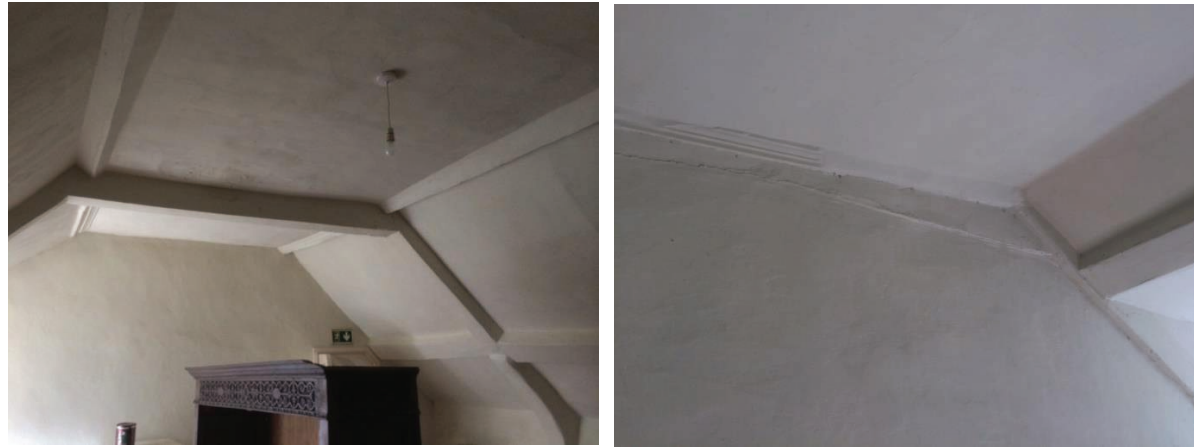
Fig. 3.9. South range, east section, attic storey.

Fig. 3.10. A detail of the running rib cornice above a plastered jointed cruck arch beneath which has been added a later partition wall.

This attic space above this eastern section of the c. 1590 south range has a jointed-cruick roof of five spans. The main purlins of each are plastered on the inside with a decorative running rib cornice. The jointed crucks tie-beams also have corning; all appear to have been decorated from construction. The space is currently bisected by two partition walls and a short corridor. Only the lath and plaster partition wall in fig. 3.9 is shown as existing in the c. 1924 plans, however as the wall does not respect the position of the jointed crucks or return the running rib cornice it would appear to be a later addition, possibly c. 1926. However the position of this wall does correspond with that on the floor below, which in turn is in line with the partition wall in the ground-floor Kitchen, which itself rests upon the east wall on the Cellar, which is made of rough stone.

The original dormer windows in this section and much of the roof construction are still intact; new roof levels were simply added on top of the existing timbers. Fig 3.10 partly illustrates

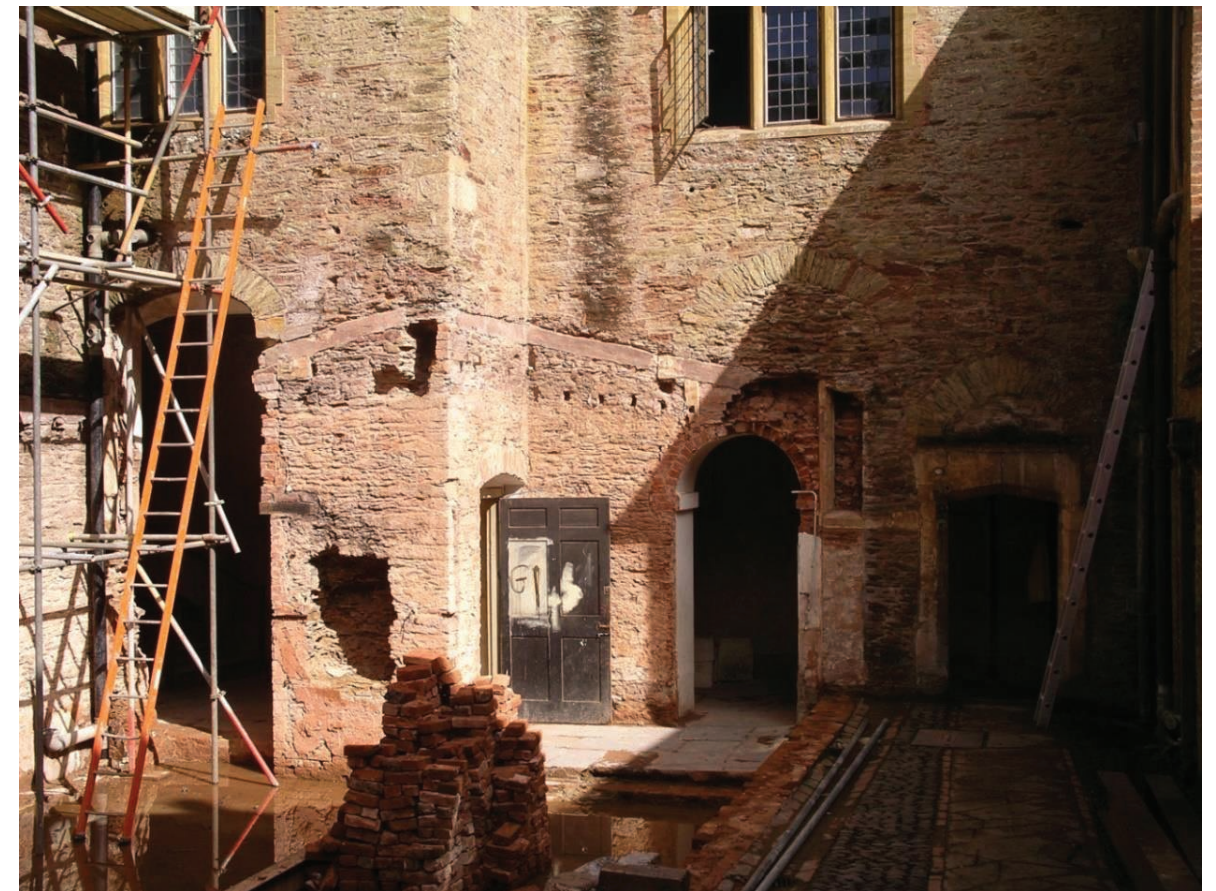
Fig. 3.11. North and central gable sections c. 2005, with the eighteenth-century openings exposed during the demolition of the Servant's Hall. There is a 1771 door opening through the south wall of the north gable. A lower-right horizontal section of the original central gable window still existed, touching the door's left jamb; the upright mullion was reused in its position.

As this section projects westwards beyond the rest of the range it has space on its south elevation for openings, there is no evidence of any except a later ground-floor level door, see plan 3.15 and fig. 3.11, which appears to date from the construction of the now demolished courtyard Servants Hall of 1771. Other features in this room include an angled niche, steps up through a door in the north wall with a repositioned plaster over-mantle of c. 1600 above, and a red brick curved wall with a door. The mullioned window in plan 3.15 is a wooden replacement of c. 2006 replicating the window position of the example that partly existed up to c. 2006 in the central gable section, see fig. 3.11.

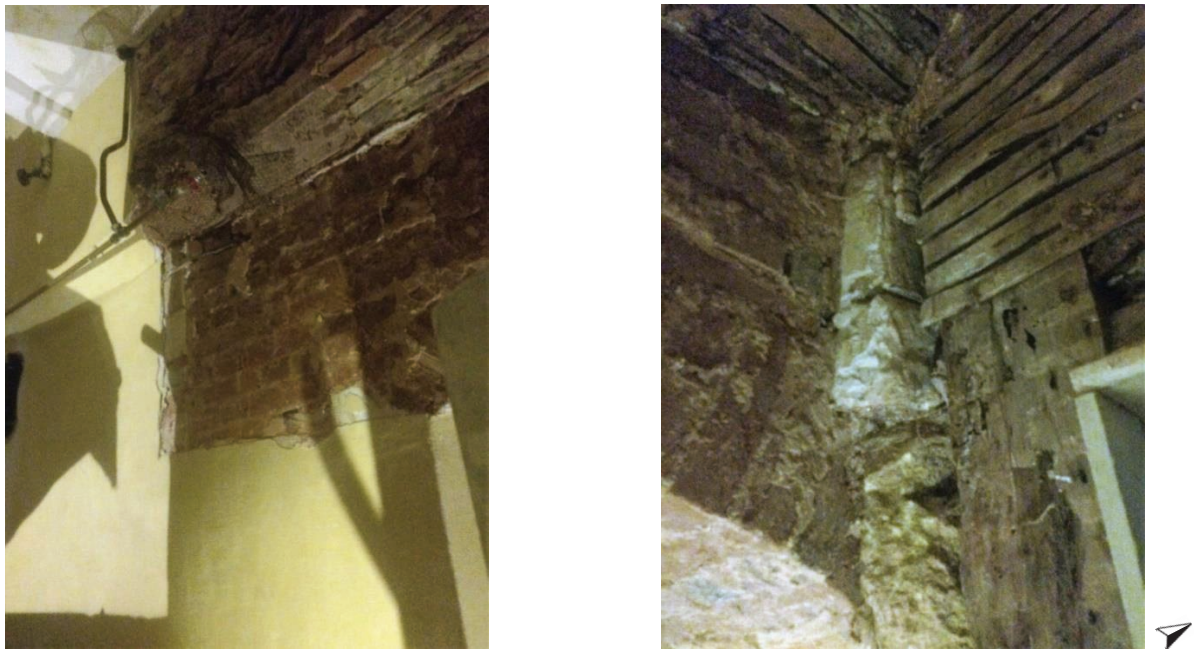
Figs. 3.12 and 3.13. The removed c. 1590 first-floor window left and right upper corners, from within its c. 1590 staircase gable.

In the south gable section the first-floor window proportions and partial outline are visible from inside the range, see figs. 3.12 and 3.13. The window was removed by the time a new red brick stair tower, rising from the ground to the first floor, superseded the corresponding portion of the older c. 1590 stairs which sits behind this once external stone wall. The oak lintel above this window opening as well as some ham stone corners from the removed window openings left and right sides are still *in situ* on the inside of the expanded wall opening, now partly filled with a red brick arch giving door access to the later staircase.

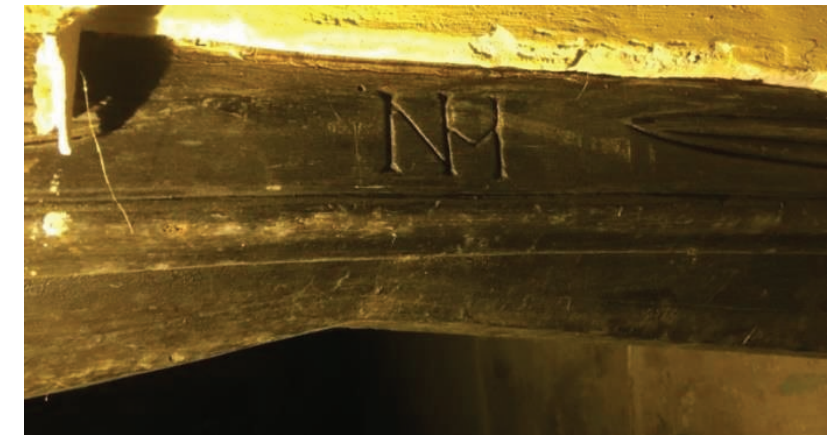
Fig. 3.14. Initials on the four-centred archway.

entrance corridor. This would position the foot of the stairs where a double-sided oak archway still exists in the hallway, see fig. 3.15. The double-sided carving and the lack of ironmongery indicate a decorative archway, not a door. Its four-centred arch is topped with the carved initials of Sir Nicholas Halswell MP (1566-1633) who was responsible for this entire building phase, see fig. 3.14.

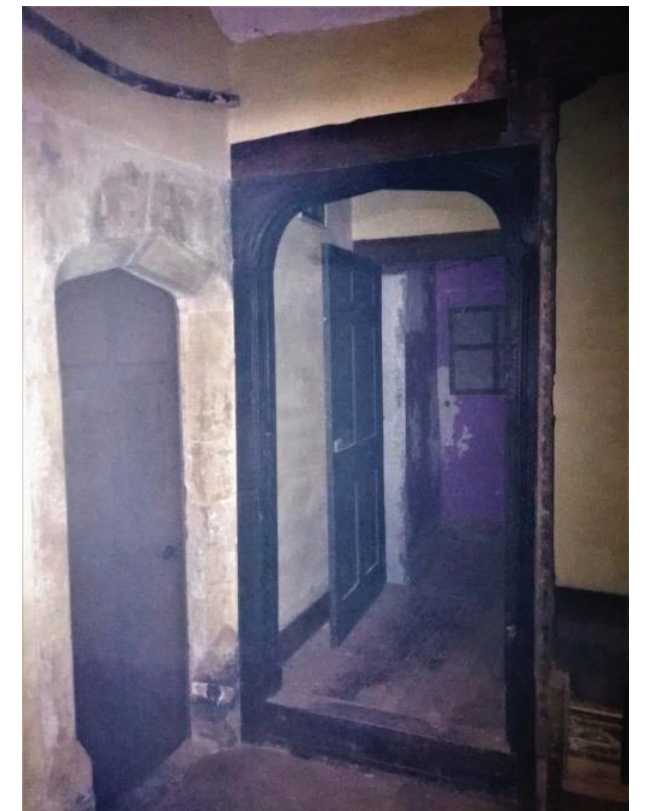
Fig. 3.15 Oak arch at the foot of the c. 1590's stair position, blocked service passageway to the new Kitchen beyond and c. 1590's stone door surround to the old Kitchen or new Parlour on the left.

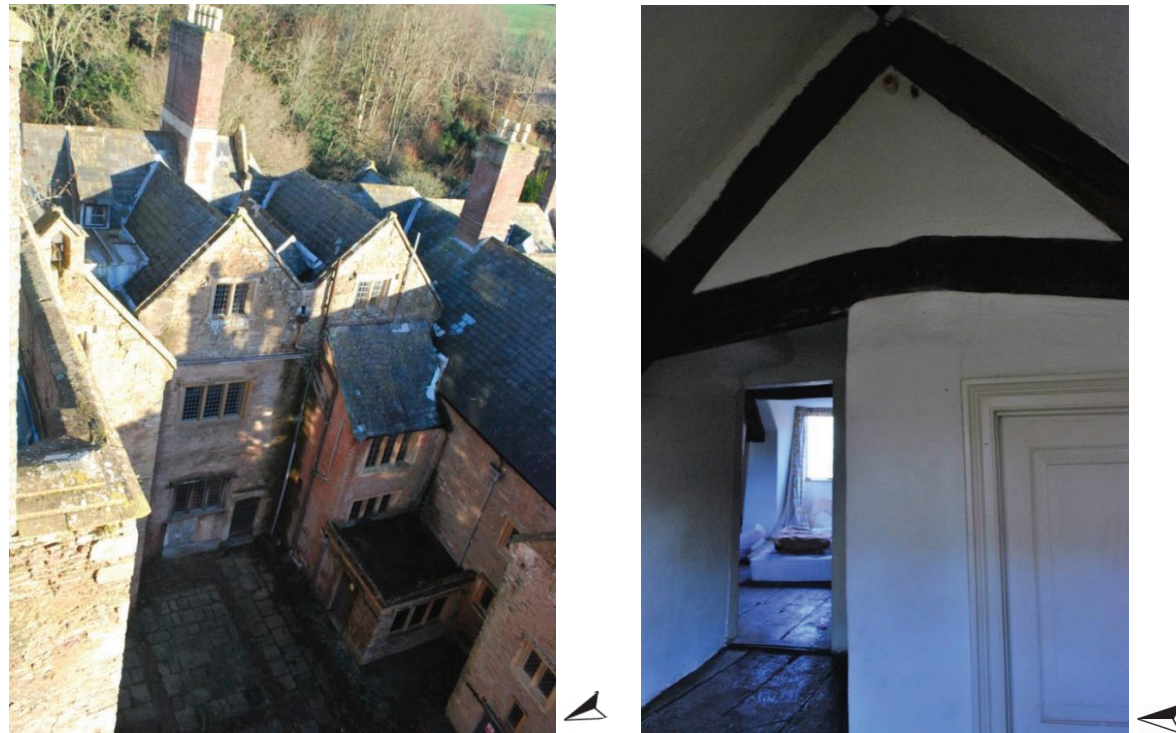
Fig.3.16. The three gables of the westward extension, c. 2014.

Fig. 3.17. Central gable section: the collar rafter roof joins with the attic of the Hall and sits above the termination of the c. 1536 staircase which lay behind the modern plaster wall and door to the right, which itself still leads downwards to the neighbouring attic chamber to the right.

The triple-gabled western addition, see fig. 3.16, served three functions. The south gable provided a new staircase which connected all floors of the new south range and the old east range. This allowed the earlier small staircase arrangement at the Hall's chimneystack to become redundant, see fig. 3.17. The central gabled section contained only corridors to facilitate that access. The northern gabled section contained rooms and judging from the greater thickness of its north wall it was built as the termination of this range.

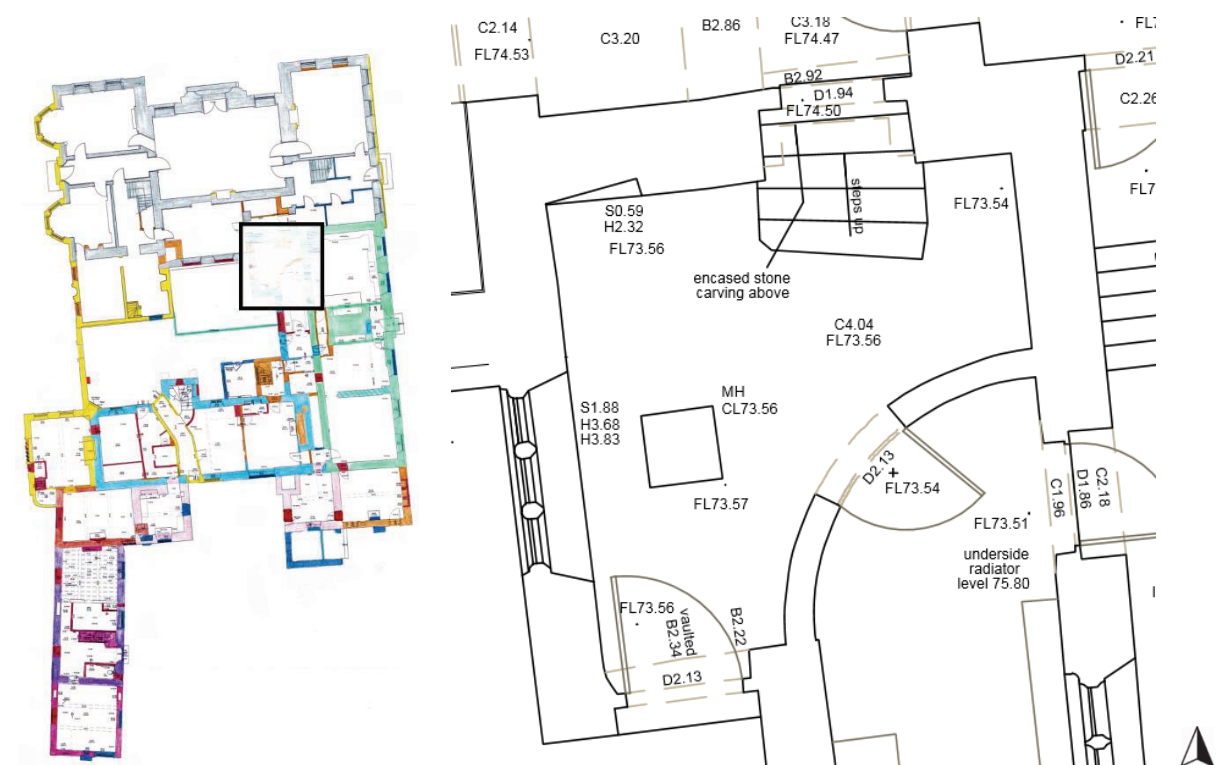
Plans 3.14 and 3.15. Location key and ground floor detail of the north gable section.

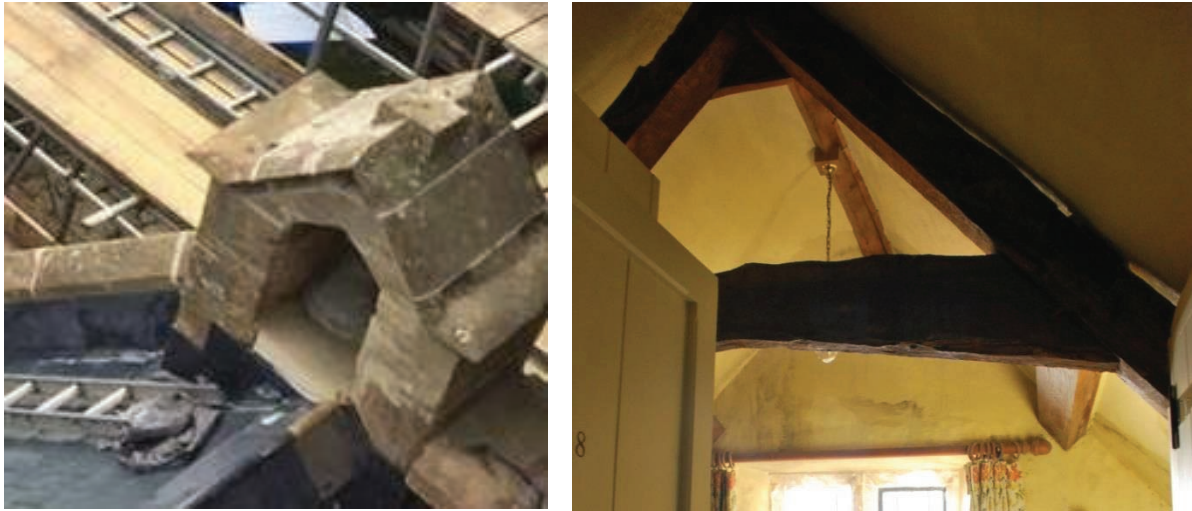
Fig. 3.18. The bellcote-topped north gable, which has five mounting indentations.

Fig. 3.19. The collar rafter roof of the bellcote gable.

Starting from the top, ironmongery was discovered in 2015 running across the roof and terminating at the east entrance door of the Hall, suggesting that the bell was used, at some time, as a door bell for the east entrance as it did for the west entrance which is contemporary with the bellcote. Its canopy has five mounting indentations, see fig. 3.18, to support an ironwork weather vane. Beneath this the gable attic, see fig. 3.19, had the same fenestration to its west side as the other two gabled sections beside it. Its ham stone mullioned window has considerable wear at the base from the bell rope that terminated in the courtyard.

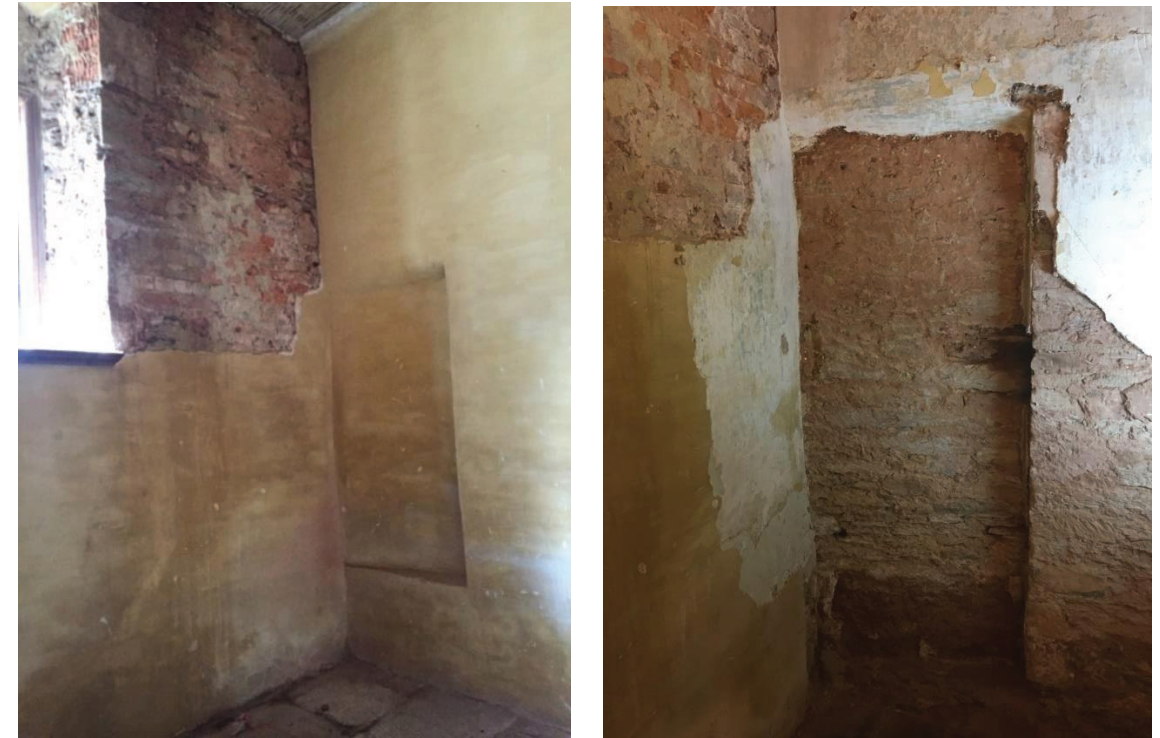
Figs. 3.20 and 3.21. In-filled opening in the north wall of the north gable, with and without modern plaster. The half-door and angle of the opening suggests a spiral staircase but without invasive examination the nature of the area remains unknown. The area to the west wall, right of the window, has been in-filled with redbrick suggesting a larger opening at this corner.

The angled niche is intriguing, recent removal of modern plaster, see figs. 3.20 and 3.21, has shown the opening reaches one step from ground level and has also uncovered a four-centred arch made of plaster, the only plaster feature of its kind at Halswell. The apex of the arch is visible but the remaining third of its span is hidden behind the corner of the west wall, which itself has been heavily disturbed and is in-filled with eighteenth-century brick. The hidden part of the door surround might indicate this north wall led to another part of the building, destroyed, or at least this doorway obscured, when the bellcote gable was added. However the flattened arch suggests it is not likely to date from before the c. 1590 phase.

The portion of the surround that is hidden behind the west wall would correspond well to a corner external stair turret, which are common in the locality. Greenham Barton Manor, already compared to Halswell for its internal oriel window, has three such external spiral stair turrets. In addition to the brick in-filling there are suggestive elements to the west to support this possibility.

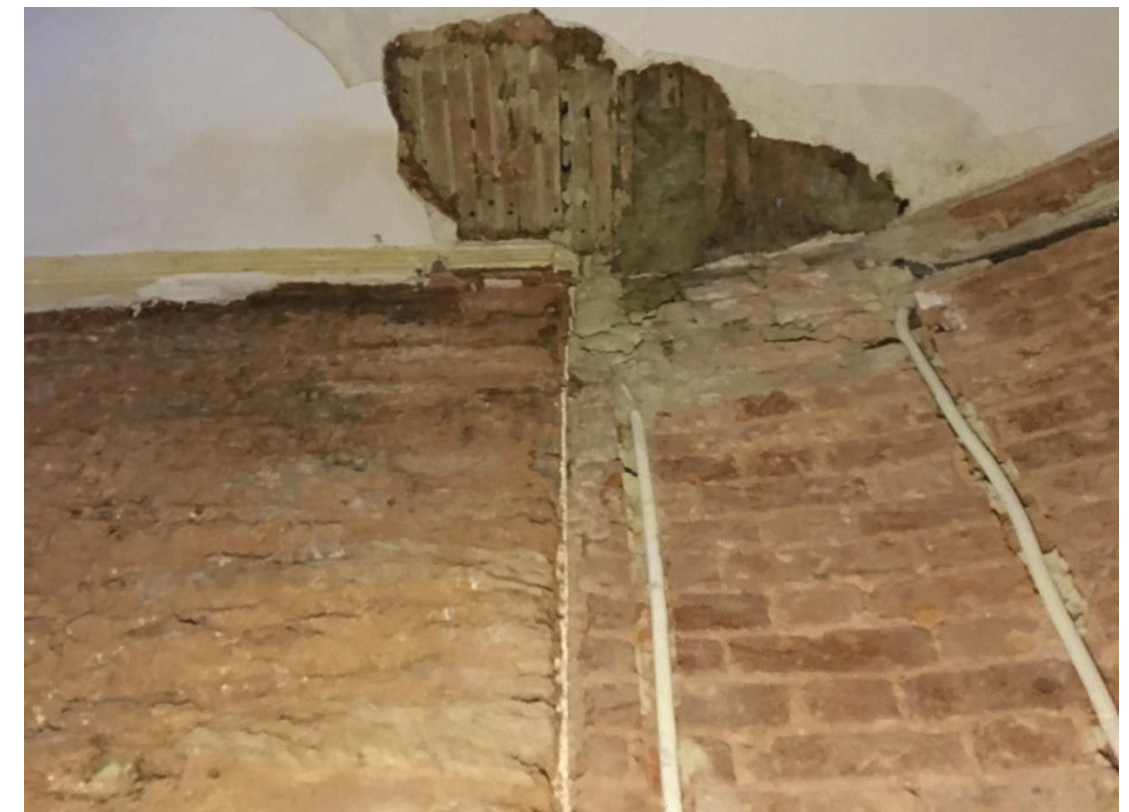
Fig. 3.27 The quoins, returning plaster and returning running rib cornice of the central gable section, with a later red brick partition added to the right.

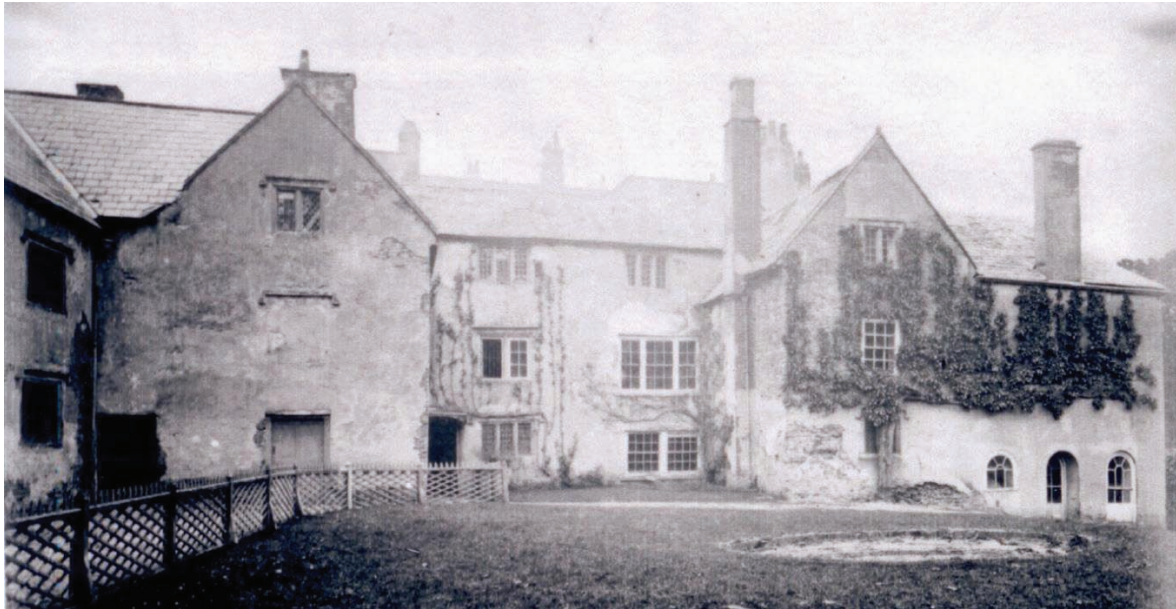
Fig. 3.28. South range, south elevation, c. 1898.

The earlier roof truss to the right in fig. 3.6 no longer directly supports purlins between this section and the modern king post. This is due to this section of the roof being raised on the south side creating a decreased roof pitch to the south-eastern section of the range. This decrease in roof pitch is associated with the original dormer windows at the south being filled-in at either side, thereby changing that elevation from two storeys with a dormered attic to a three-storey elevation. The roof retains its original higher pitch westward from this foreground king post and the unequal roof levels are masked by a further south chimneystack at this junction attached to the slightly later gabled projection at the south, see figs. 3.28 and 3.29.

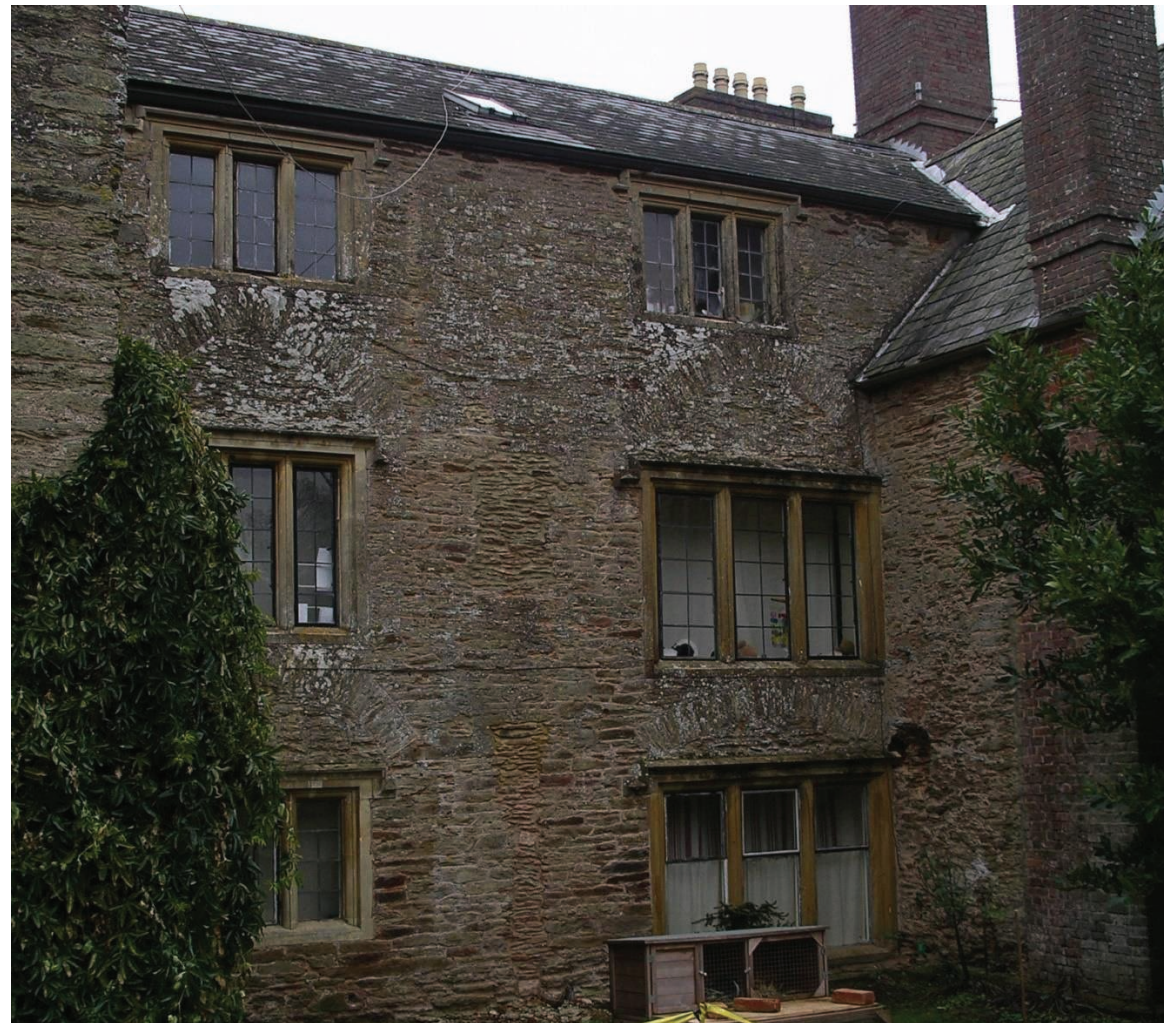
Fig. 3.29. The exposed area of the south range, c. 2004

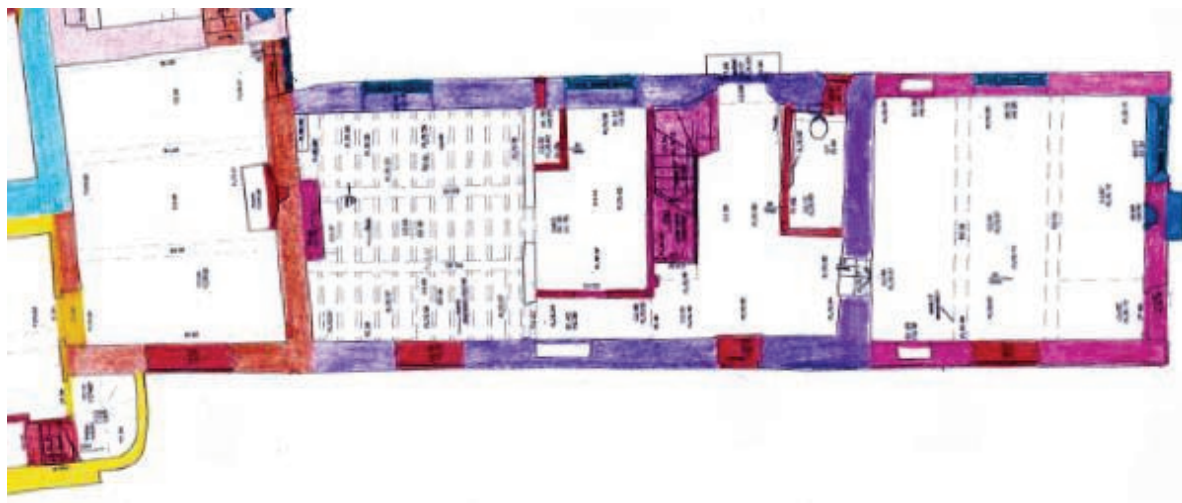
Plan 4.2. Colour code: c. 1590, light blue; c. 1610, pink; early seventeenth century, brown; late-seventeenth century, purple; 1754, yellow; magent, 1766; c. 1900-1926, dark blue; after 1950, red.

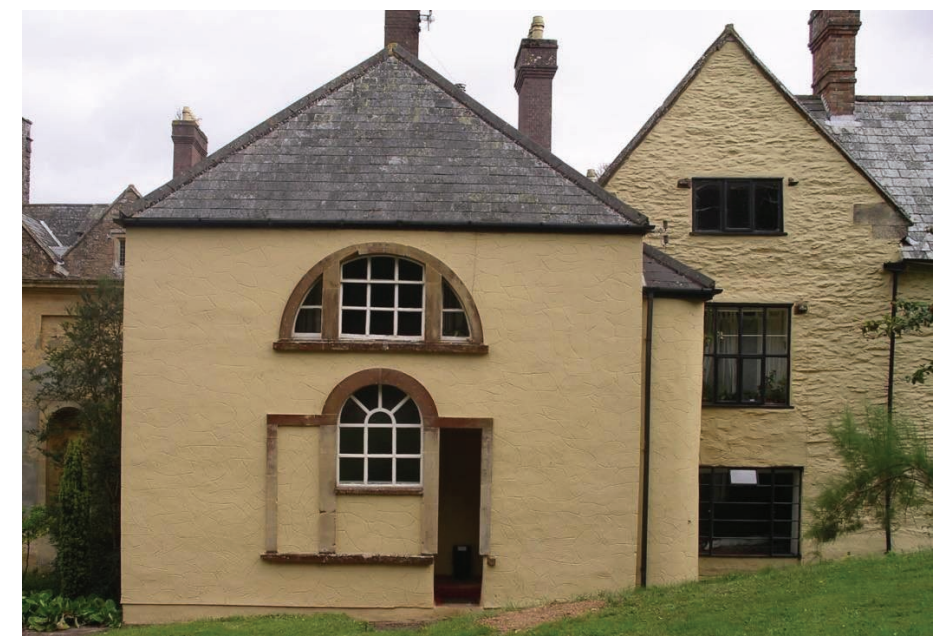
Fig. 4.1. Single-bay, two-storey below an attic extension of rough stone with twentieth-century Crittal windows, a 1754 Palladian addition overlaps from its north.

The single-bay at the north extends from the west wall of the western projection on the south range; the roof construction of this new gable has consumed that of the west side of the earlier projection, which is retained within the attic space, see fig.4.2. This single-bay addition of two-storeys below an attic projected further west than the other buildings at that time. There is no staircase linking the three floors of this addition, the ground and first floors act as extensions to the earlier connecting projection on the south range and there is no remaining evidence of a stairs from first floor to attic.

Slightly larger in proportions but in style this addition is in keeping with the earlier phase of finial-topped gables with cut-stone kneelers and hood moulds above the mullioned windows. In this case the only remnants of original fenestration are the hood stops at attic and first-floor levels, which can be seen in fig. 4.1 at either side of modern windows. The installation of the metal window on the ground floor has badly disturbed the opening, so much so that it is not known whether this opening contained a window or a door, or indeed if there was a pre-1950's opening on this level.

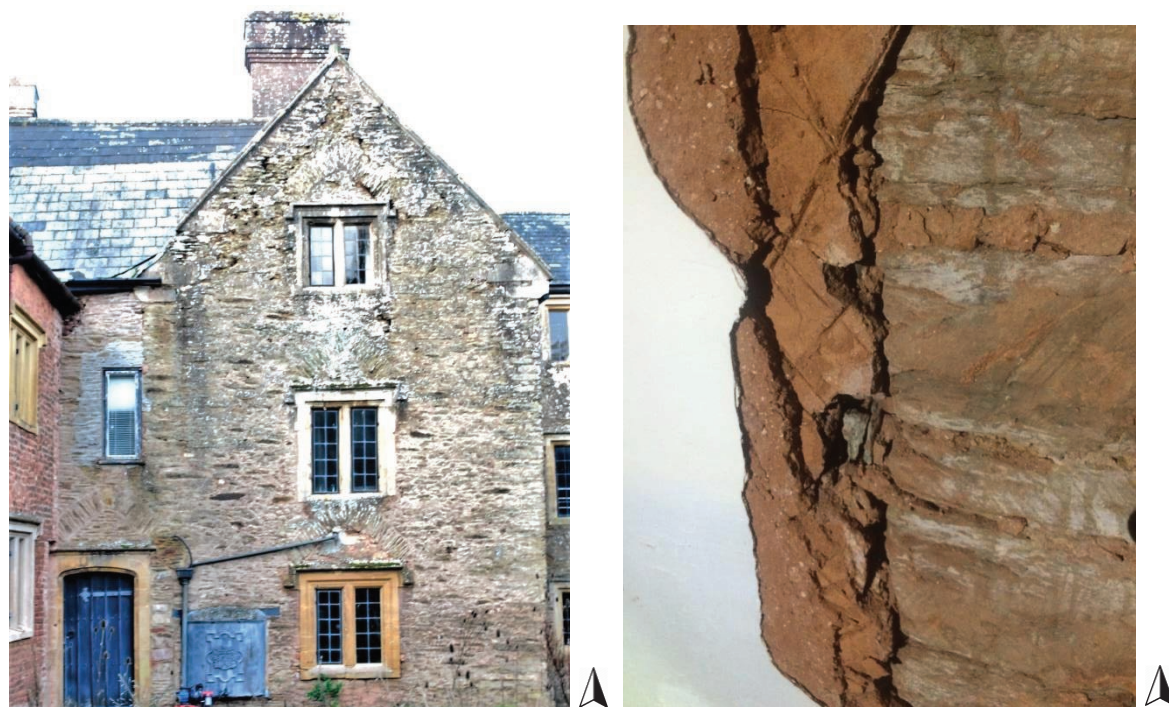
Fig. 4.2. The western projection of the south range with the addition's roof joining it from the west, the new south wall of the addition is partly visible with a doorway and modern window above.

The evidence that this is a separate phase of building comes through its position; wedged between other buildings the joins of separate phases are clear internally beneath the plasterwork, as well as through reference to the wall thicknesses. The existing walls of the south range, and its western projection, have been used to form two sides of this building, requiring new walls only to the addition's south, west and a short section to the north. The original free-standing corner of the older south-west projection is visible in fig. 4.2 where the new door surround rests against its quoins, its relieving arch cuts into those older quoins.

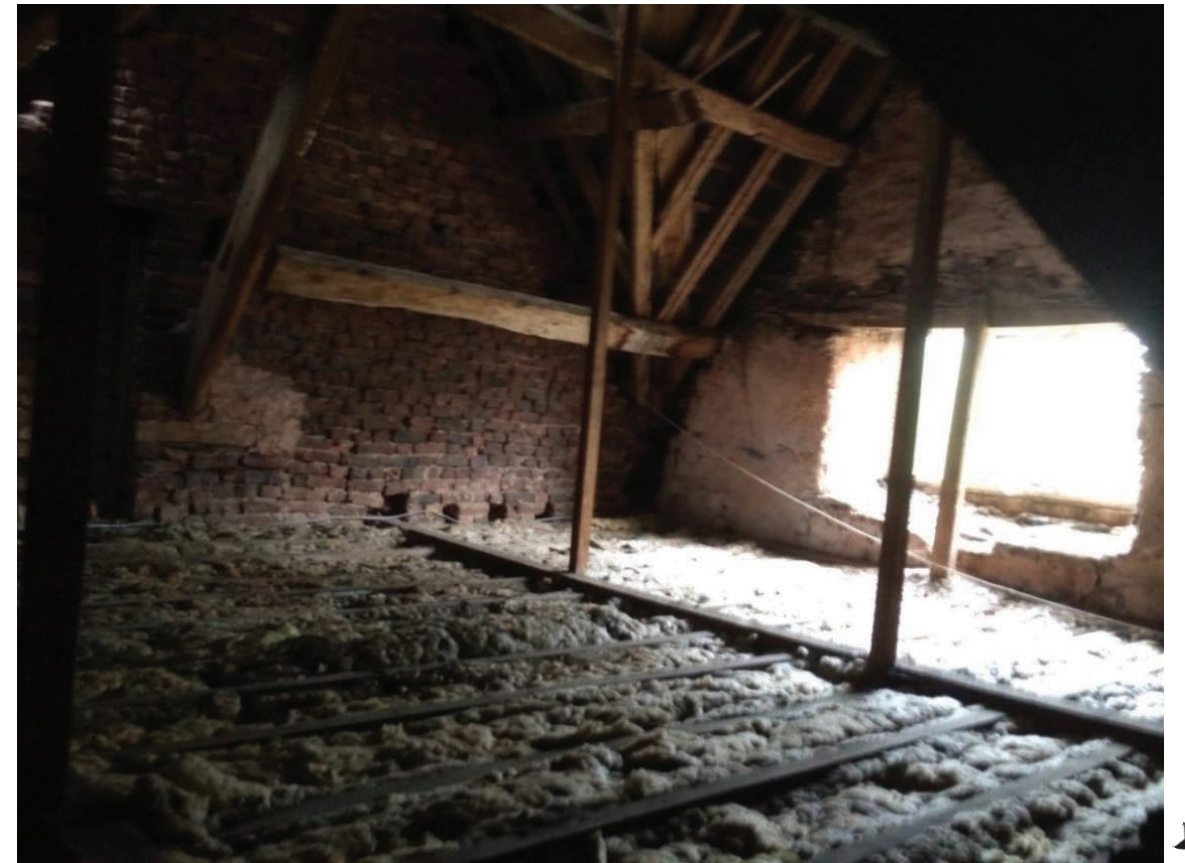
Fig. 4.4. The earlier single-bay addition at attic level, looking toward the longer range.

To the south of this single-bay addition is a longer building which is of a slightly later date and agricultural in nature, see figs. 4.4 to 4.7. At attic level, the intrusion of this building's roofline into the earlier is clear. A later red brick partition wall is built upon the earlier stone southern wall of the single-bay section. There is a low doorway to the left of this image that connects the attics of both buildings, this is the only level at which the two buildings interconnected. There are no heat sources in either of these attic spaces.
