HALSWELL HOUSE, SOMERSET

A Structural History 1536-1689

Dissertation in Building History

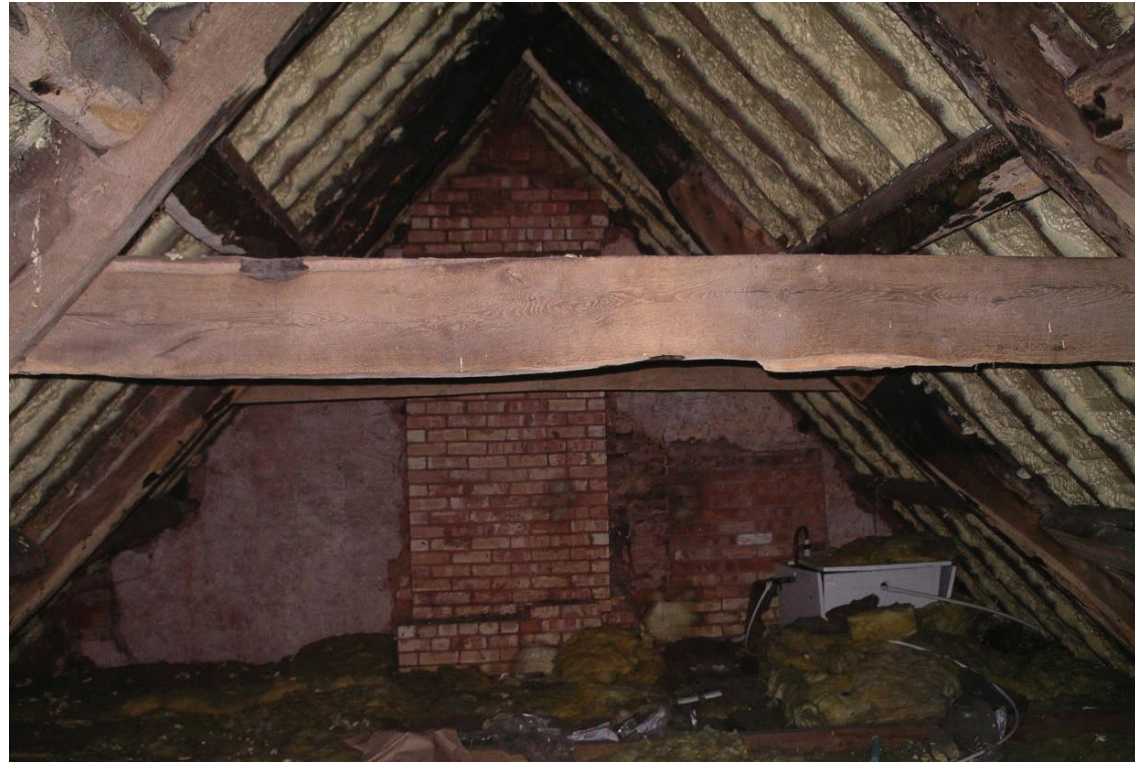
Fig. 4.5. South-west wing attic looking north to a later red brick wall with an in-filled door to the left.

The dateable material in the attic consists of collar rafter roof timbers, see fig. 4.5, and remnants of plaster, on a lath section above one tie beam and on the original south gable which is now hidden within a later and longer roofline. At the base of this gable wall there is some evidence of a fireplace and removed stairs from ground to first floor between the hearth and the east wall. This twist of the stairs is also still discernible in the stone of the first-floor gable wall, though this configuration has long since disappeared, as has the use of the attic space as a habitable area.

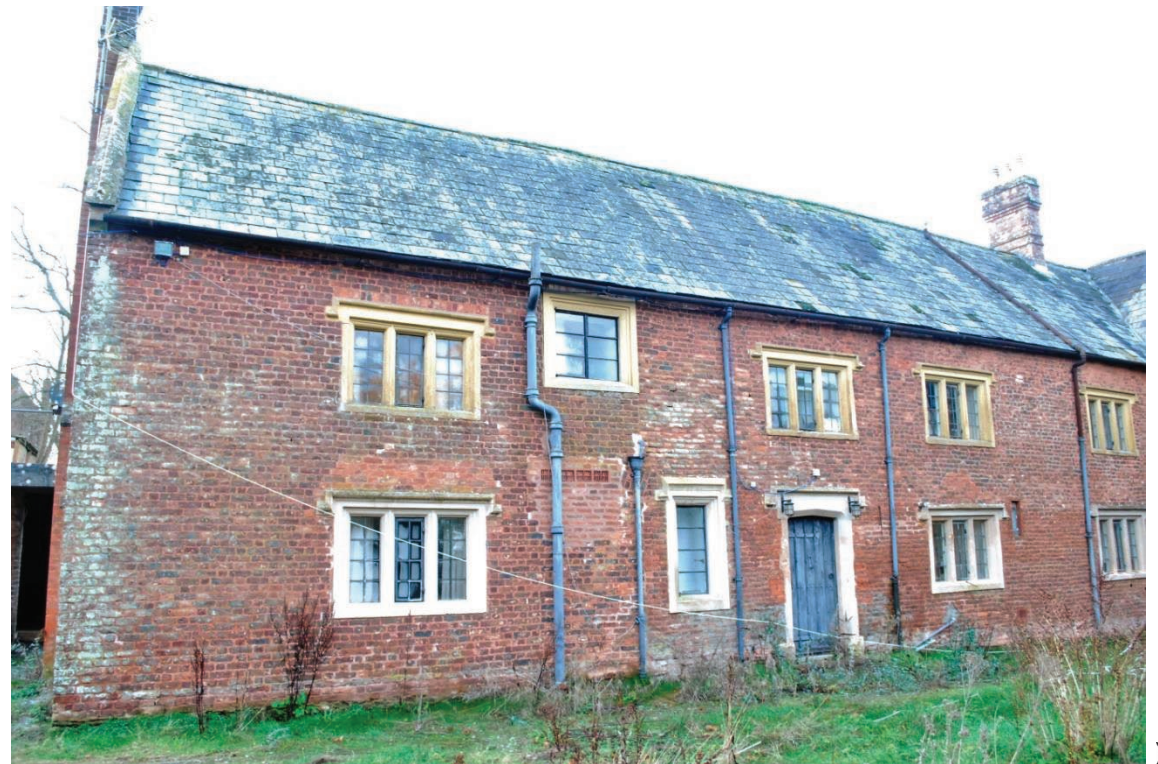
Fig. 4.6. South-west wing, east elevation. The southern section of this range is 1766.

To the south of this single-bay addition is a longer building which is of a slightly later date and agricultural in nature, see figs. 4.4 to 4.7. At attic level, the intrusion of this building's roofline into the earlier is clear. A later red brick partition wall is built upon the earlier stone southern wall of the single-bay section. There is a low doorway to the left of this image that connects the attics of both buildings, this is the only level at which the two buildings interconnected. There are no heat sources in either of these attic spaces.

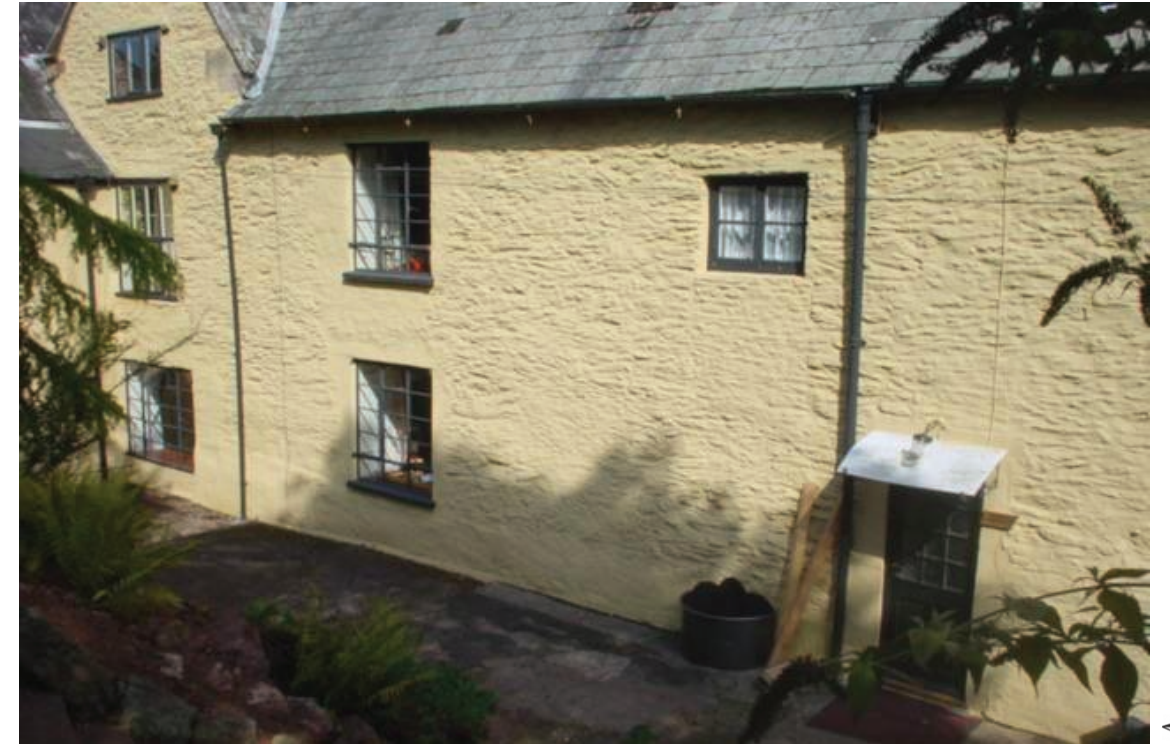
Fig. 4.7. South-west wing, west elevation, the northern, fully seventeenth-century section.

The west elevation is of rough stone and was built against a natural mound of land, now removed; resulting in a partly-submerged ground floor from that elevation, see fig. 4.9. There are narrow windows near the ceilings of both the north and south rooms so the ground level did not rise beyond these. The west elevation has been heavily modified in the twentieth-century however the only apparent historic door opening on the elevation, now in-filled, is at first-floor level, see fig. 4.7 and 4.9. There is a small wooden casement window inserted in

the top section of this earlier door opening, see fig. 4.7. This would have opened internally to the landing opposite the later staircase, which was moved to this area after the smaller seventeenth-century one near the earlier fireplace was removed. This probably occurred when the dairy was added to its south wall, as the proximity of a heat source adjoining the cooled dairy would have been problematic. Internally the ground floor has a stone drain along its west wall, possibly a feature to carry away penetrating ground water from the spring that fed the well or water reservoir on the hill above, which itself was encased in a stepped pyramid in c. 1741, see fig. 4.9.

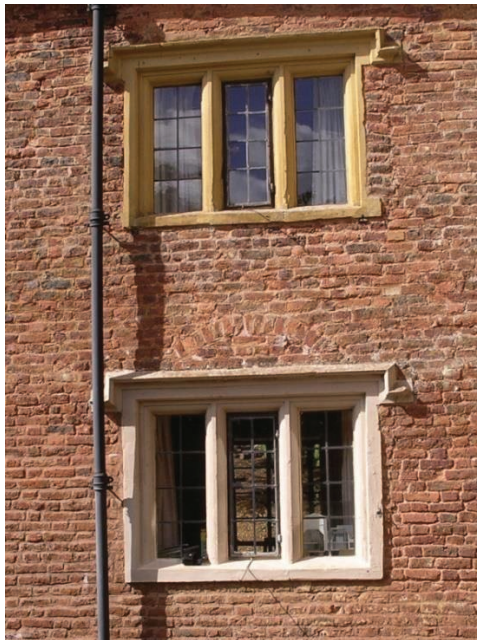
Fig. 4.8. Mullioned windows inserted at a later date.

Many, if not all, of the mullioned windows are later inserts. Most of the windows display clear signs where they meet the brickwork of being inserted after the brick was already in place, see fig. 4.8. These were likely to have been installed between c. 1900 and c. 1926.

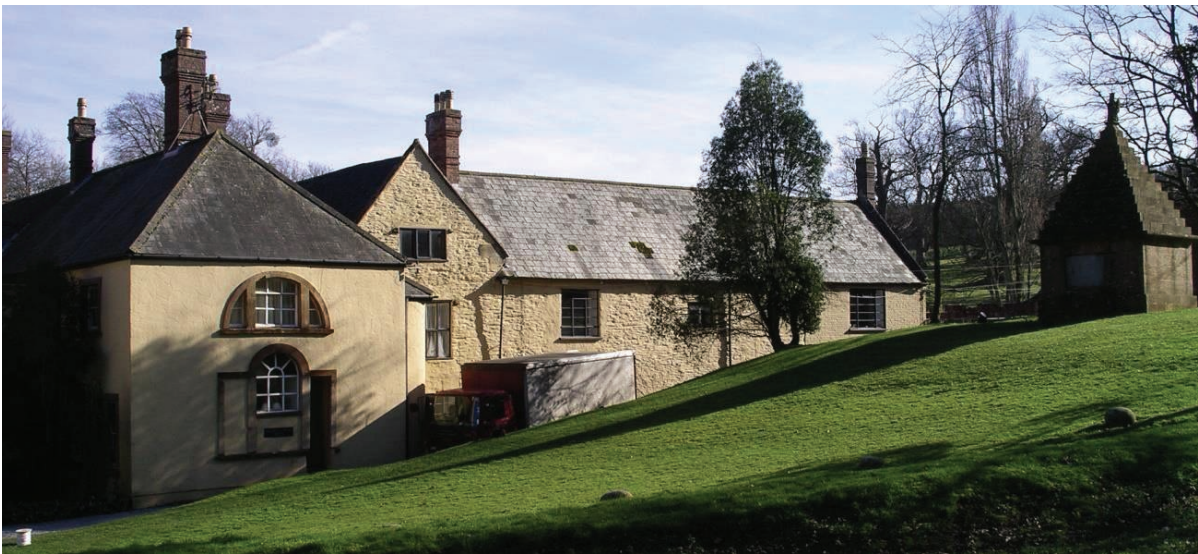
Fig. 4.9. West elevation with natural landscape contour which once abutted the building's wall necessitating access at this elevation only from the first floor.

The floor heights in the building were changed, probably in c. 1950; the original floor joists in the northern first-floor room have been taken out and realigned at a higher level, this would have made the attic space too low for habitation. The exterior of the east elevation of this stone building has been faced with redbrick. The bricks appear to be of seventeenth-century manufacture so may have formed an outer skin to the building when constructed. The southern portion of this building, see plan 4.2, was built as a dairy in 1766,⁸⁸ the brick join is perceptible on the east façade and very clear on the west where it abuts the rough stone of the earlier building, see fig. 4.9.

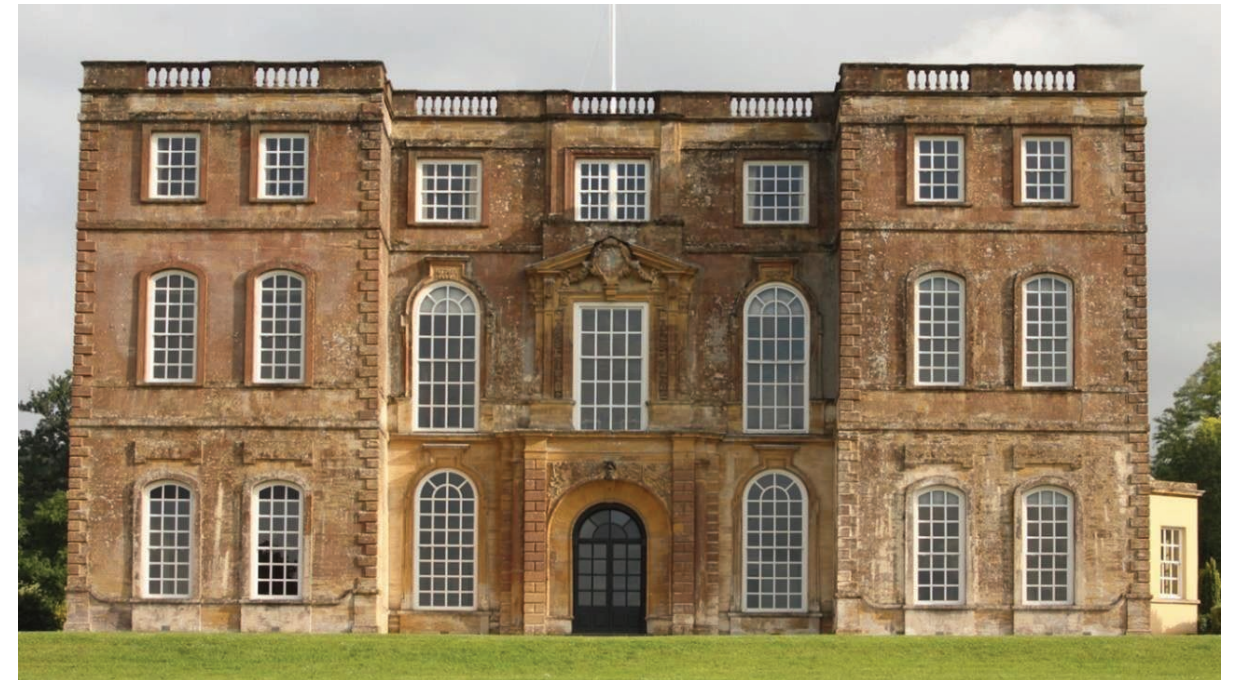
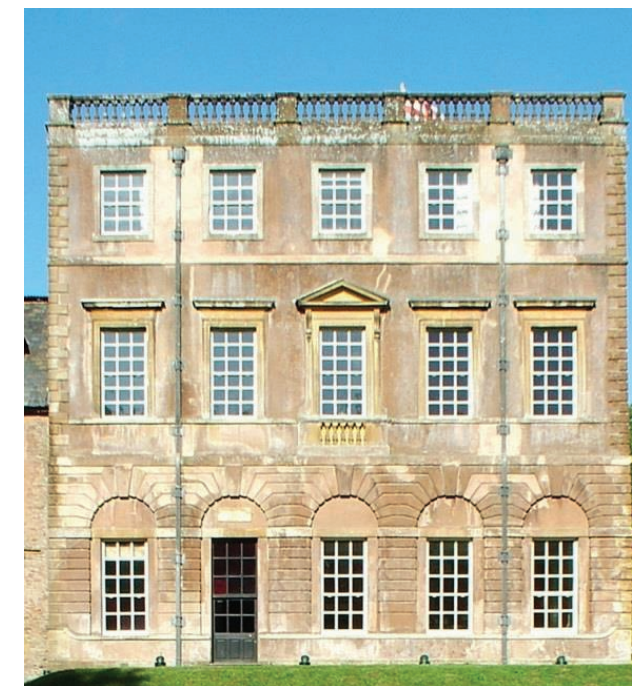
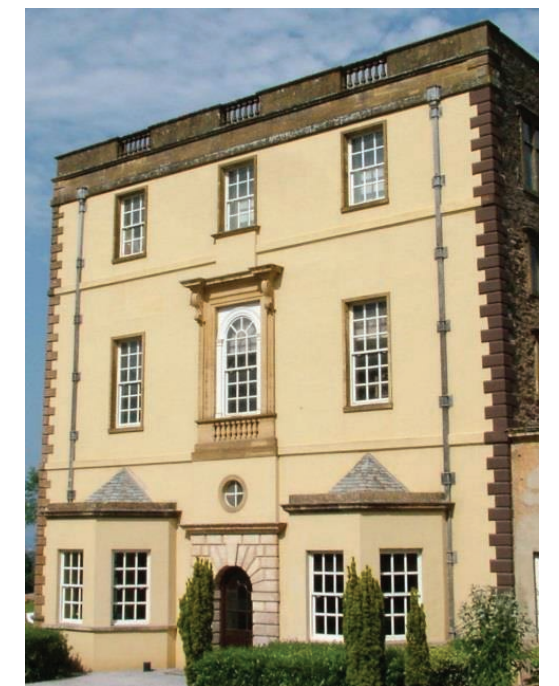
Figs. 5.1, 5.2 and 5.3. Baroque Wing, clockwise: north, west and east façades.

The exterior work done by Cartwright consisted of a Palladian facelift to the east and west facades of the Baroque Wing, see figs. 5.1 to 5.3. The east elevation has a plaster rusticated-ashlar skin to the whole ground floor and the five windows above are applied with simple entablatures to four windows flanking a central pediment with blind balustrade below

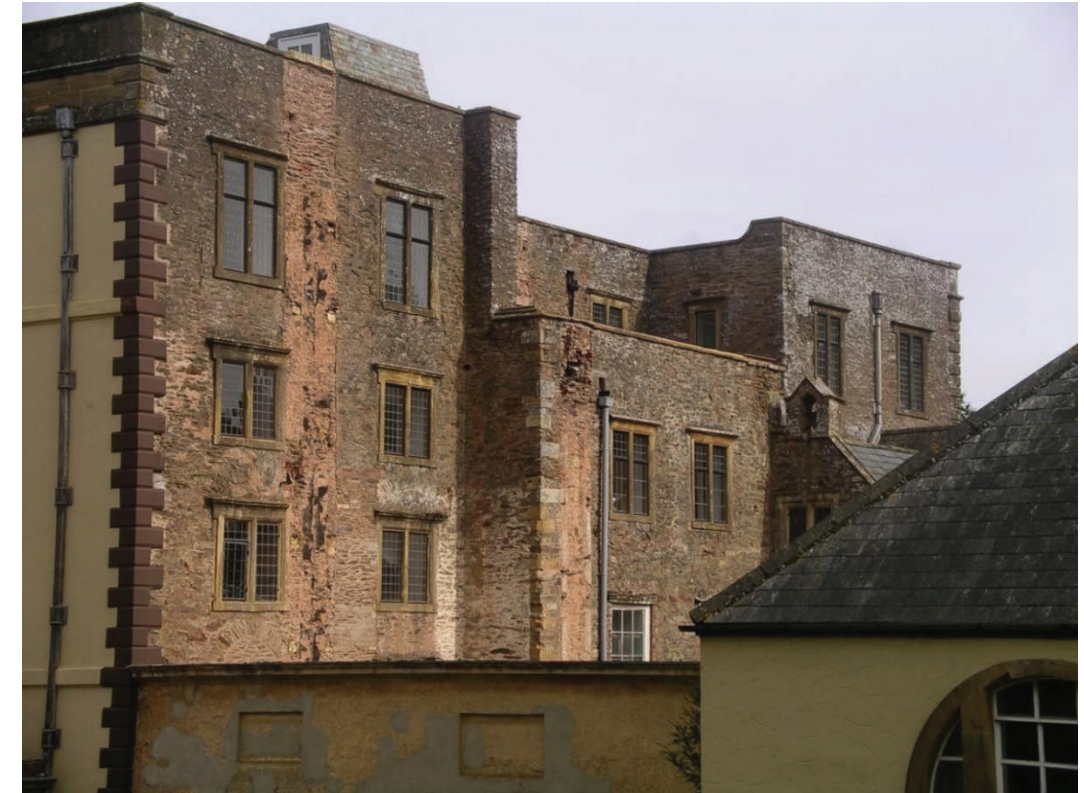
Fig. 5.6. South elevation: showing two vertical scars of removed chimneys from the now demolished Servant's Hall and a repurposed butler's pantry.

This section, see plans 5.2 and 5.4 and figs. 5.6 - 5.8, appears by its upper fenestration to

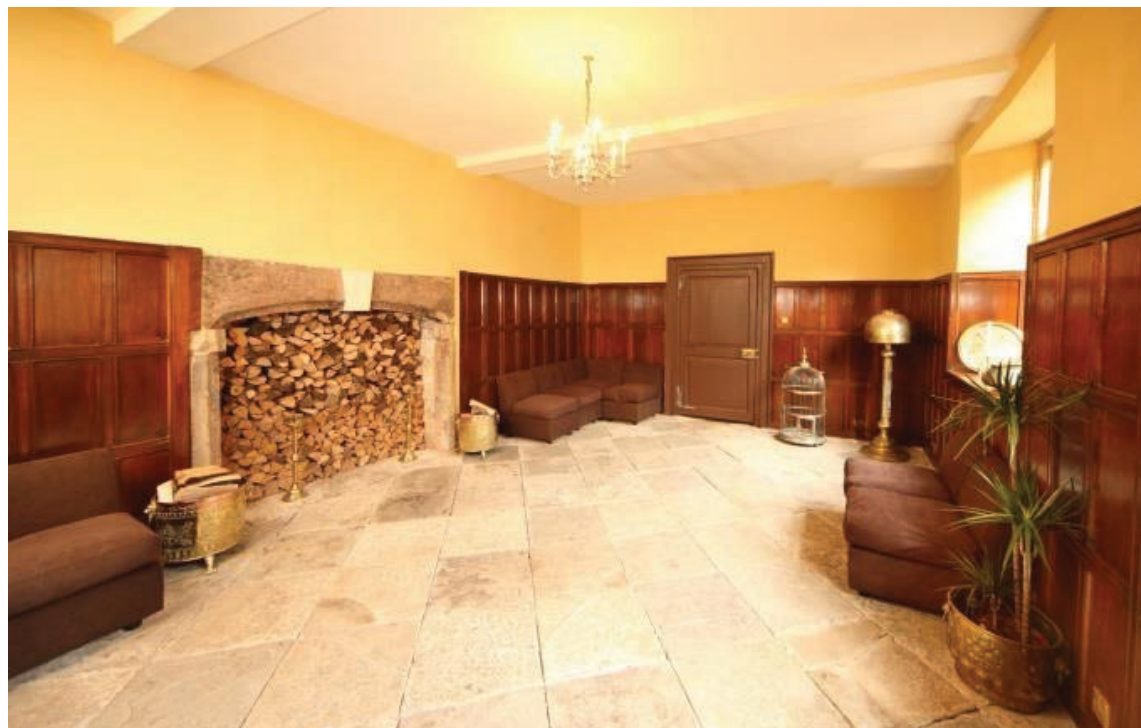
Fig. 5.7 The ground-floor Servant's Hall.

However the unusual nature of the projection is readily understood as a means of creating a circular flow for servants, the ground floor was the Servant's Hall in 1730,¹⁰¹ see fig. 5.7, as well as allowing for a grand bedroom on the intermediate floor of the Great Stairs, a level which otherwise leads only to the old manor house.

The re-used thirteenth-century gothic windows in the Gatehouse, see fig. 1.16, and the stone fan vault rubble in the Servant's Hall chimney, see fig. 1.17 and fig. 5.7 for the fireplace, lead tantalisingly to these three elements being part of a demolished religious building, possibly the oratory licenced at Halswell in 1318.

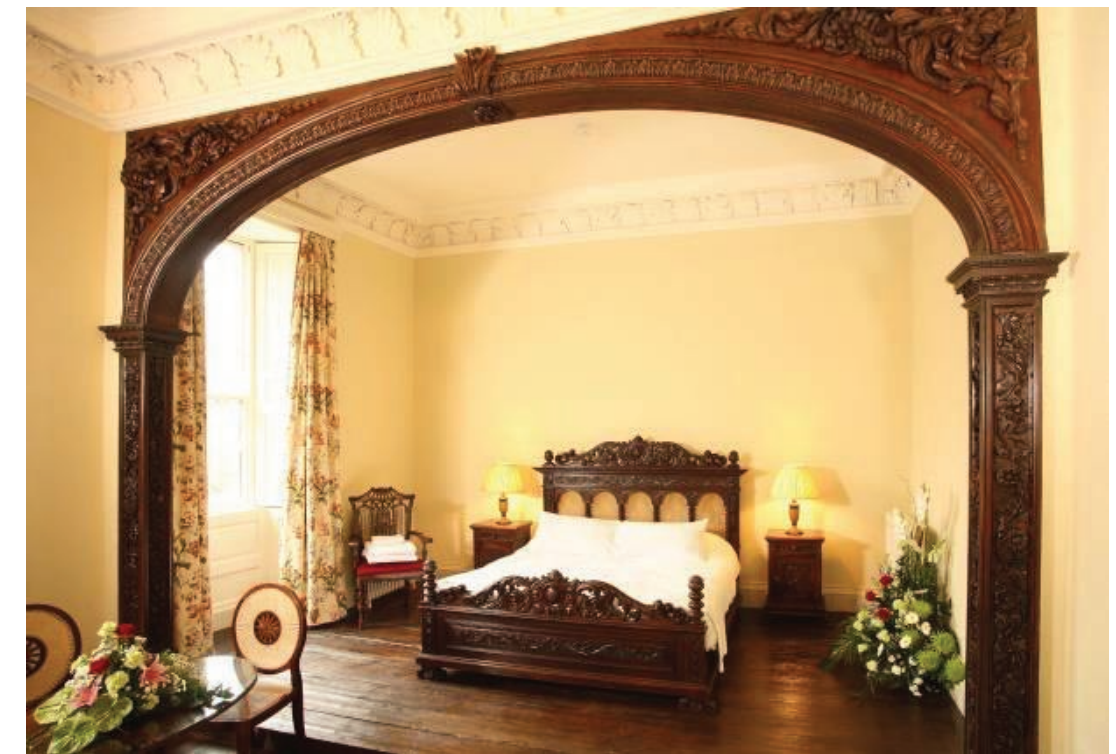
Fig. 5.8. The first-floor Alcove Bedroom, above the Servant's Hall in the 'double-pile' southern section.

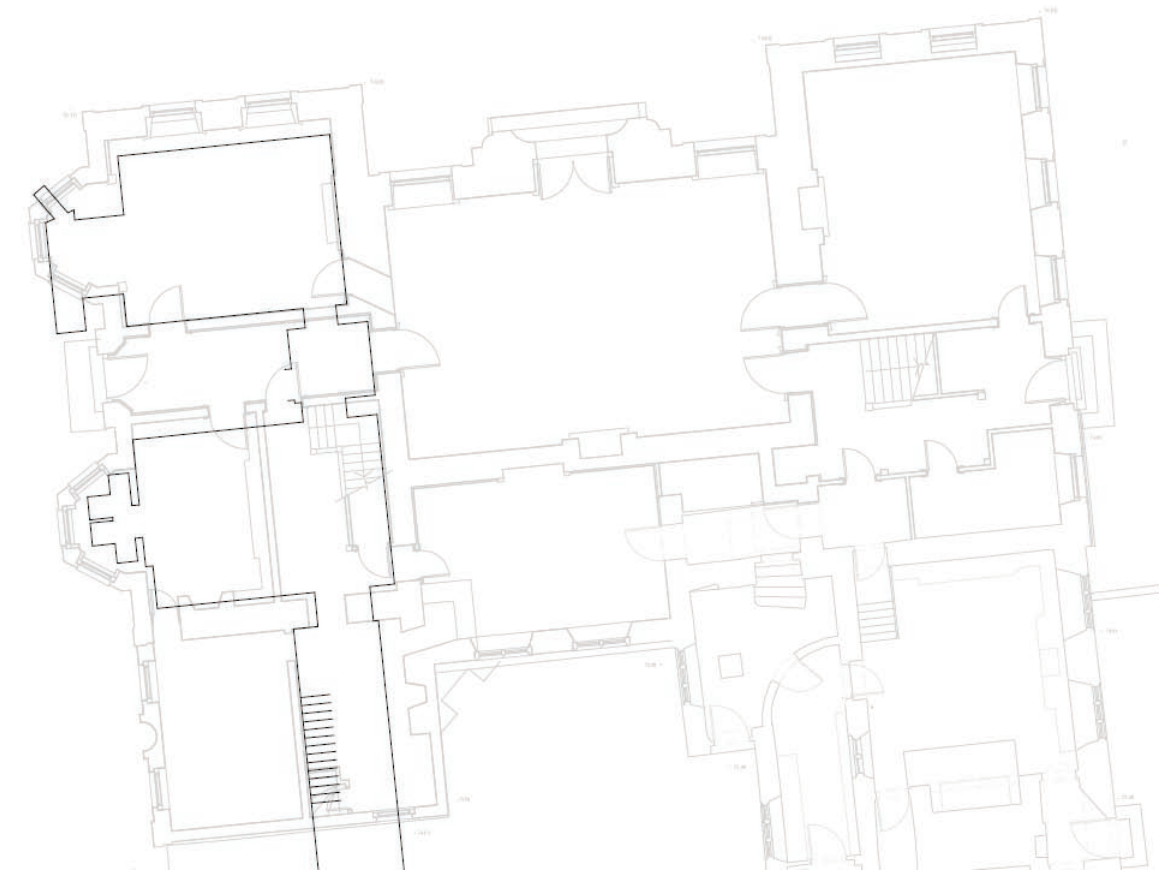
Plan. 5.5. Cellar plan. The two large cellar chambers fill the western section of the 'H' plan; the contemporary cellar passage to the south is now beneath an additional room of 1754.

The cellar beneath the western portion of the Baroque Wing supports the hypothesis that the 'H' plan wing was purpose built and did not rise from earlier foundations of a missing chapel or accommodation wing, filling as it does the western footprint of the building that rises above. The cellar construction itself is consistent with a building of this date, and could not be early-fourteenth century, when the missing oratory was licenced at Halswell.

However the cellars have two features that stylistically do not appear contemporary with the date of the house above. In the north wall of the southern chamber is a small in-filled hatch once opening to a long narrow chamber equal to the west hallway above it, with arched red brick racks for bottle storage, see figs. 5.9 and 5.10. In design this hatch appears closer to the early windows in the 1536 phase than to other architectural features at Halswell, except the moulding here is not hollow as in those windows but ovolo. Its sill splays sharply downward which is common in early sills and similar to the earliest extant windows in the house. The sill and architrave above have in-filled holes to their centres appropriate for a

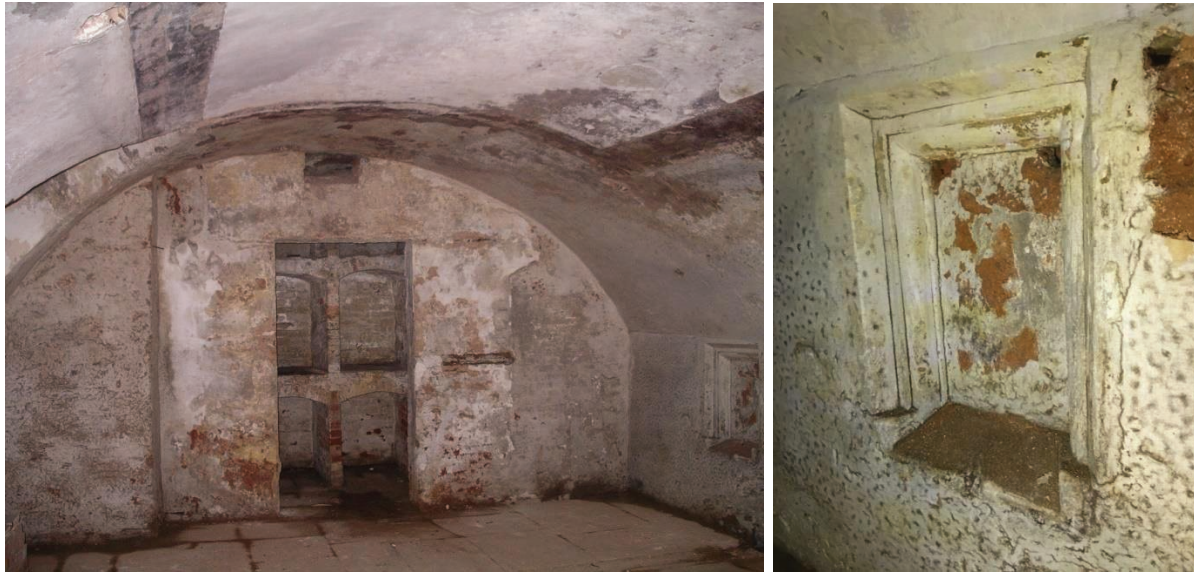
Fig. 5.9. Cellar, southern chamber, west wall, with a hatch surround to the north and a blocked opening in the ceiling to the south.

dividing iron bar. Though the hatch has these superficial similarities to an early window surround it may be a coincidence of design. The ovolo-type moulding may come from reused window material, the dividing iron bar and angled sill for wine security. Old fashioned, but not completely out of keeping with the traditional stylistic elements being built above ground.

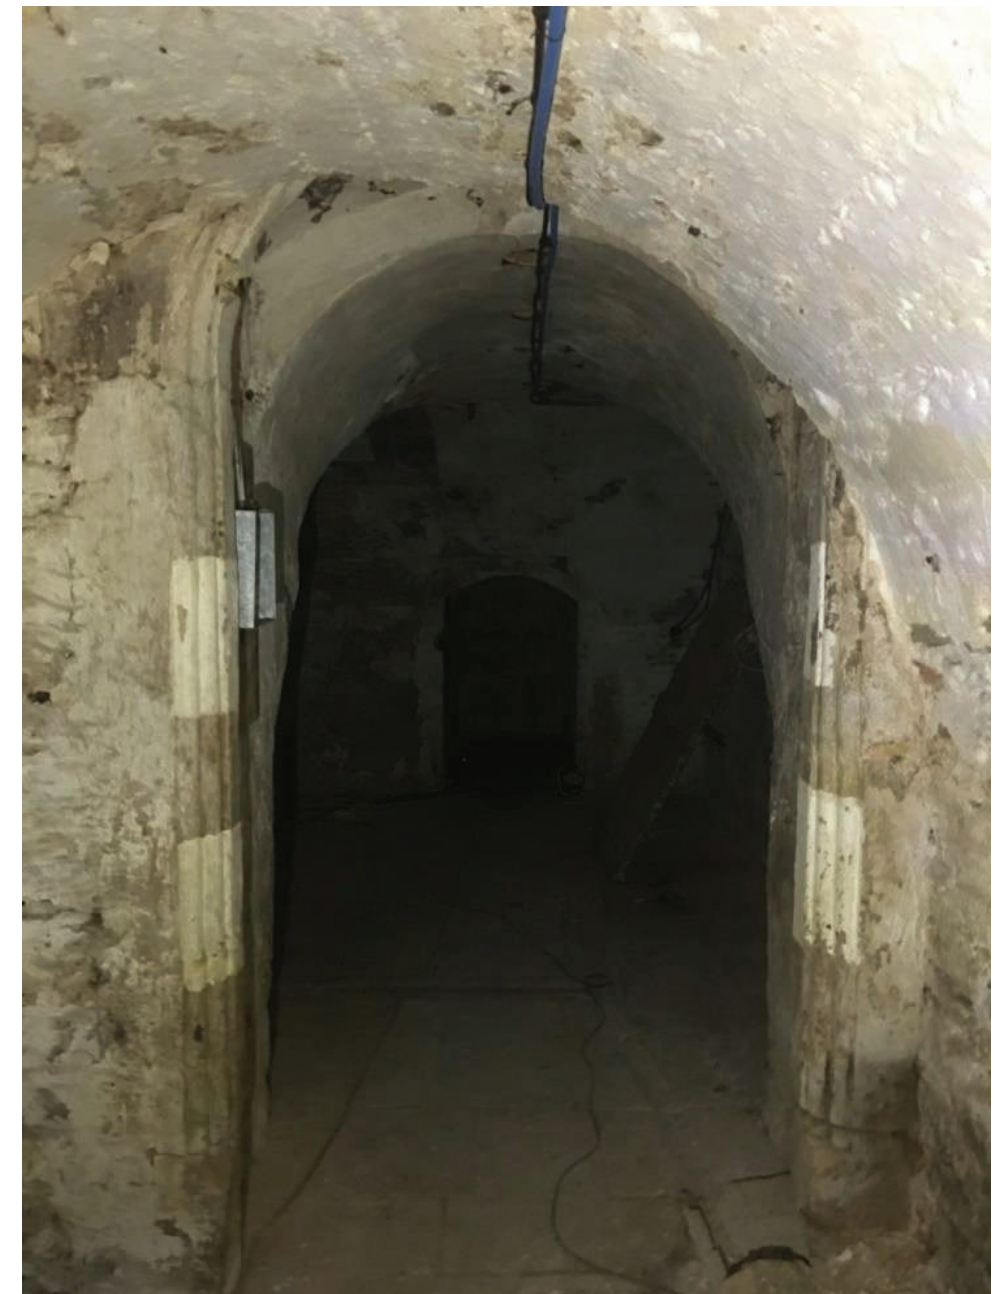
Fig. 5.11. Door surround on the south of the Baroque Wing cellar.

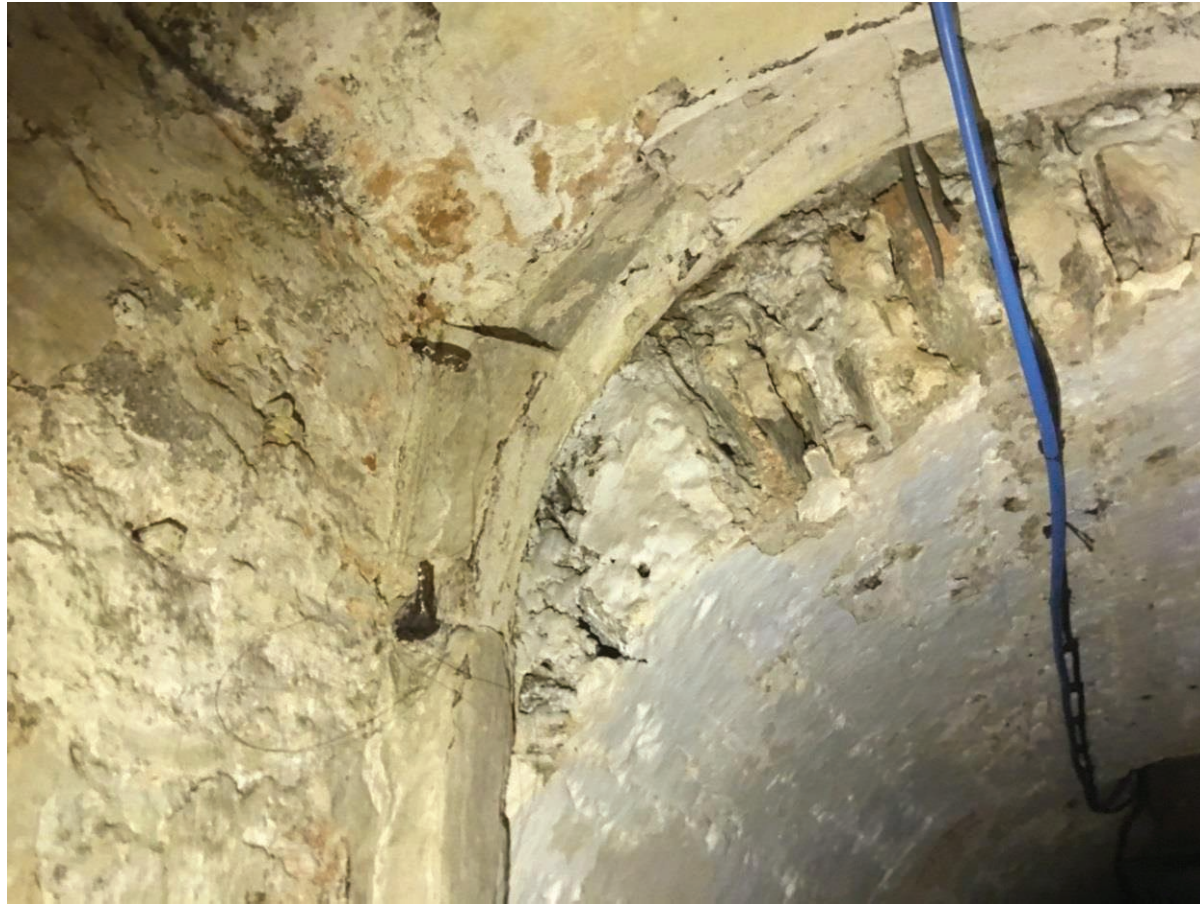
Figs. 5.12, 5.13 and 5.14. The cellar door apex and views of the intersecting tunnel displaying the full thickness of its ceiling structure.

The connecting cellar tunnel must have been then built during the same construction phase as there are no other entrances to the 1689 cellar. The creation of this tunnel under the north wall of the south range appears to have damaged the integrity of the wall above where there is a distinct bowing of the masonry, visible on the floor plans. The tunnel was lit by two above-ground light lanterns, see fig. 5.17, one of which was removed in 1754 when an extension was added bringing this section of the courtyard to within the north wing. A stairs was built partly through the circular opening of that lantern, see fig. 5.14.

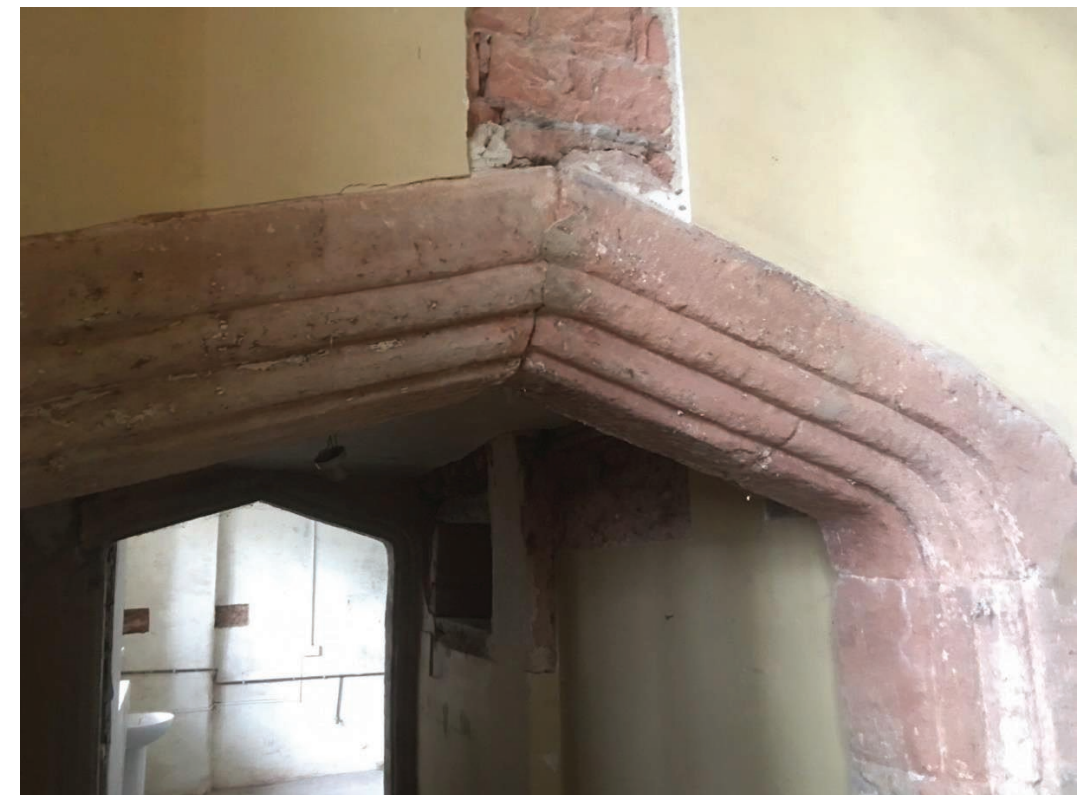
Fig. 5.15. Two early door surrounds in the Hall, with similar cross-section profiles as the cellar door.

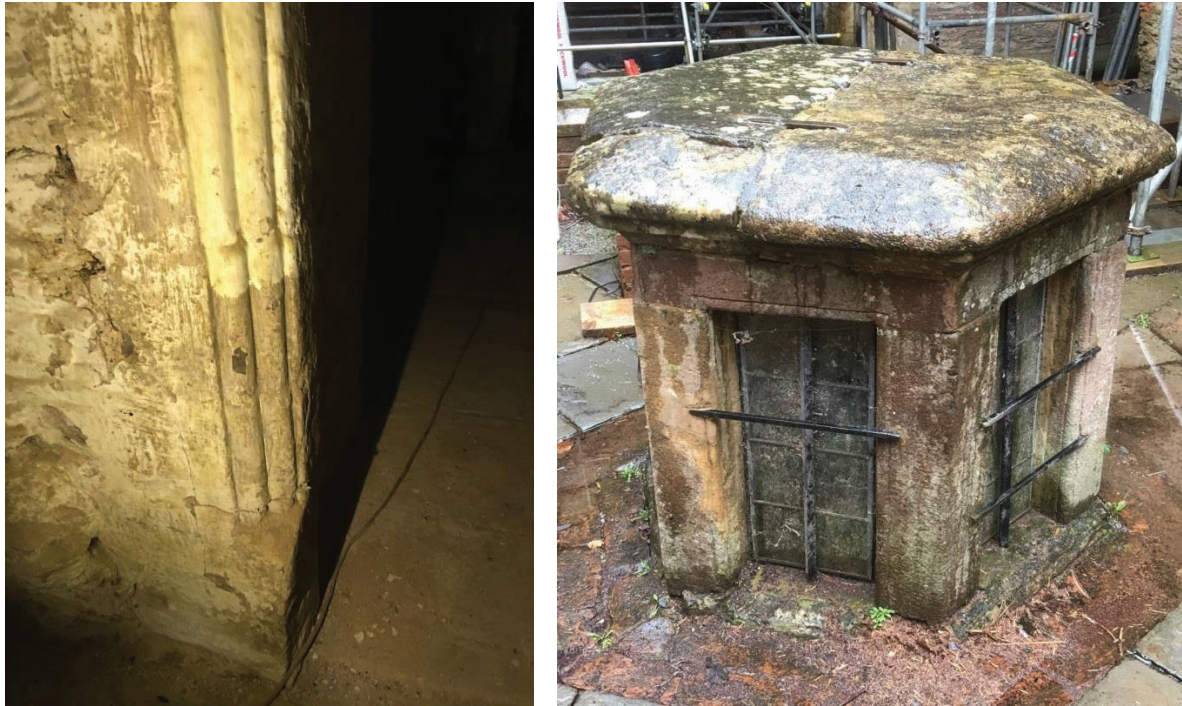
Fig. 5.16 Cellar door detail.

Fig. 5.17. The remaining cellar passage light lantern of c. 1689 in the courtyard.

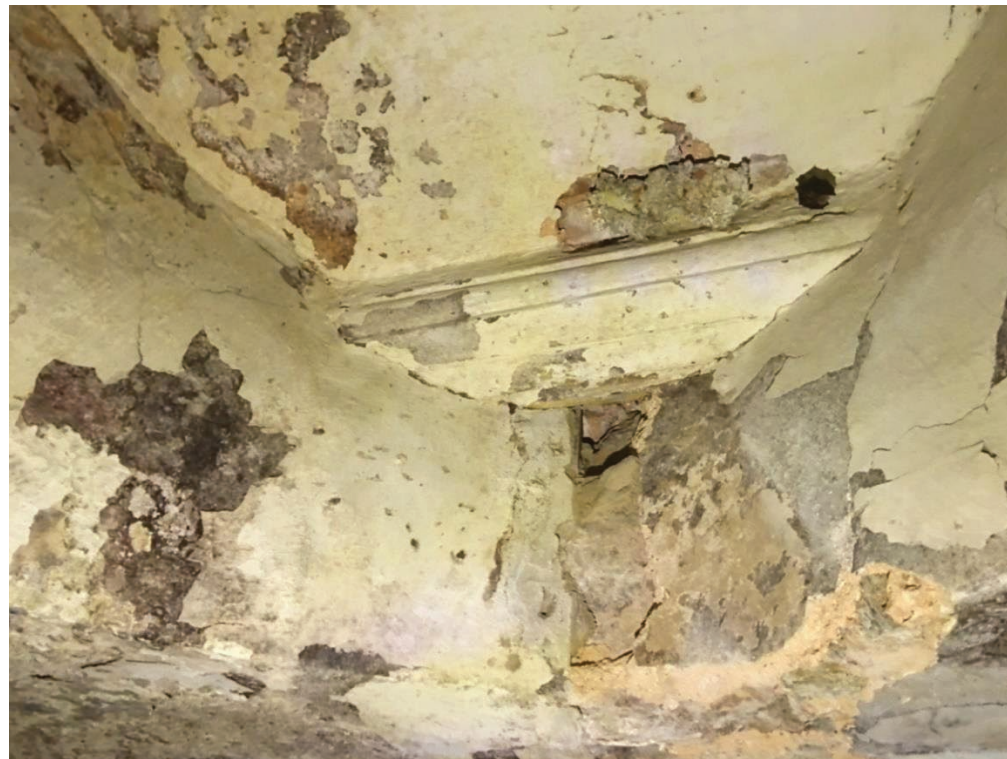
Fig. 5.18. An ovolo-moulded piece of masonry, reused in the construction, or blocking-up, of the ceiling opening to in the south-west of the southern chamber. The blocked opening would have led to the courtyard before an extension of 1754 brought that area within the house.

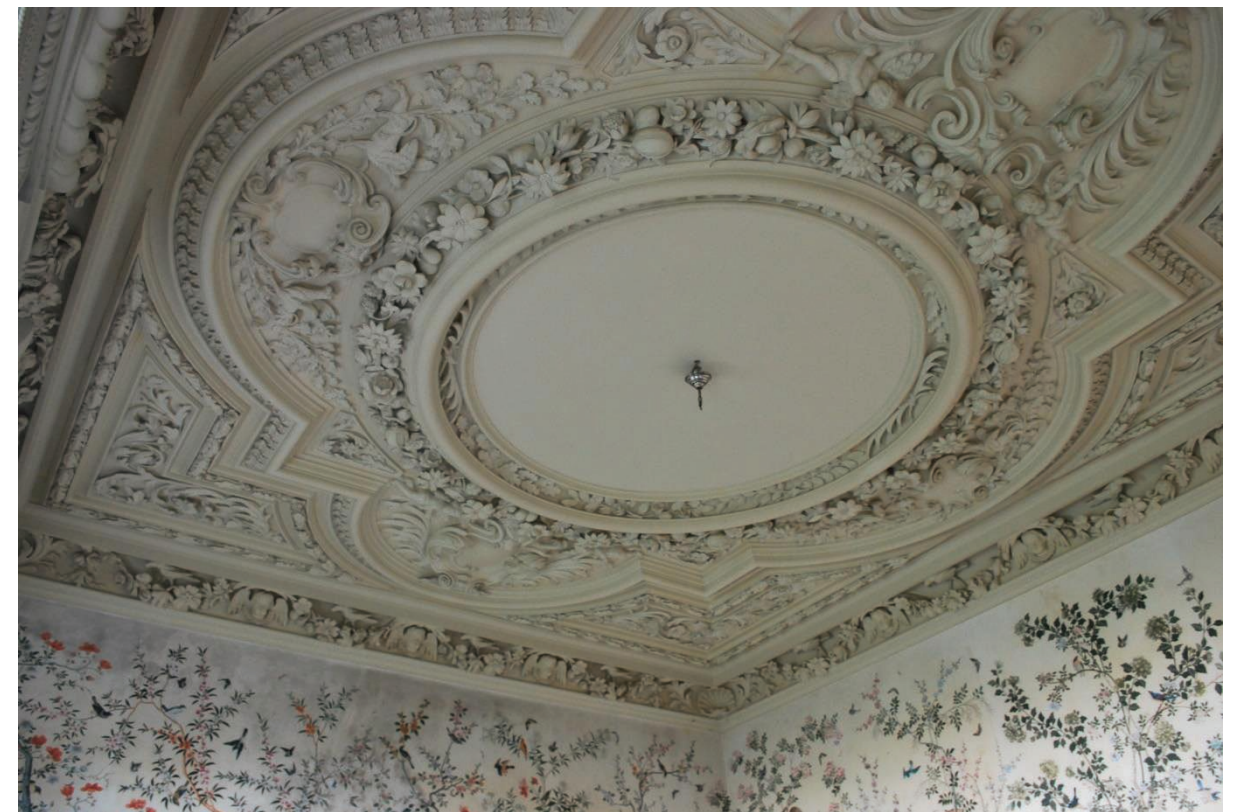
Fig. 5.19. The c. 1689 plaster ceiling design, re-cast c. 1926, in the north-east corner first-floor room.

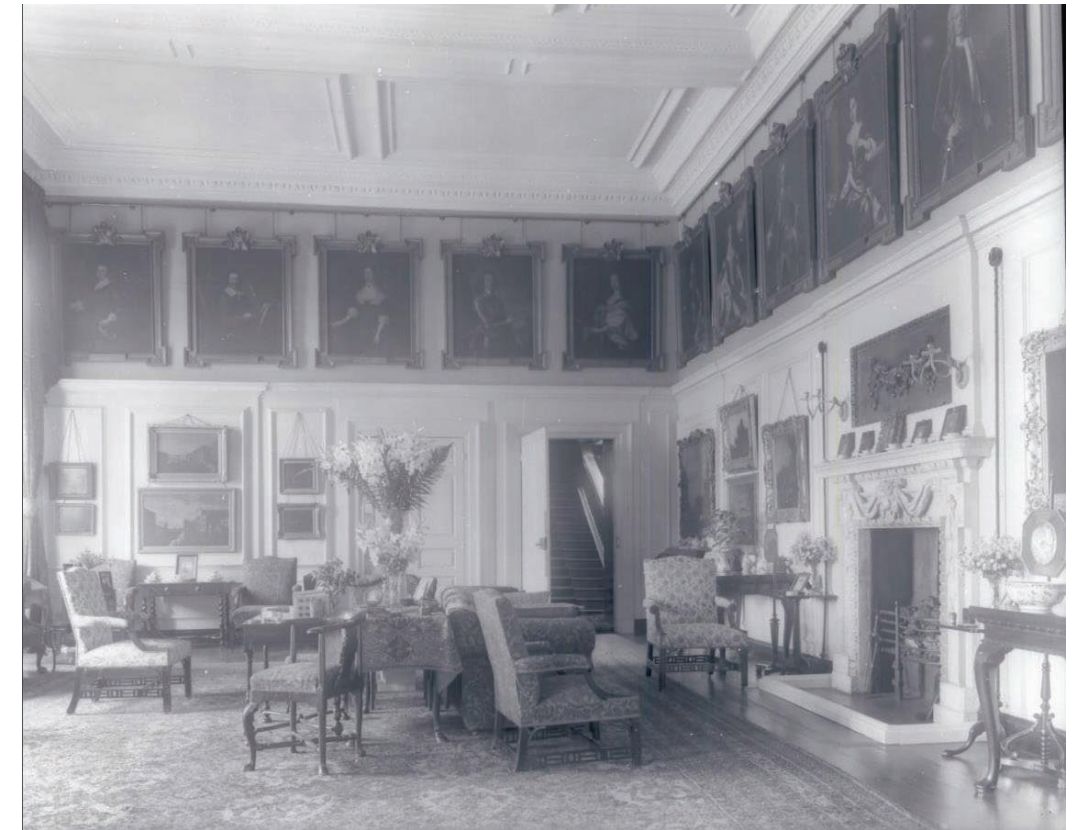
Fig. 6.1. The Hall, or Saloon, the central reception room at the centre of the Baroque Wing.¹⁰⁹

The reference to 'Chamber' is less clear. However the fireplace in the Hall, or Saloon, see fig. 6.1, depending on which inventory is consulted, the 1730 or the 1785,¹⁰⁴ also has a fireplace which dates from this period and as the main reception room of the house it is reasonable to judge this is the other room to receive the modern make-over of Escott's note. Julian Orbach has verbally attributed this fireplace to Henry Cheere (1703-1781).¹⁰⁵ The painted wood panelling and high plain frieze are typical of Baroque houses¹⁰⁶ and although the style could still have been produced in 1753 there is no reason to suggest it from dates from later than 1689. All original fireplaces in the Baroque Wing are lost, however one intriguing remnant has recently been identified in a mid-eighteenth century alms-house in the village, see fig. 6.3.

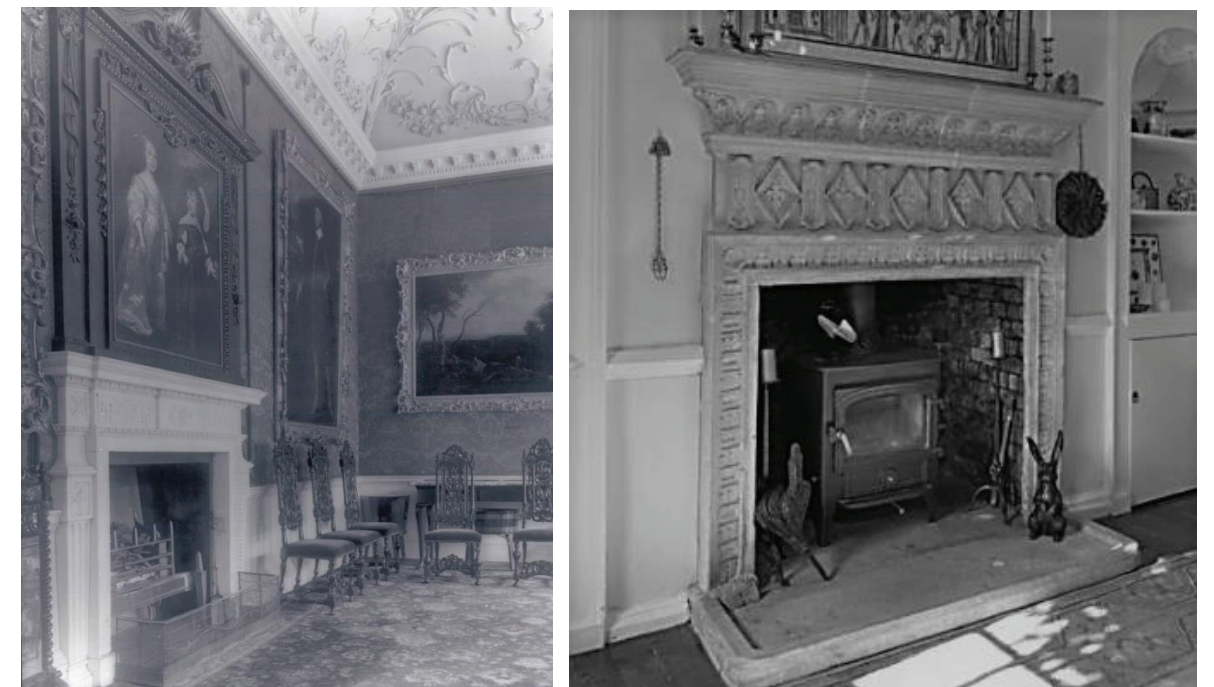
Fig. 6.2. The 1753 Drawing Room, the fireplace survives; the interior was replicated in c. 1926.¹¹⁰

This suits the later style of the room and its fireplace, see fig. 6.2.

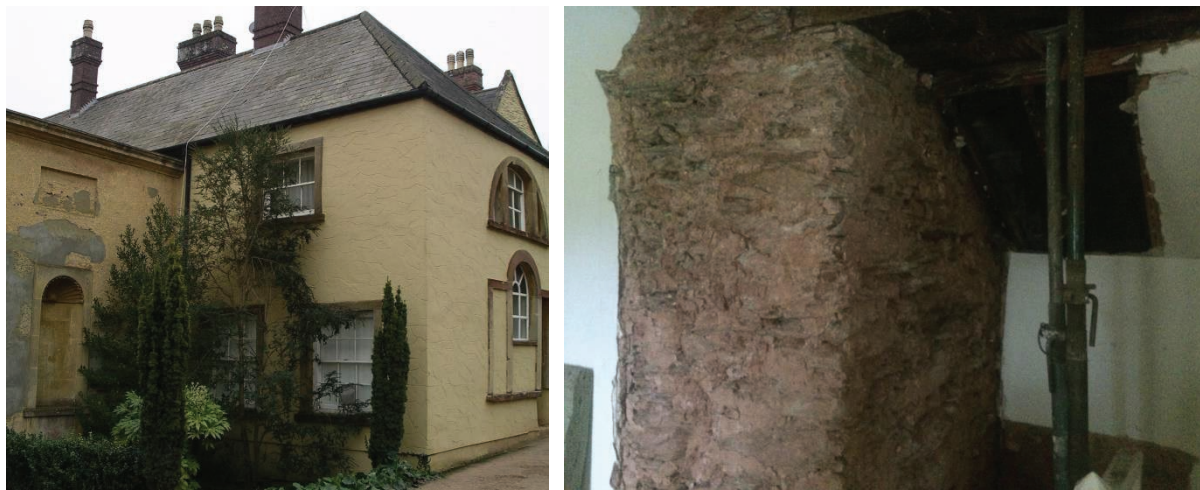
Figs. 6.4 and 6.5. Butler's, c. 1754. Inside, at its corner junction with the early-seventeenth century gabled in-fill at that sections original north-west corner.

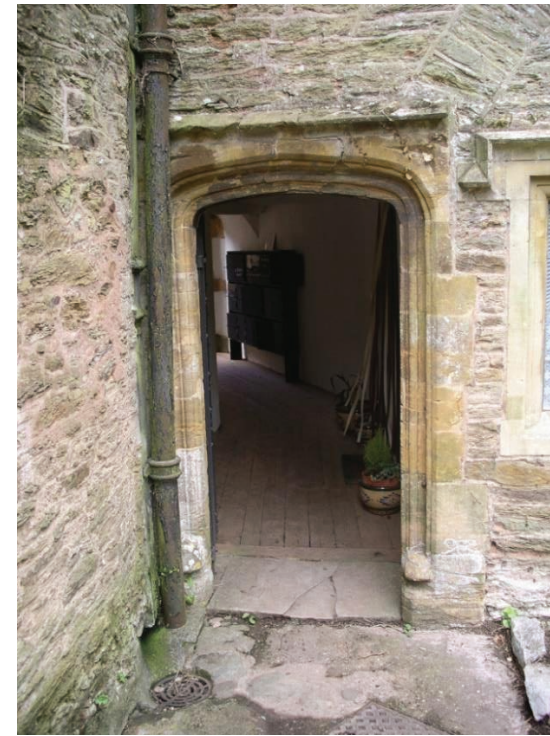
Fig.6.6. Passage opening, south.

Further work from same phase of works is a bent passageway through the c. 1590 south range. At its south, see fig. 6.6, there is a fine and unusual door surround which sits awkwardly against the return wall to its west. This doorway has no relieving arch but cuts into the relieving arch of the window to its east. Consequently it appears to have been moved to this position from elsewhere. The wall beneath the neighbouring window has been disturbed to ground level, lacking original masonry inside, so it is asserted the opening was previously for a door, quite probably with this door surround.

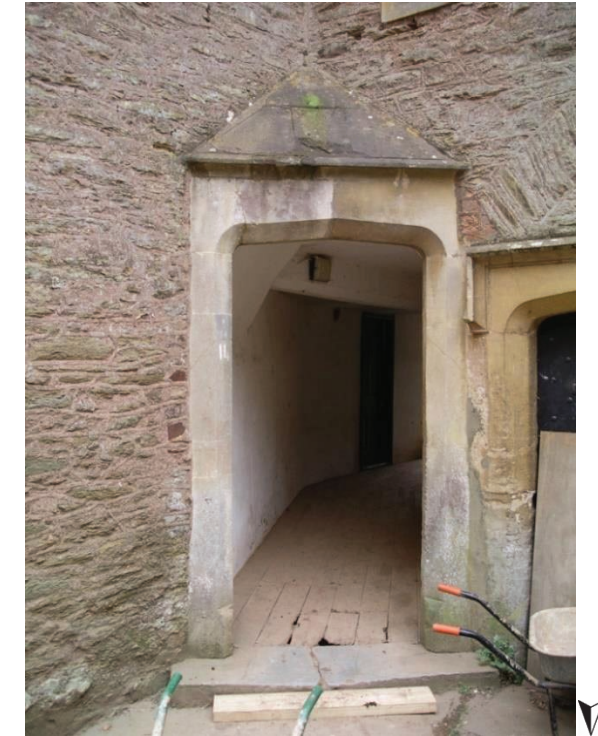
Fig. 6.7. Passage opening, north.

On the north elevation where the passage meets the courtyard there is another stone opening with a four-centred arch, see fig. 6.7. This is simpler and the stone less weathered. It has a matching pair in the south-west of the courtyard occupying the opposite corner position between the courtyard's red brick west wall of 1754 and the termination of the original south range. Both doors' surrounds display disturbances to the older stone walls with which they intersect, indicating they were added later. This second door leads into Butler's, believed to be by Cartwright, and acted as that additions only doorway until one was broken through its Serlian window opening by 1926, see fig. 6.4.

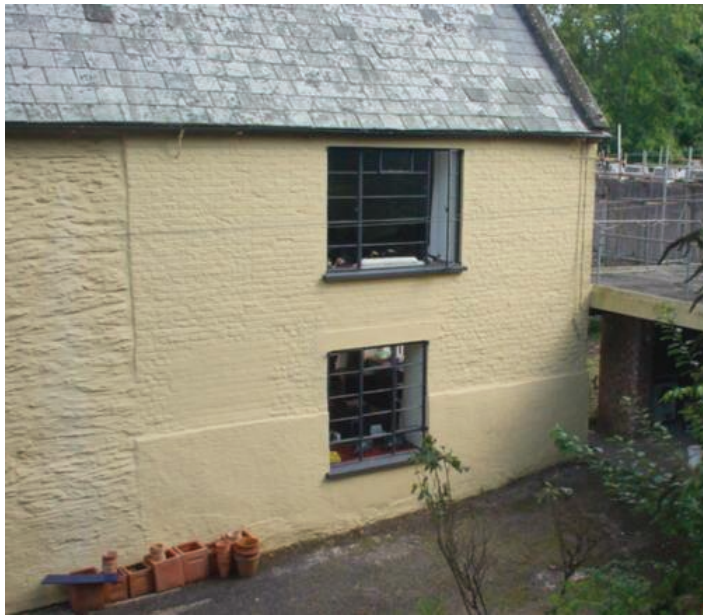
Fig. 6.12. The dairy of 1766. This redbrick extension is clearly defined where it abuts up to the earlier stone building. The original ground level is equivalent to the concrete apron at the lower level. Its original in-filled window is visible to the left of the ground-floor 1950's window insertion.
