HALSWELL HOUSE, SOMERSET

A Structural History 1536-1689

Dissertation in Building History

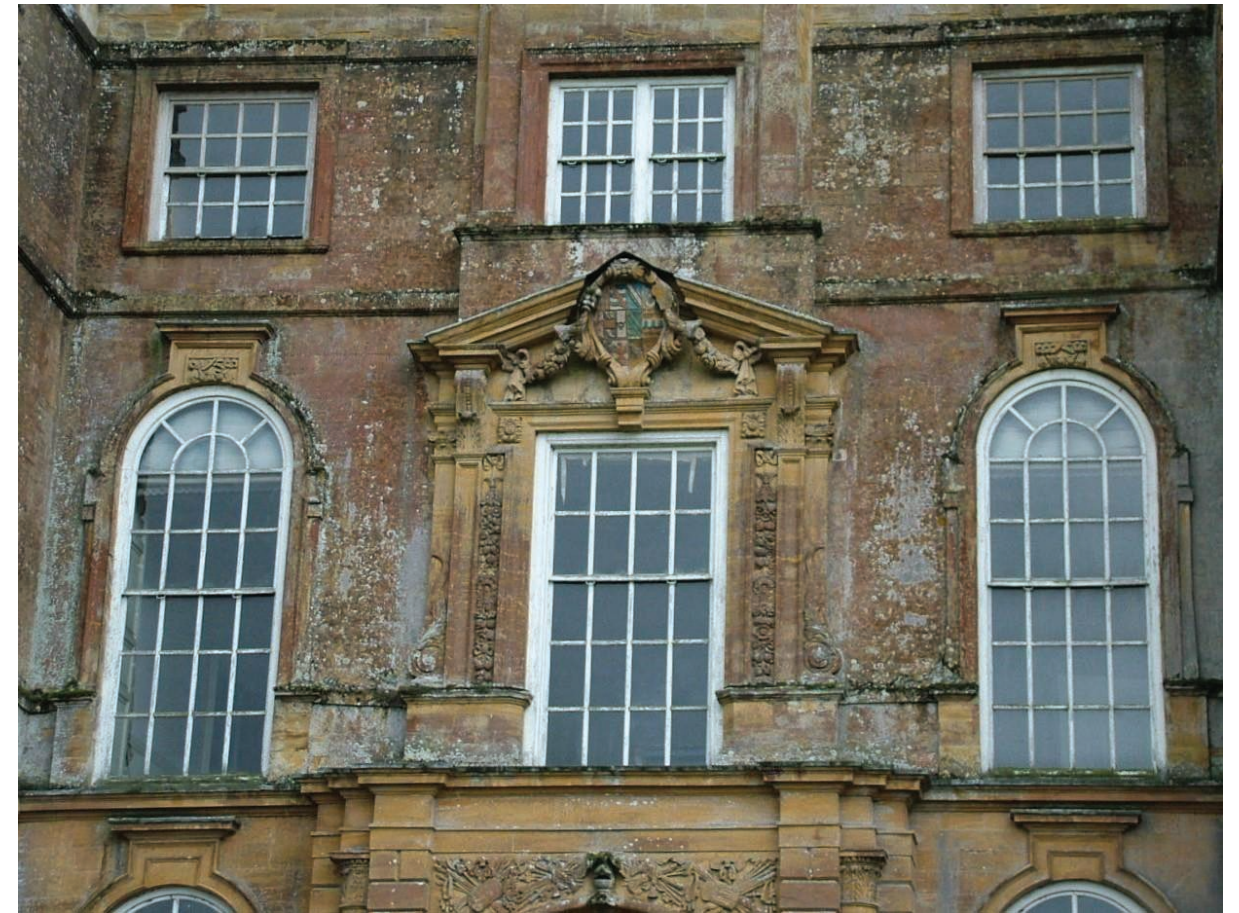
Fig 6.16. Baroque balcony area in 2004.

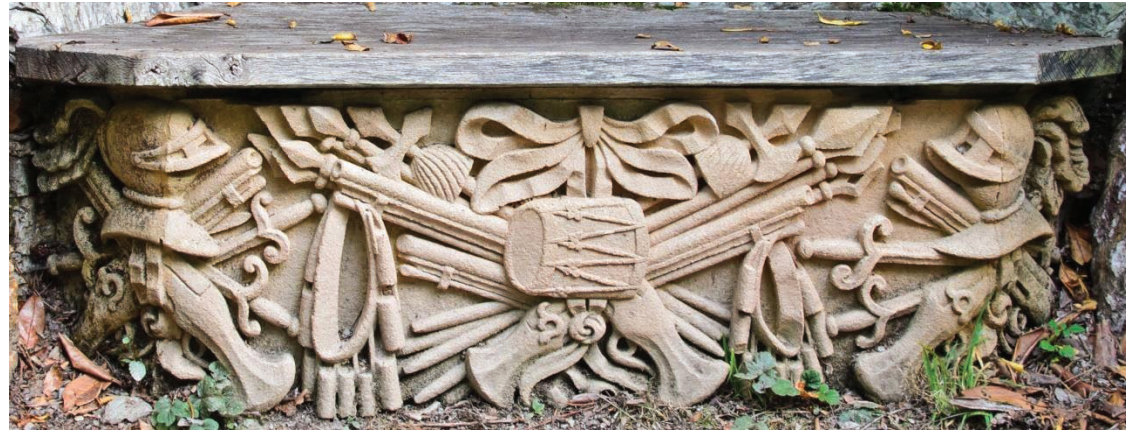
Fig. 6.18 The Trophy Seat at Hestercombe House Gardens, reputedly from above a door of the east or west elevation at Halswell and given to Hestercombe in the mid-eighteenth century.

Another remnant of the removed Baroque decoration exists at the neighbouring country house, see fig. 6.18. This stone relief of military attainments does match the unusual militarist relief carvings around the Baroque Wing's north door and is traditionally believed to have been moved here after Cartwright's modifications in 1754.

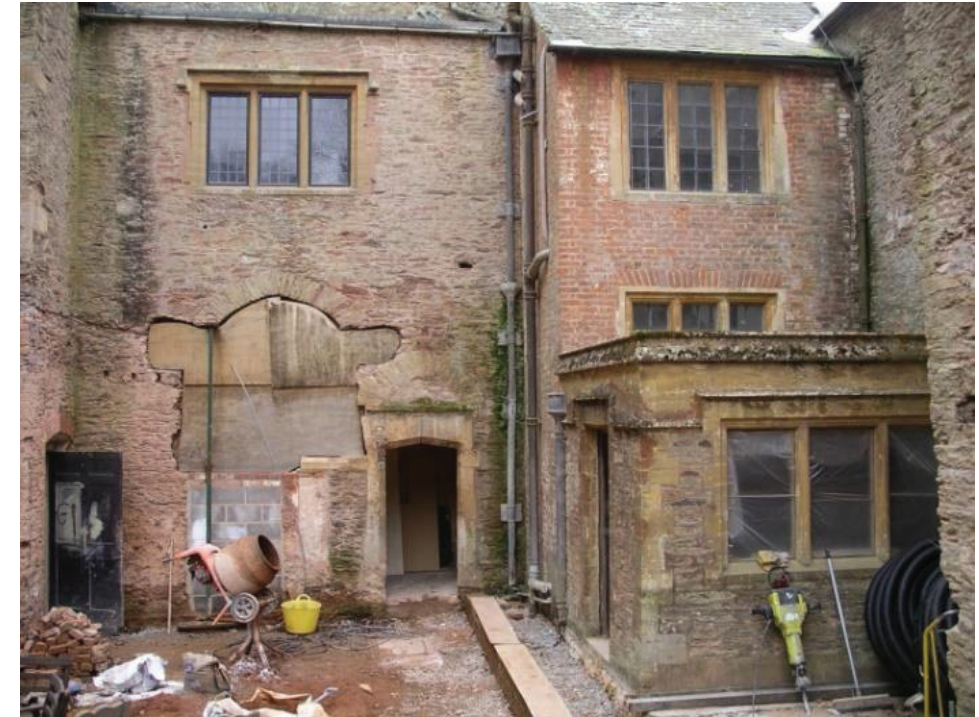
Fig. 6.19. Red brick staircase and the single-storey addition of c. 1926 in 2005.

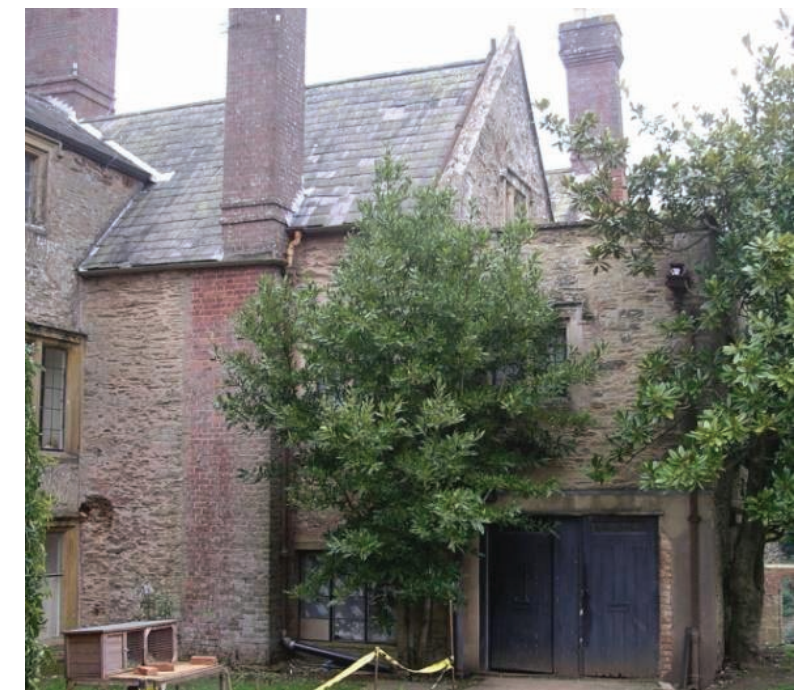
Fig. 6.20. The c. 1926 covered porch addition in 2004.

Another addition made between 1908 and 1926 was a two-storey porch and washroom under a flat roof. Placed against the c. 1610 east projection on the south range, see fig. 6.20, it was removed in 2016, see fig. 6.23.

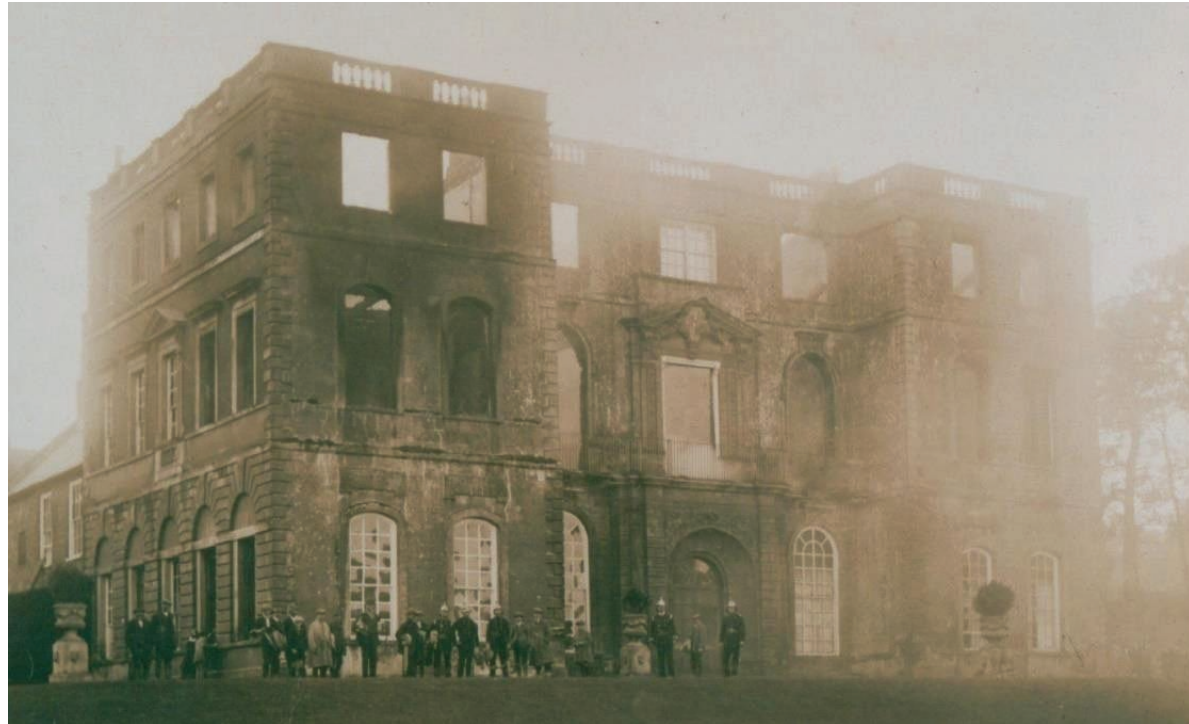
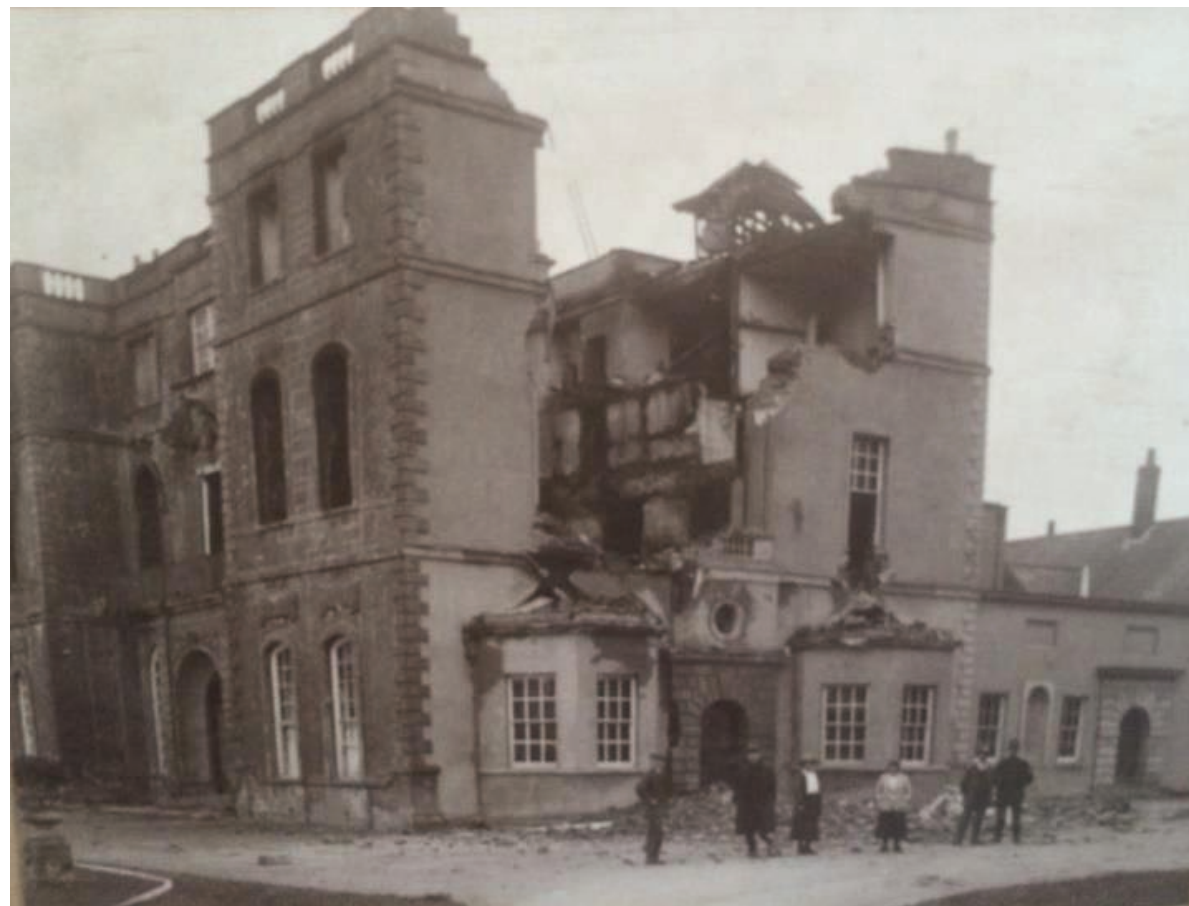
Figs 6.21 and 6.22. Baroque Wing after the 1923 fire.¹¹⁶

⁶⁴ Images of a fire in 1923, see fig. 6.21, show these were still sashes by that date. Plans created by G & T. S. Vickery in c. 1924 (see Appendix for full plans) show the windows as stone mullions. That phase of restoration was complete by 1926, as recorded by a date-stone inscription on the east elevation.

carried out between 1924 and 1926. Two photographs, see fig. 6.21 and 6.22, show the magnitude of the rebuild that was necessary for the Baroque Wing. The plasterwork recasting is of good quality and faithful to the 1908 images, concrete floors and a flat concrete roof were inserted. The oak baluster five-storey stairs seems to have mostly remained intact and as did the entirety of the earlier house.

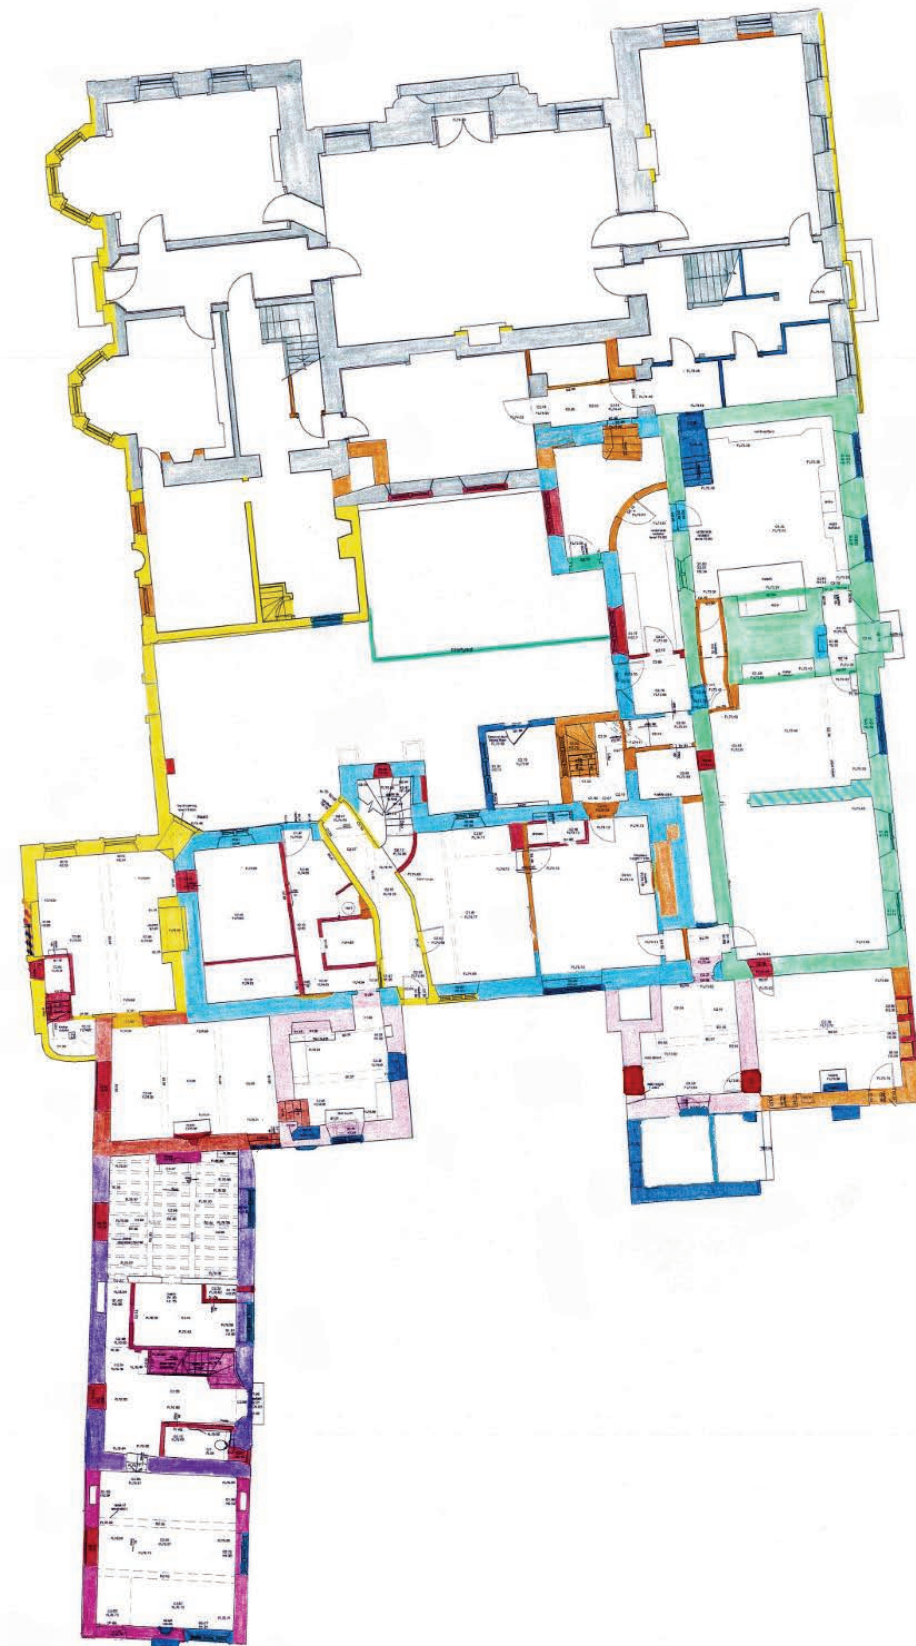
Plan 1.1.

Colour Key: c. 1536 – 1550, c. 1590, c. 1610, early-seventeenth century, late-seventeenth century, 1689, 1754, 1766, 1771, c. 1772-1899, c. 1900-1926, after 1950.

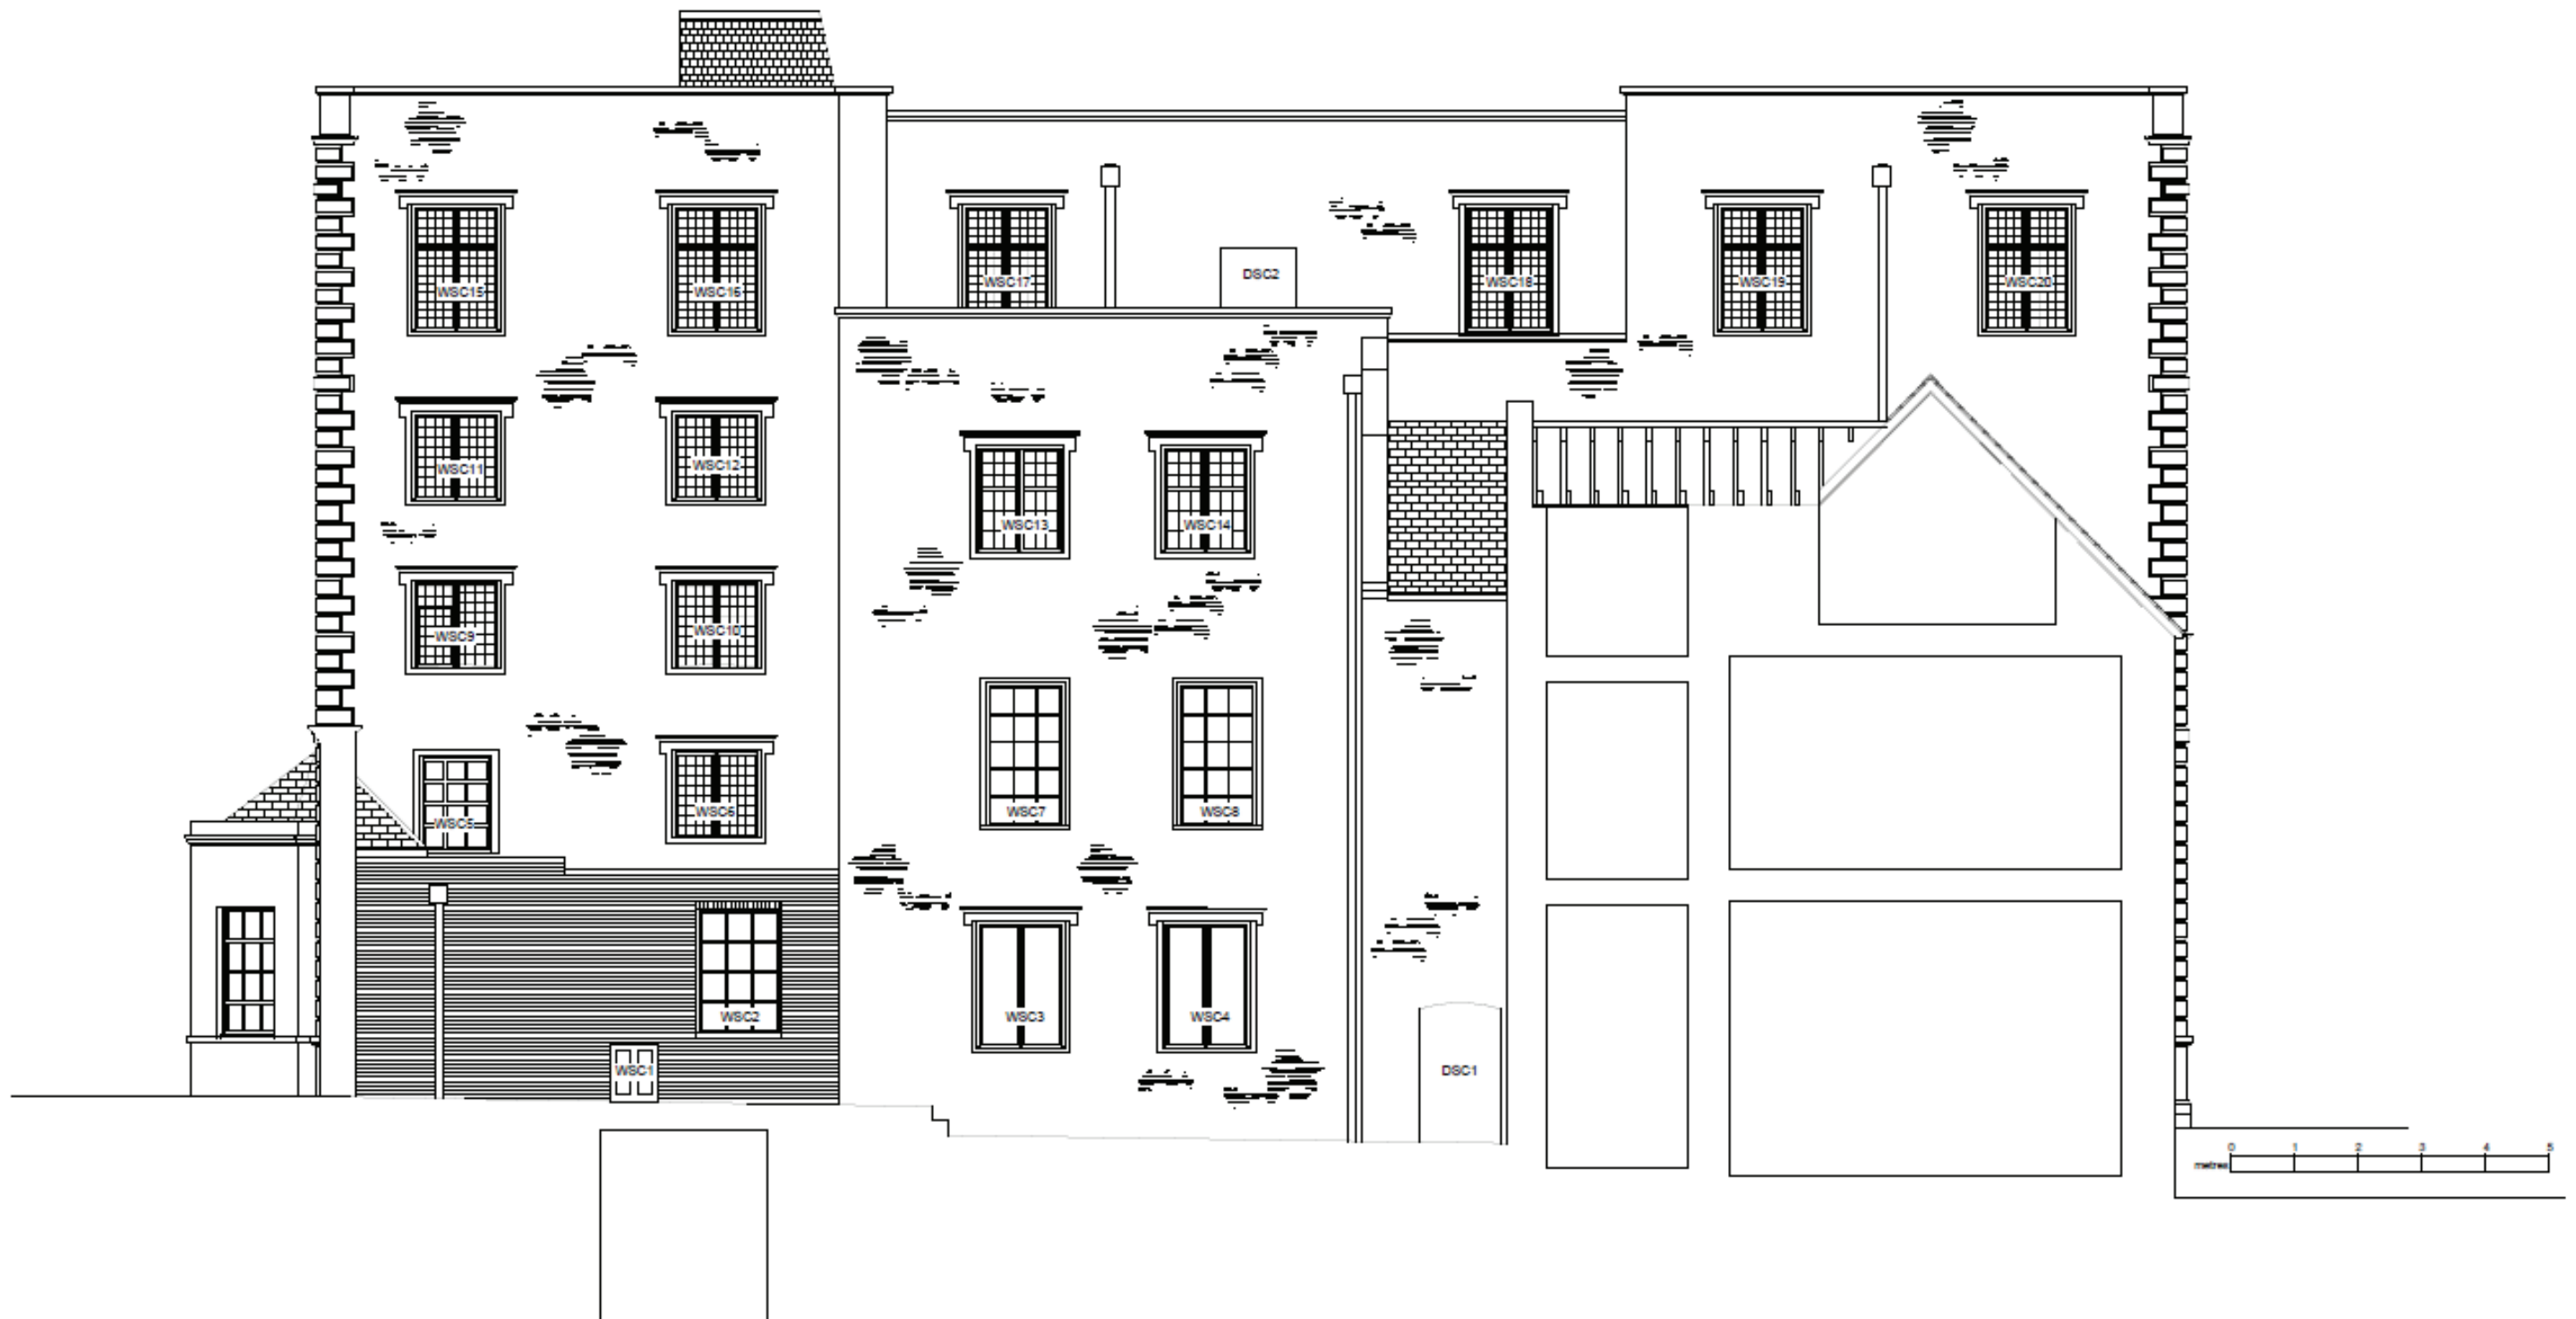
SOUTH ELEVATION, BAROQUE WING, WITH A CROSS SECTION OF THE EAST RANGE THROUGH THE HALL

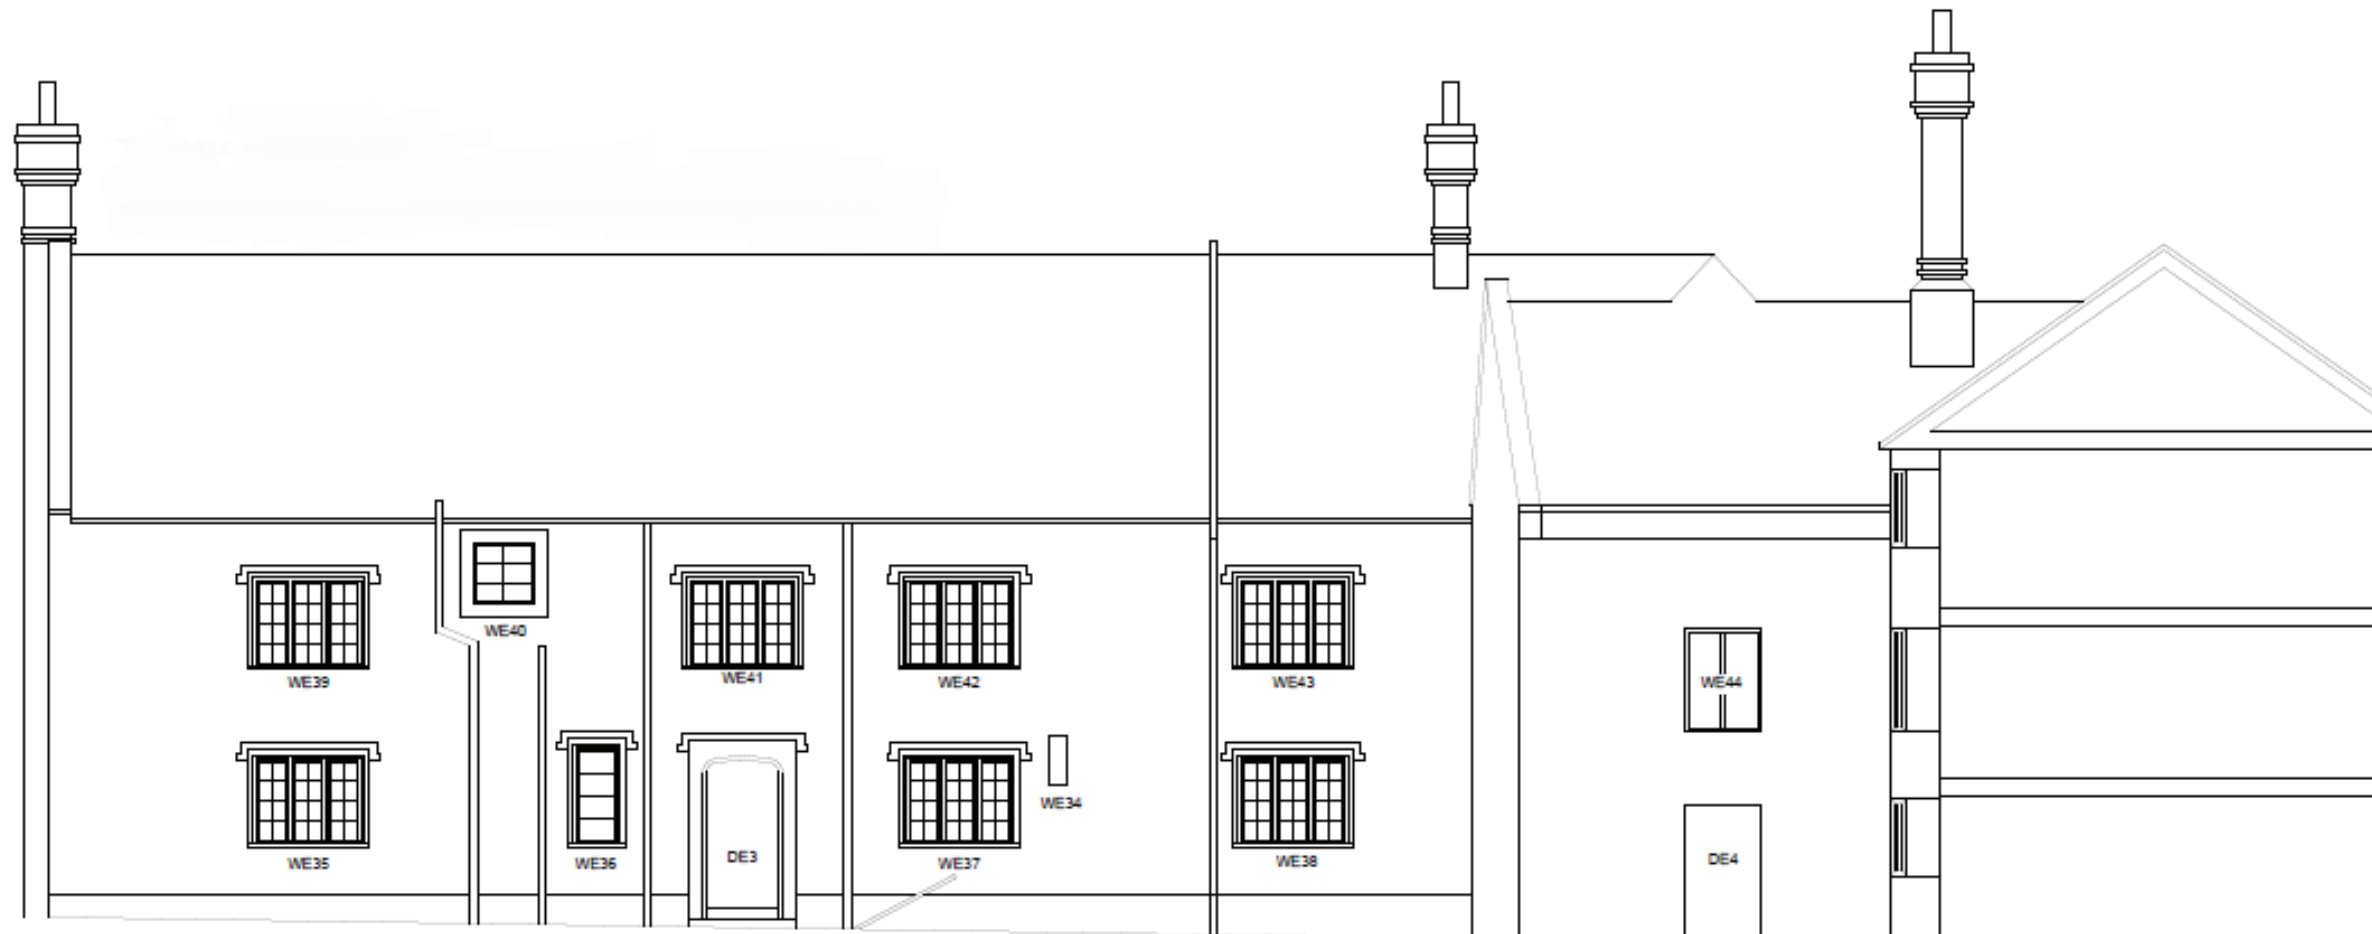
EAST ELEVATION, SOUTH WING
INCLUDING CROSS SECTION FROM THE CENTRE OF SOUTH RANGE

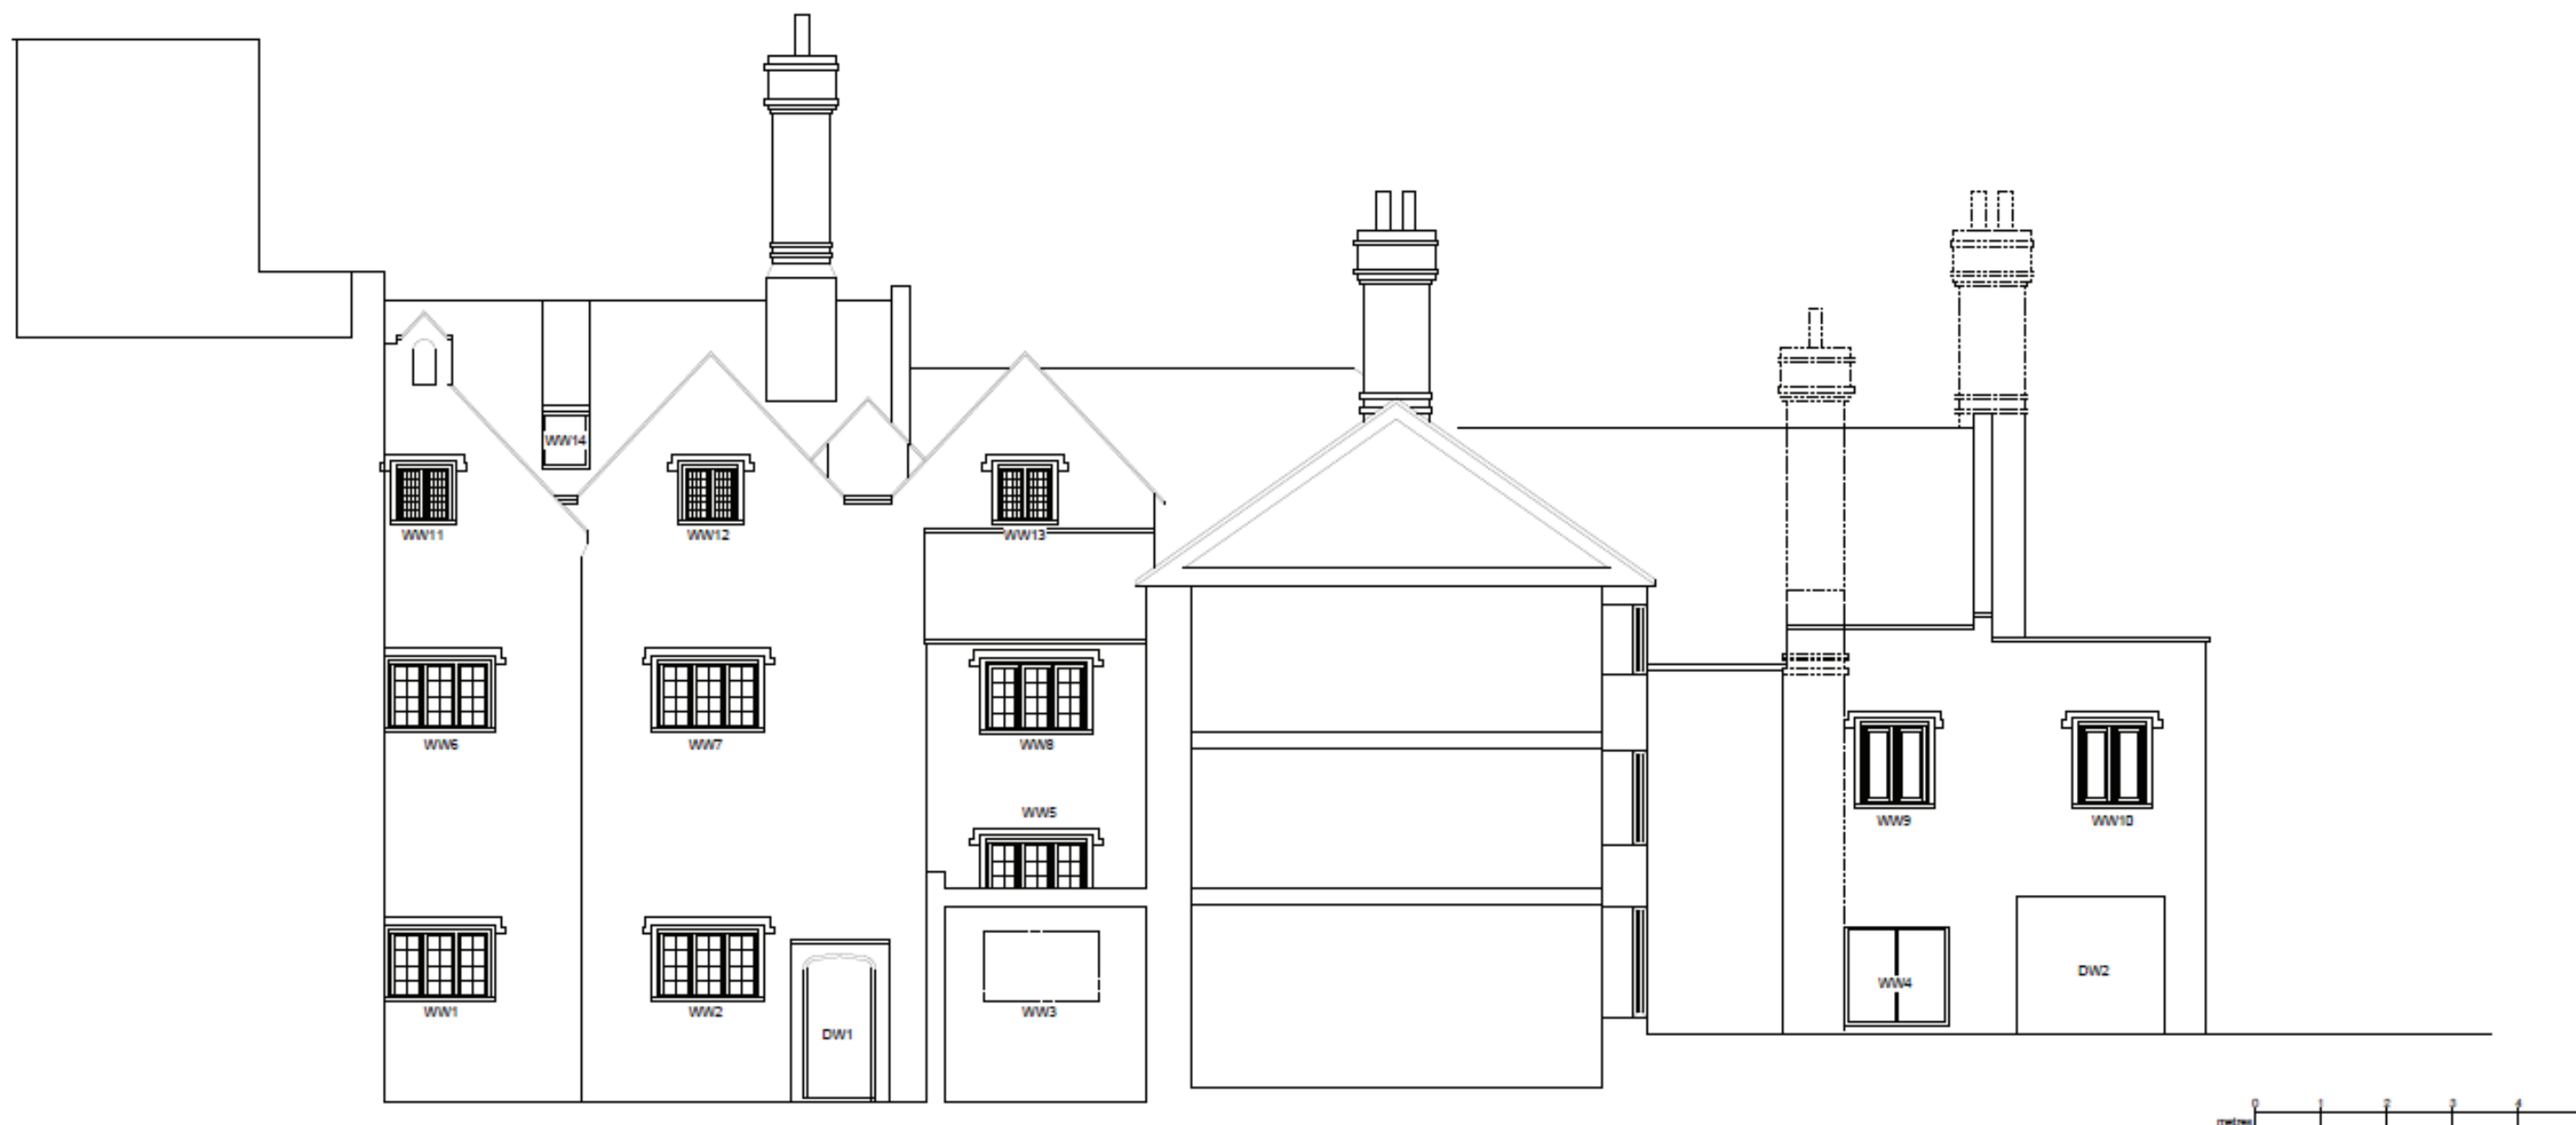
WEST ELEVATION, EAST RANGE FROM WITHIN THE COURTYARD
 INCLUDING A CROSS SECTION THROUGH THE CENTRE OF THE SOUTH RANGE
Photographic key: Left to right and ground floor to top floor. WW1 = Window West 1. DW1 = Door West 1

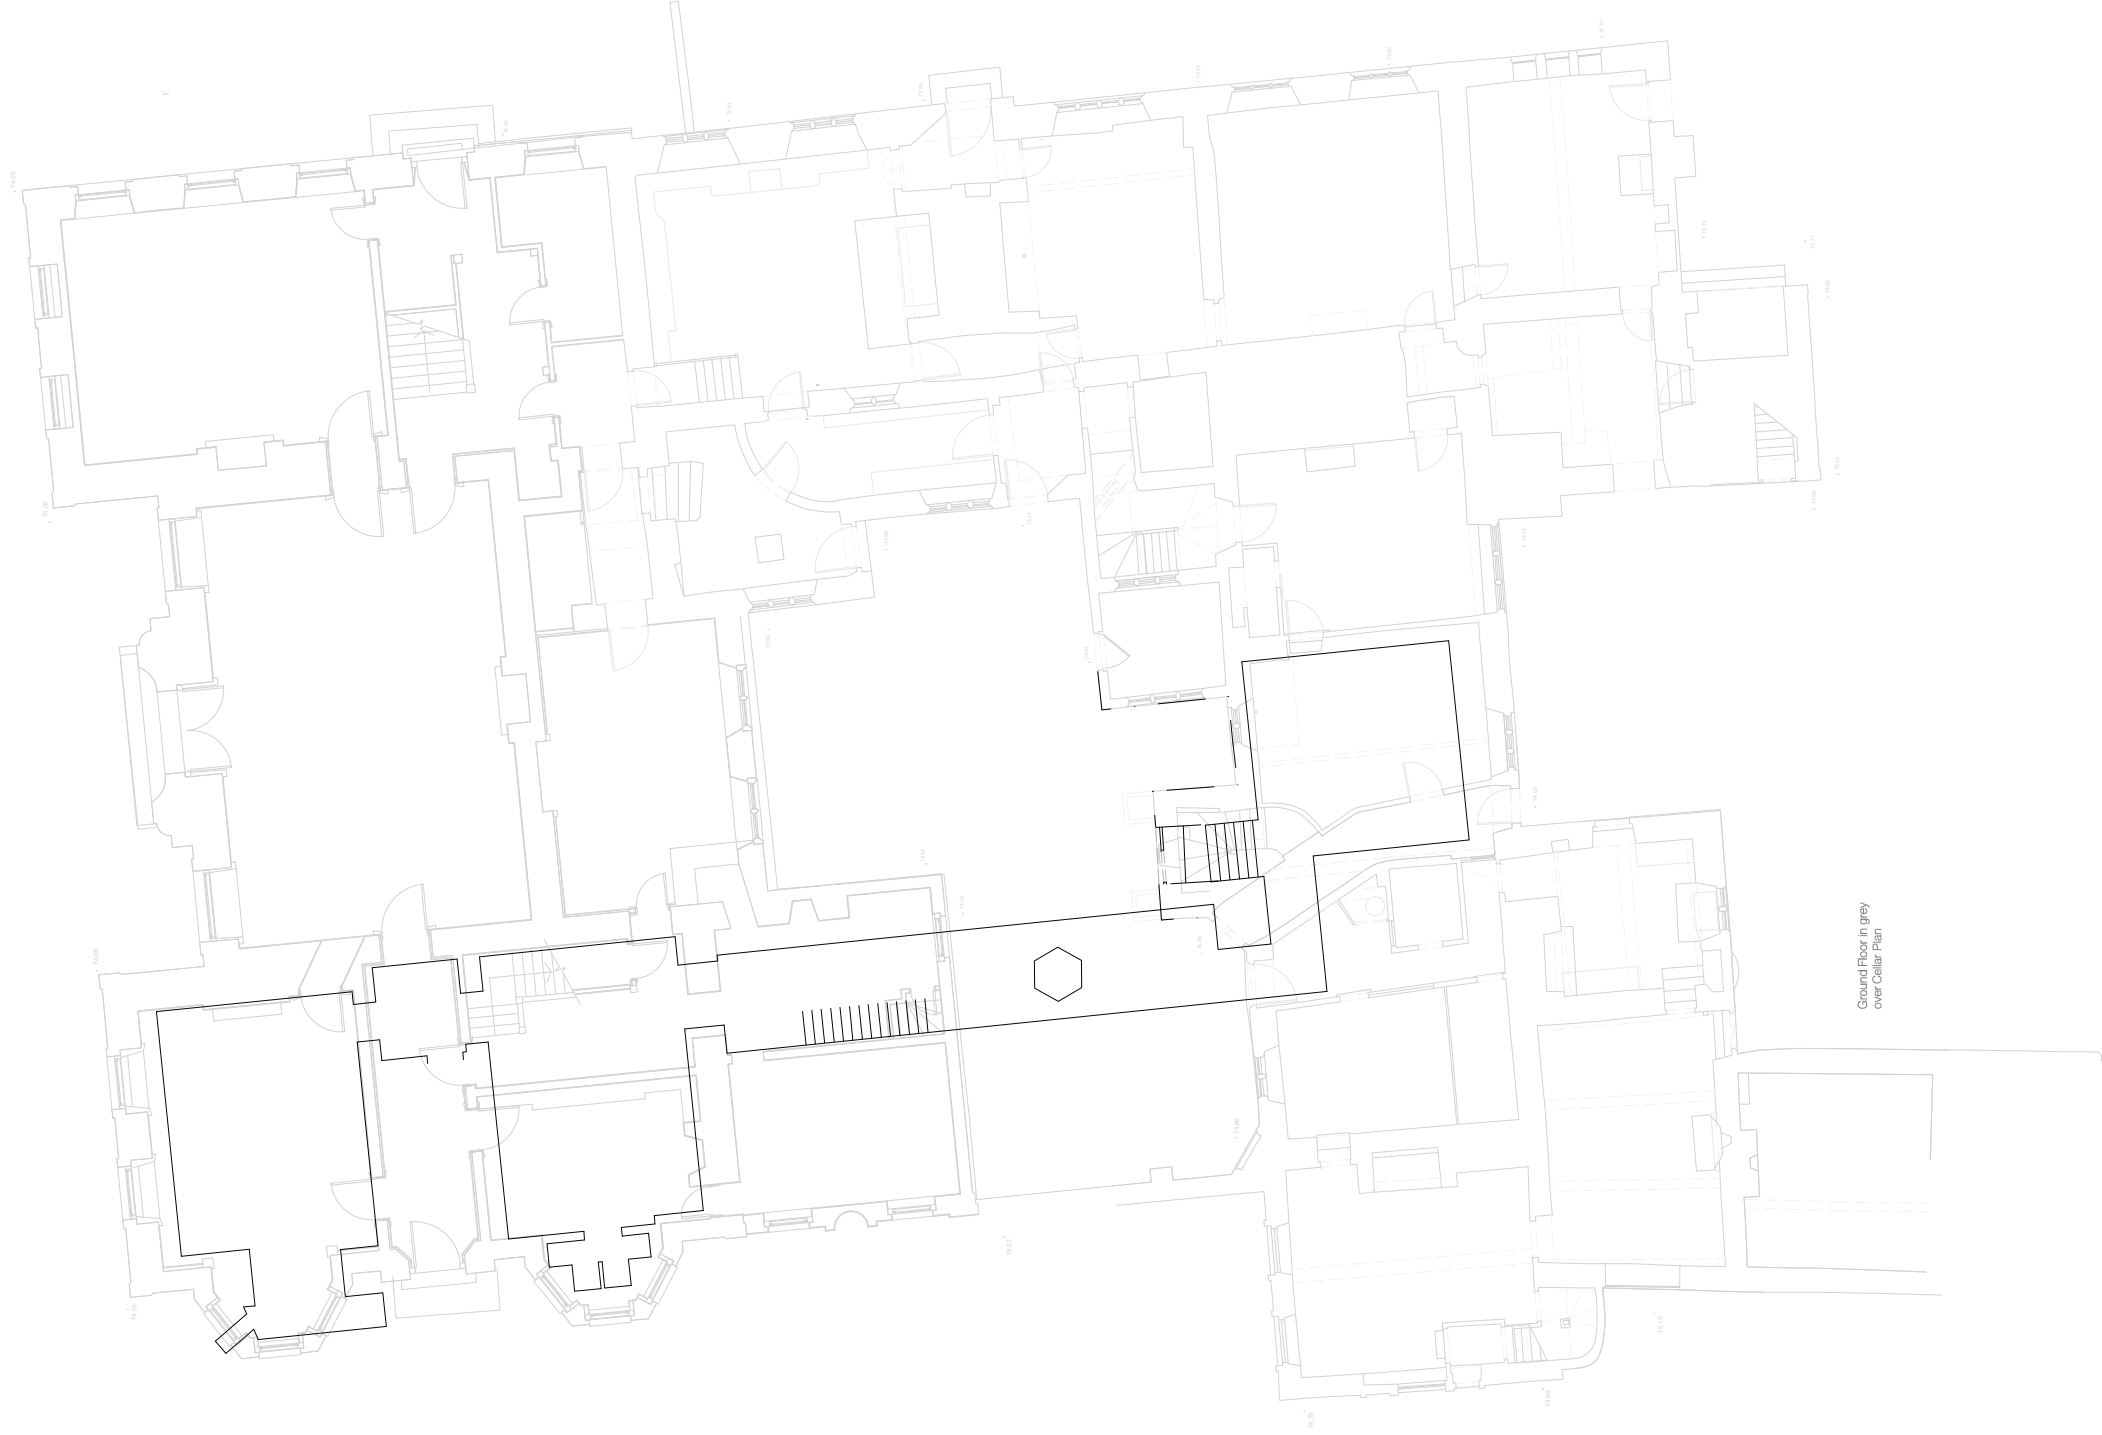
Ground Floor in grey
over Collar Plan
