**Summary of works: Archaeological monitoring and
recording in East and South Range, Halswell House,
Goathurst, Somerset**

Report No. 25-30

Archaeological monitoring and recording in the East and South Range, Halswell House, Goathurst, Somerset.

Summary of works

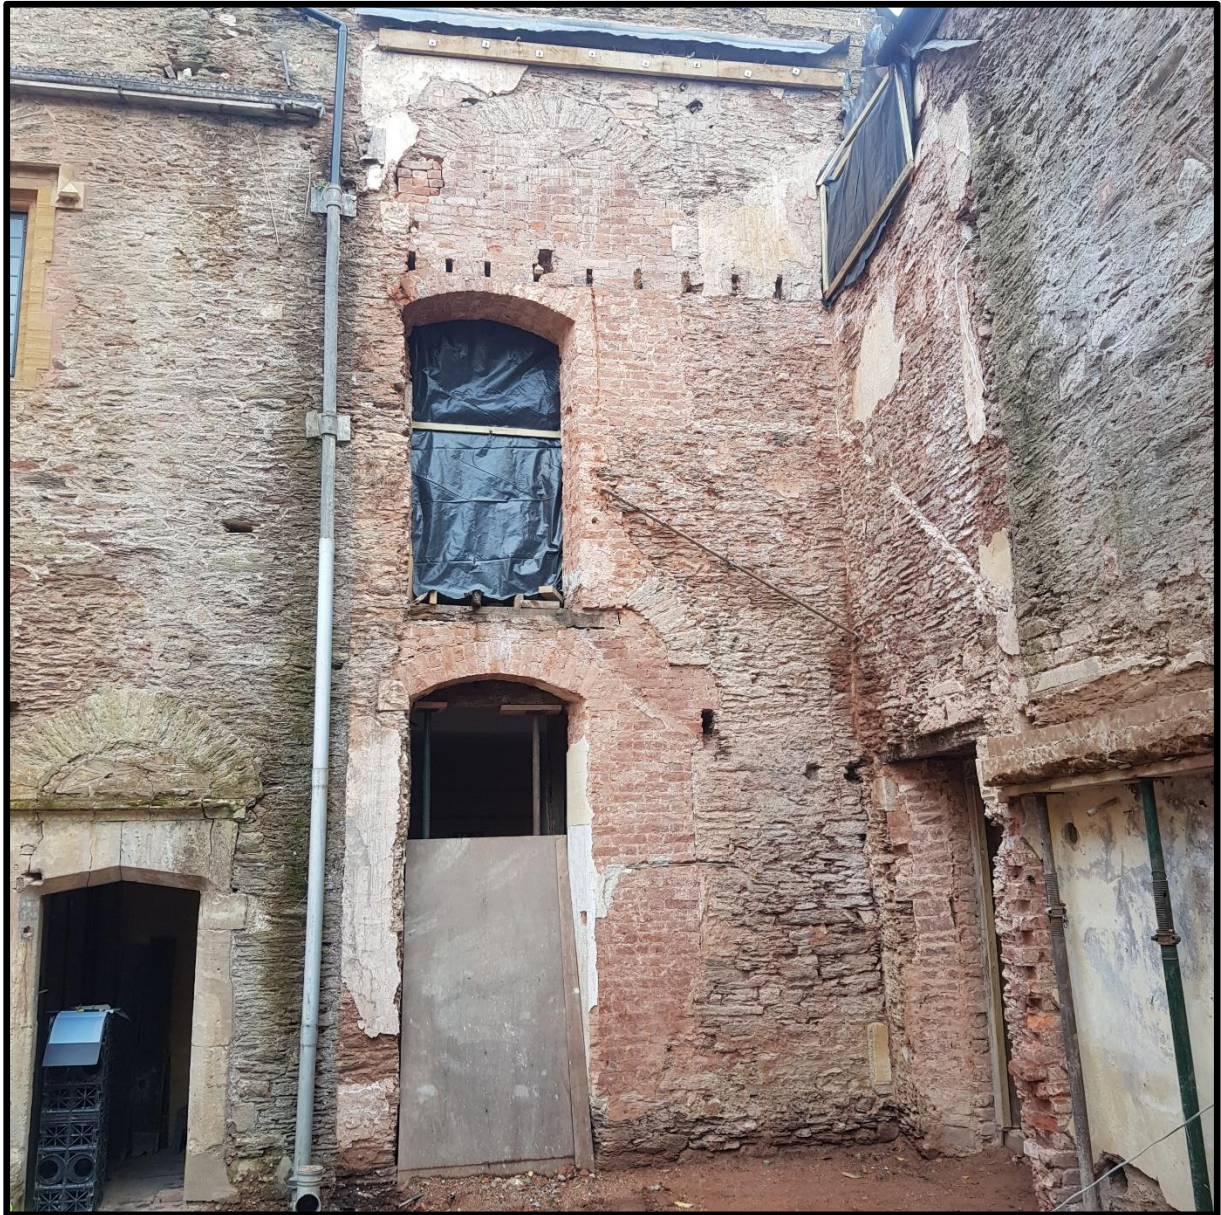
General view of the west elevation of the east range showing the projecting partial foundation of a possible earlier stair structure, the position of two earlier window openings, the position of the two later windows, and the late 18th century staircase arrangement. Looking east.

The works inside G18 and G19 exposed the fragmentary remains of a possible early Morte slate rubble foundation projecting beyond the line of the west wall of G19, with a small section surviving underneath the later timber partition separating G18 from G20 to the north. The scarring on the ground floor in the interior west wall of G18 suggests that this may originally have been a stone stair providing access from the courtyard to the upper floors of the newly extended south range. An area of scarring on the first floor level suggests that here too the original stair was removed and later infilled.

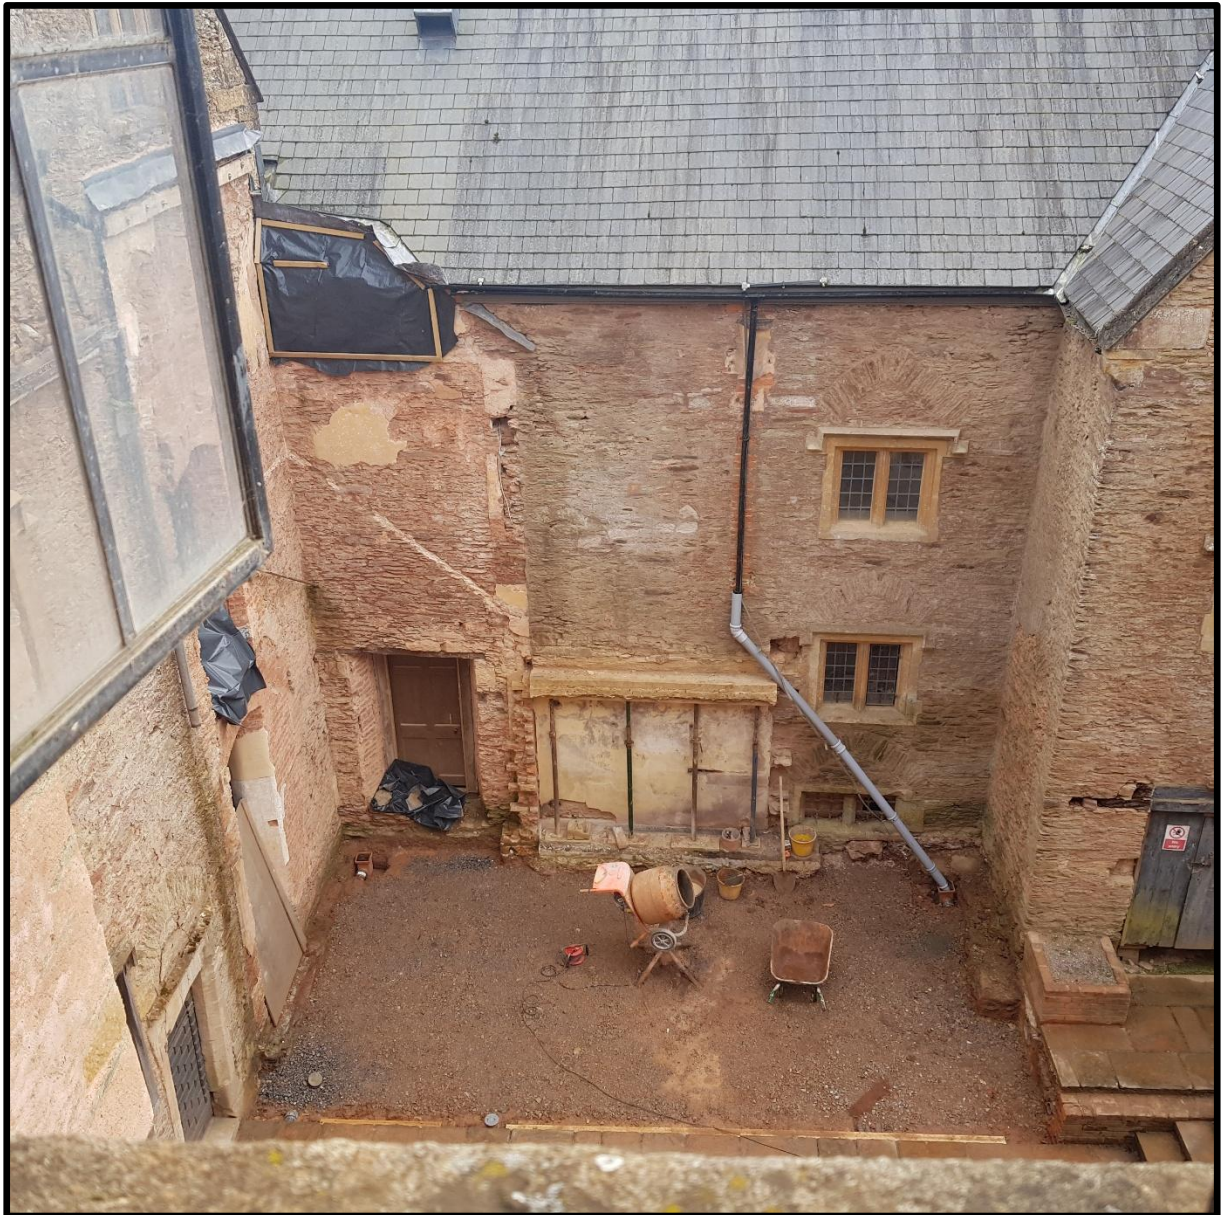
General view of the north elevation showing the position of two earlier windows, the remains of a possible pentice, the position of an earlier ground-floor window and later inserted doorway. Looking south.

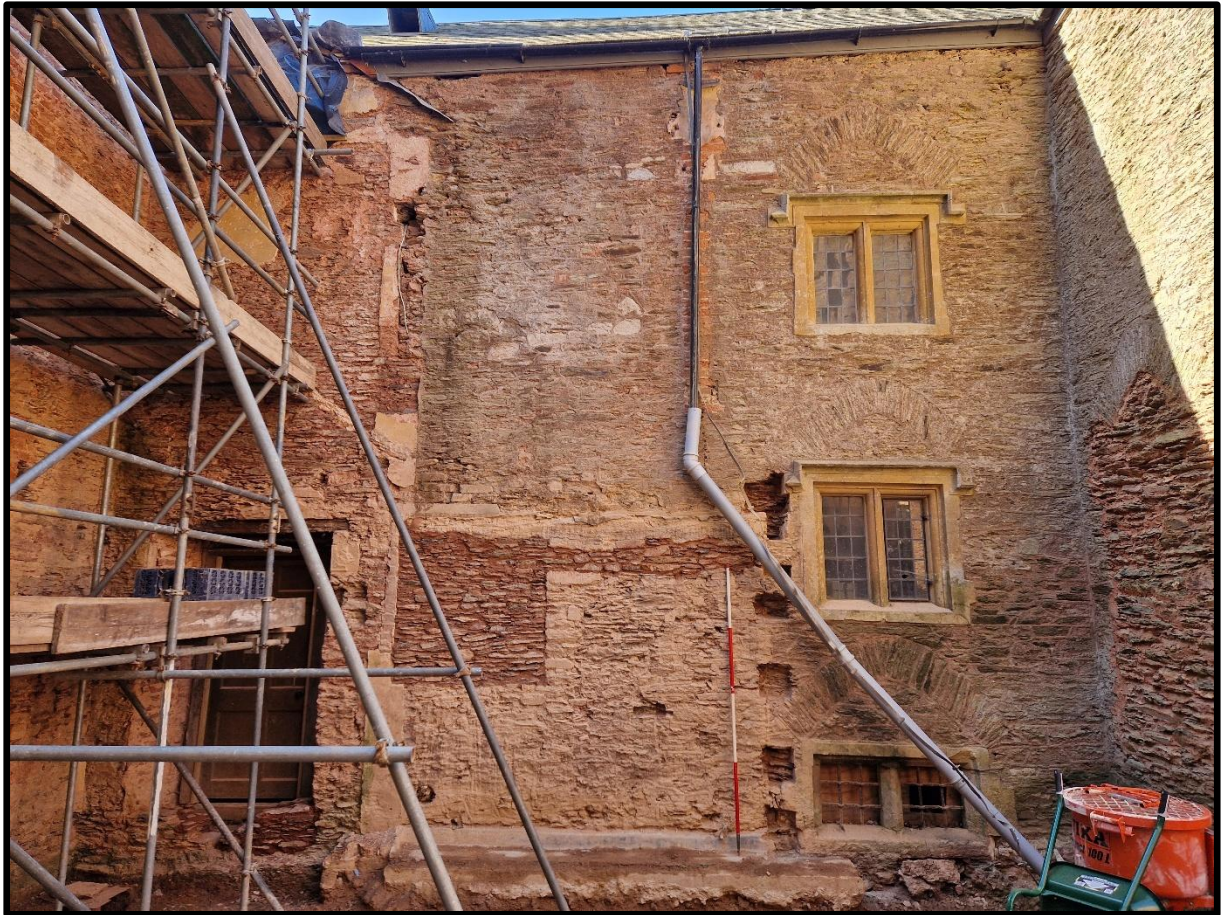
General view of the north elevation of the south range showing the partial position of the earlier window on the ground floor. 2m scale. Looking south.

In addition, previous historic building inside G12/13 and F16 has identified the remains of two similar long rectangular window openings. These pre-date the heightening of the south range, part of the major works undertaken in c.1590 by Sir Nicholas Halswell, suggesting that these windows, both within the south range and the staircase, are of a possible mid-late 16th century date.
