**Summary of works: Archaeological monitoring and  
recording in North Range, Halswell House,  
Goathurst, Somerset**

**Report No. 22-32**

**November 2022**

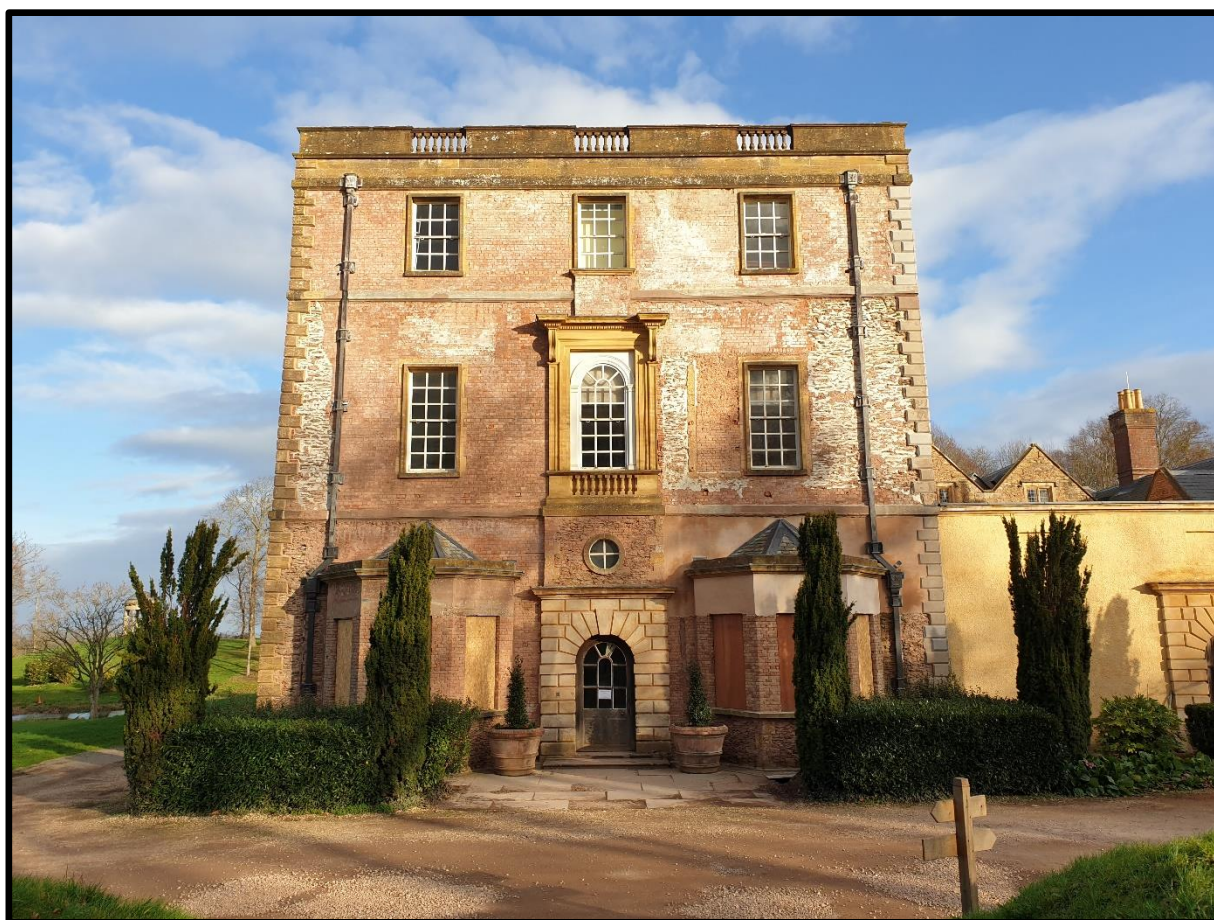
West elevation of North Range.

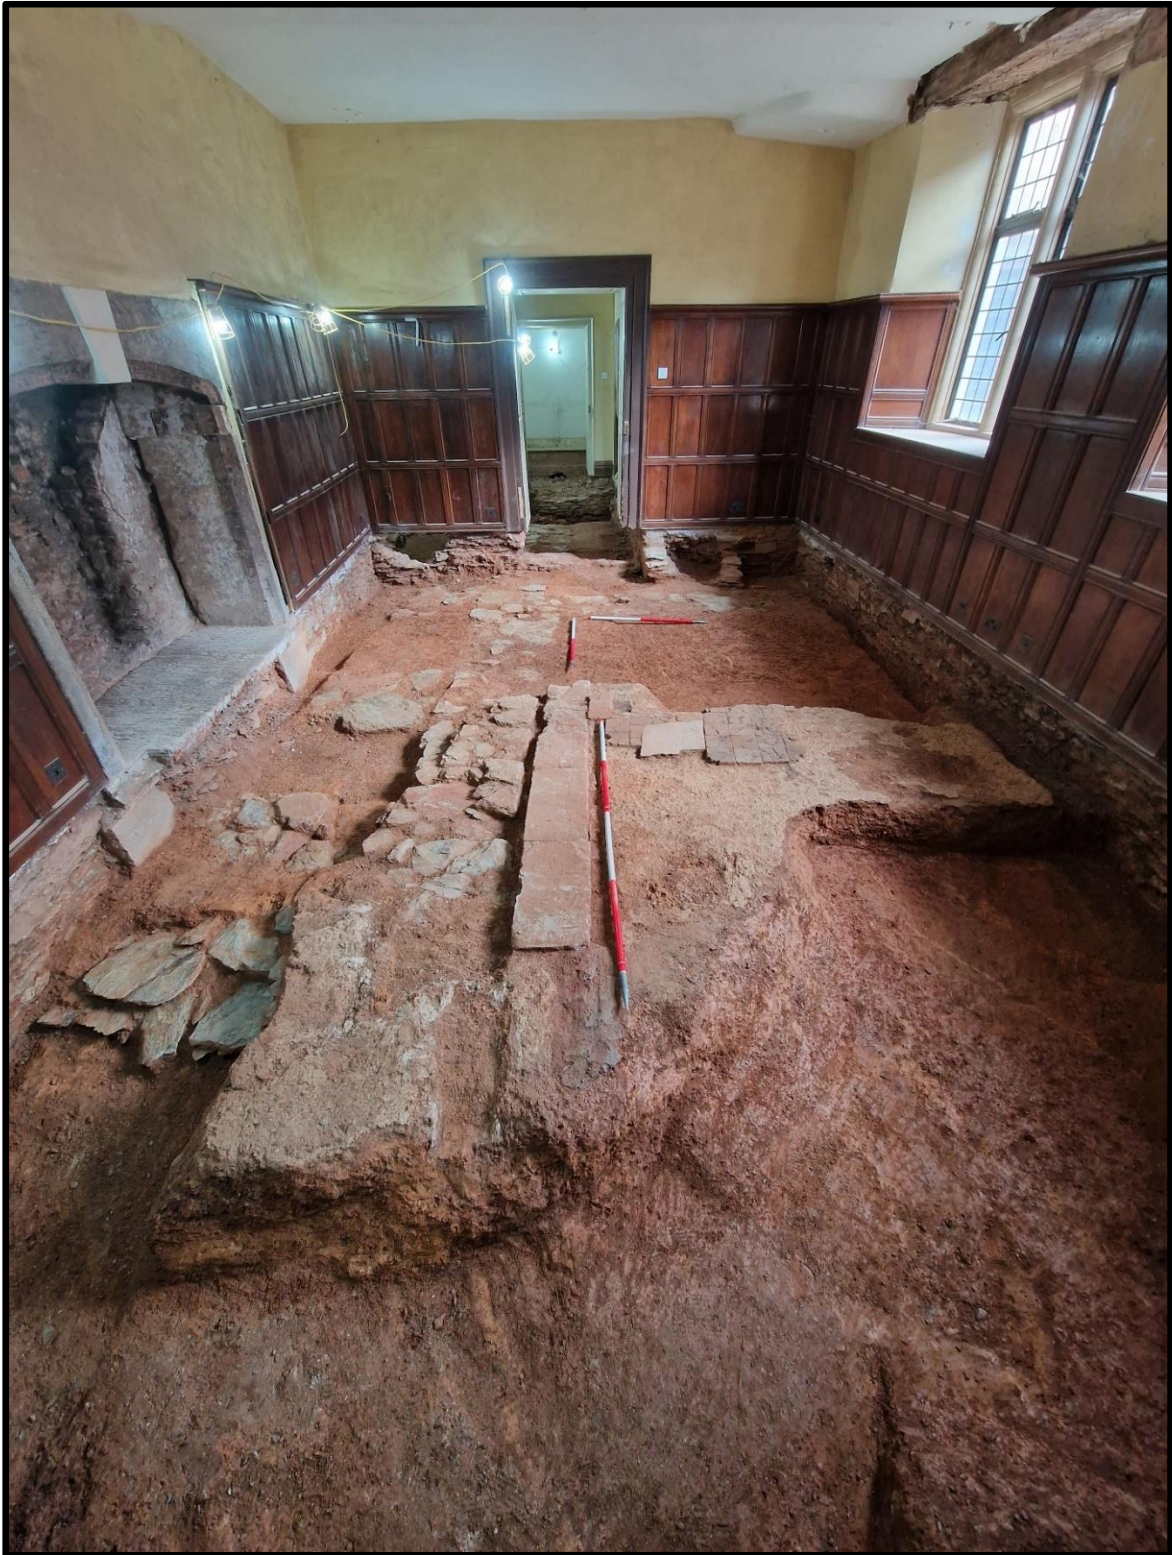
Internally, the earliest floor of the medieval north range was a beaten earth floor located immediately above the truncated natural subsoil. This was sealed underneath a shallow levelling deposit which was in turn overlain by a light yellowish white lime mortar bedding for a tiled floor. A small area of the pavement survived, consisting of 15<sup>th</sup>-early 16<sup>th</sup> century plain green glazed earthenware tiles, as well as ham stone and limestone pavers. The pavement was laid at a slight angle to the north wall with all the tiles heavily worn and fragmentary. The level of the floor was only marginally higher (0.12m) than the floor in the South Range. While two rows of the tiled flooring may be original, the rest was relaid or repaired at a later date, including the ham- and limestone pavers. A line of possible North Curry greensand floor slabs was inserted along the northern edge of the room, with a small gap between the pavement and the north wall. This might suggest perhaps that the original lime plaster had, by this period

been replaced with wooden panelling, and that the flooring was inserted up to the edge of the latter.

General view of Room G46 showing the remains of the earlier north range. 1m and 2m scales. Looking east.

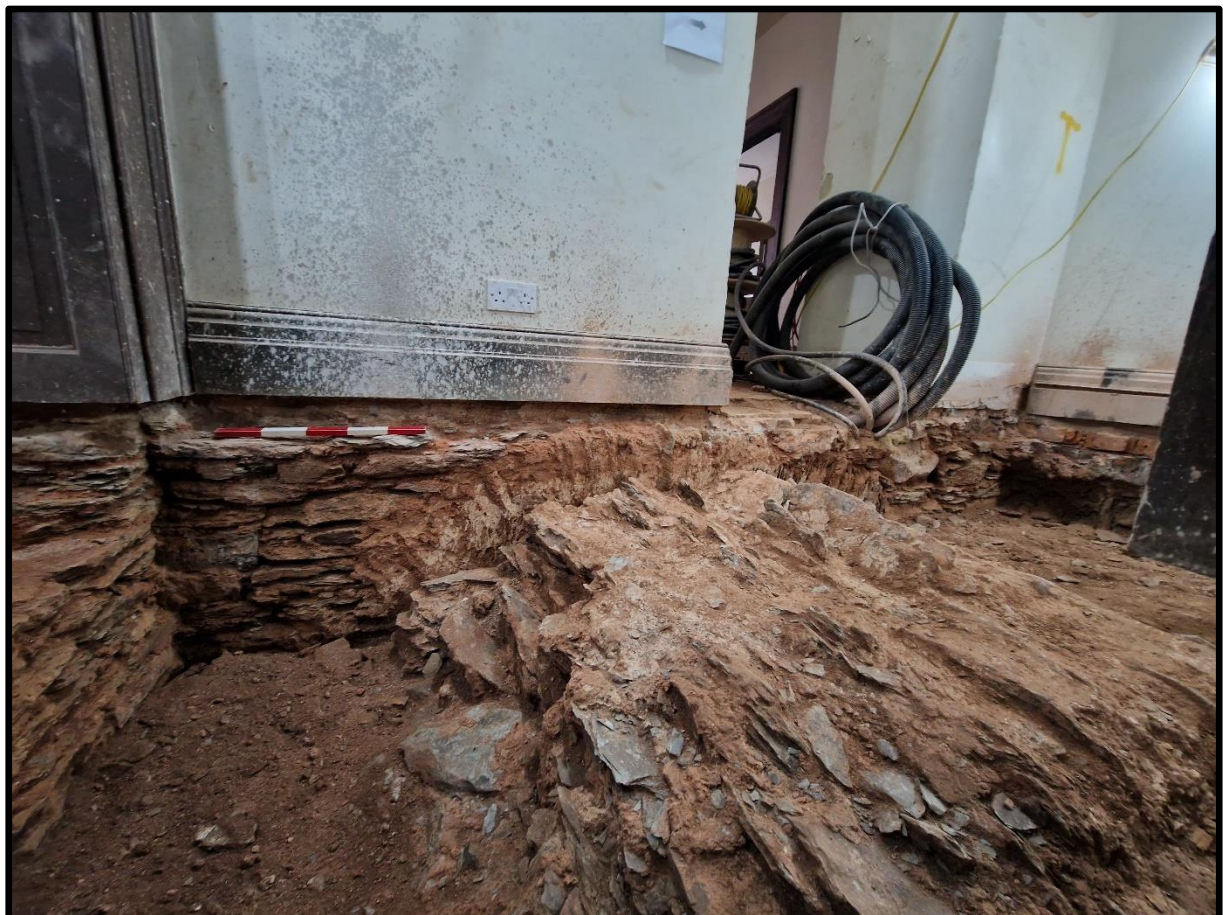
General view of north elevation of the south wall in G40 showing the relieving arch within the wall construction and the vault roof. 0.5m scale. Looking southwest.

The work also confirmed that the western wing of the later North Range was basemented from the beginning. The north elevation of the south wall defining G40 showed the contemporary

relieving arch within the wall construction, while the vaults, although they abutted both the south and east walls, were on balance likely to be contemporary with these. In addition, a further 35 architectural fragments were recovered from a post-fire deposit identical to the one identified in G1.

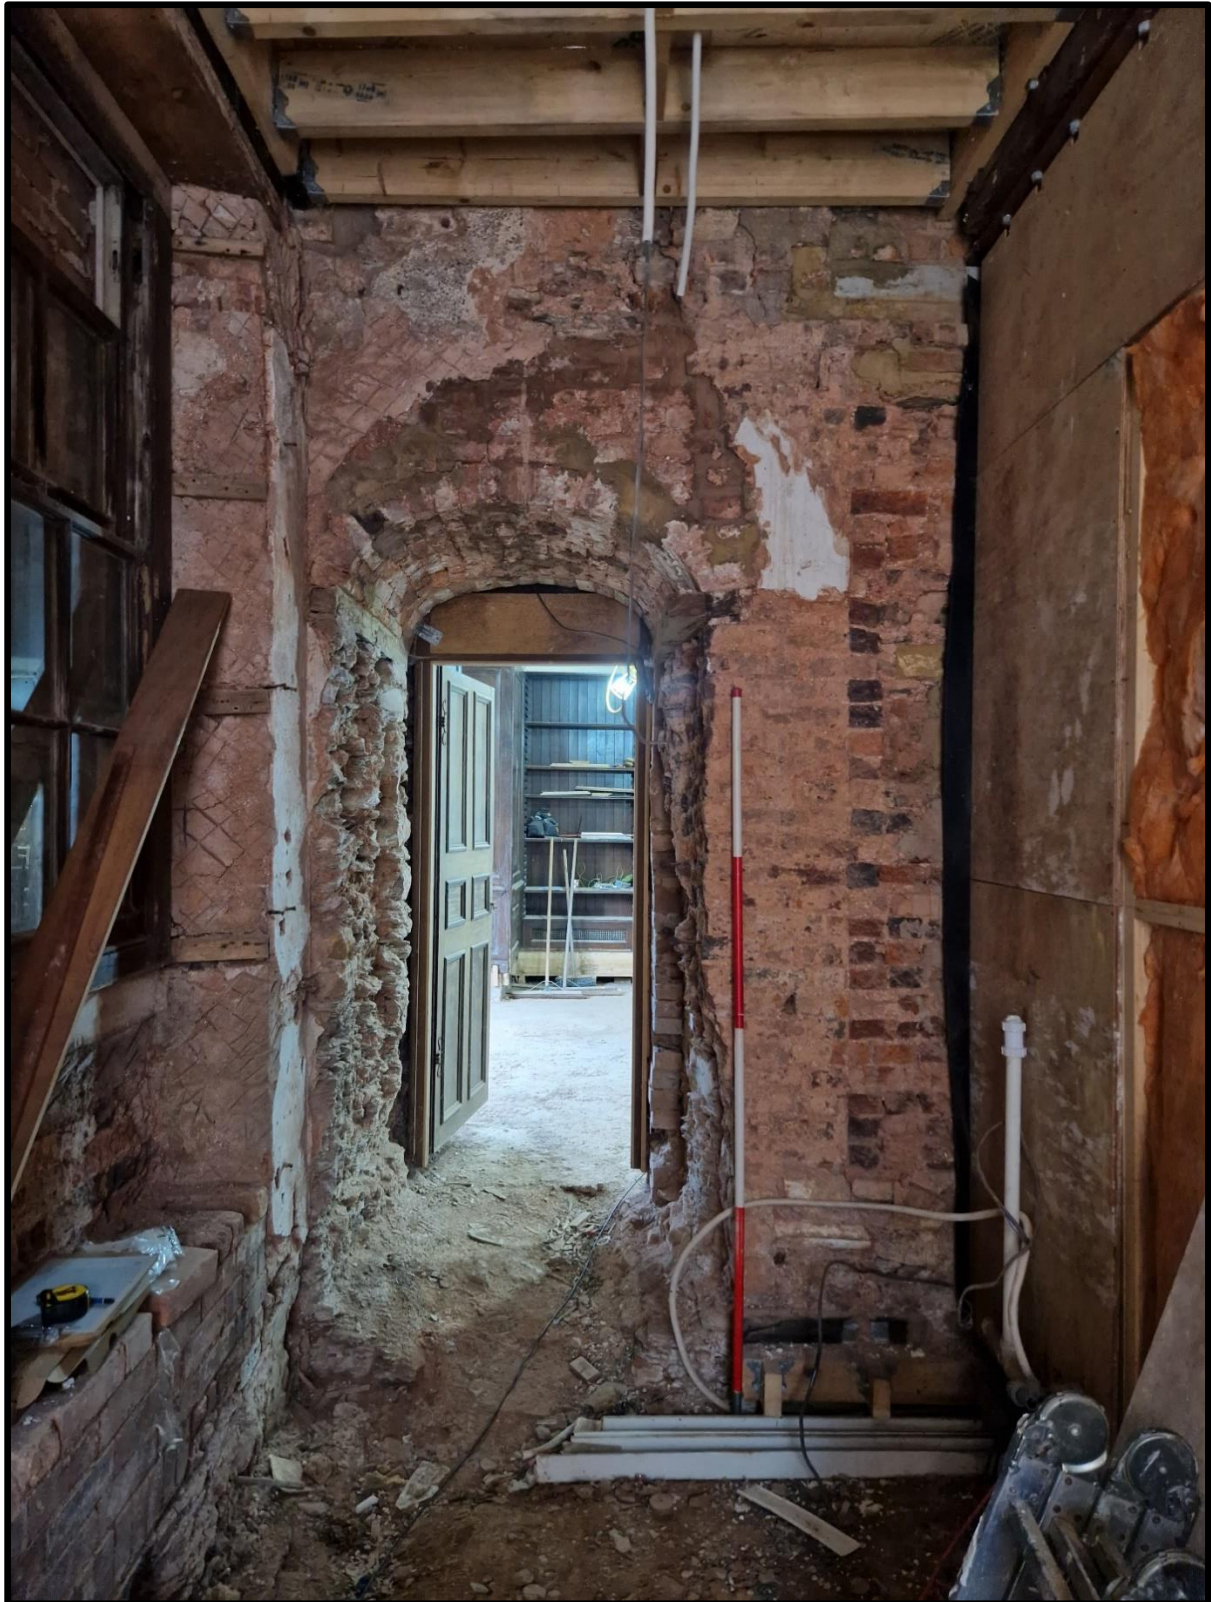
General view of the opening between G49 and G39 showing the earlier projecting brickwork to the right and the later arched opening (centre). 2m scale. Looking north.

Finally, building recording was carried out in G49 and within the doorway to G39 to the north. This revealed the remains of an earlier brick wall inserted into the south elevation of the north wall. This is part of a possible earlier building range extending south and east, rather than a later chimneystack, although whether this was originally an external wall, or an internal partition is uncertain. Neither is it clear whether the opening into G39 existed at this period. The curved brick ceiling with contemporary timbers for affixing wooden panelling is later in date.
