**Summary of works: Archaeological monitoring and
recording on the North Lawn, Halswell House,
Goathurst, Somerset**

Report No. 25-38

Archaeological monitoring and recording on the North Lawn of Halswell House, Goathurst, Somerset.

Summary of works

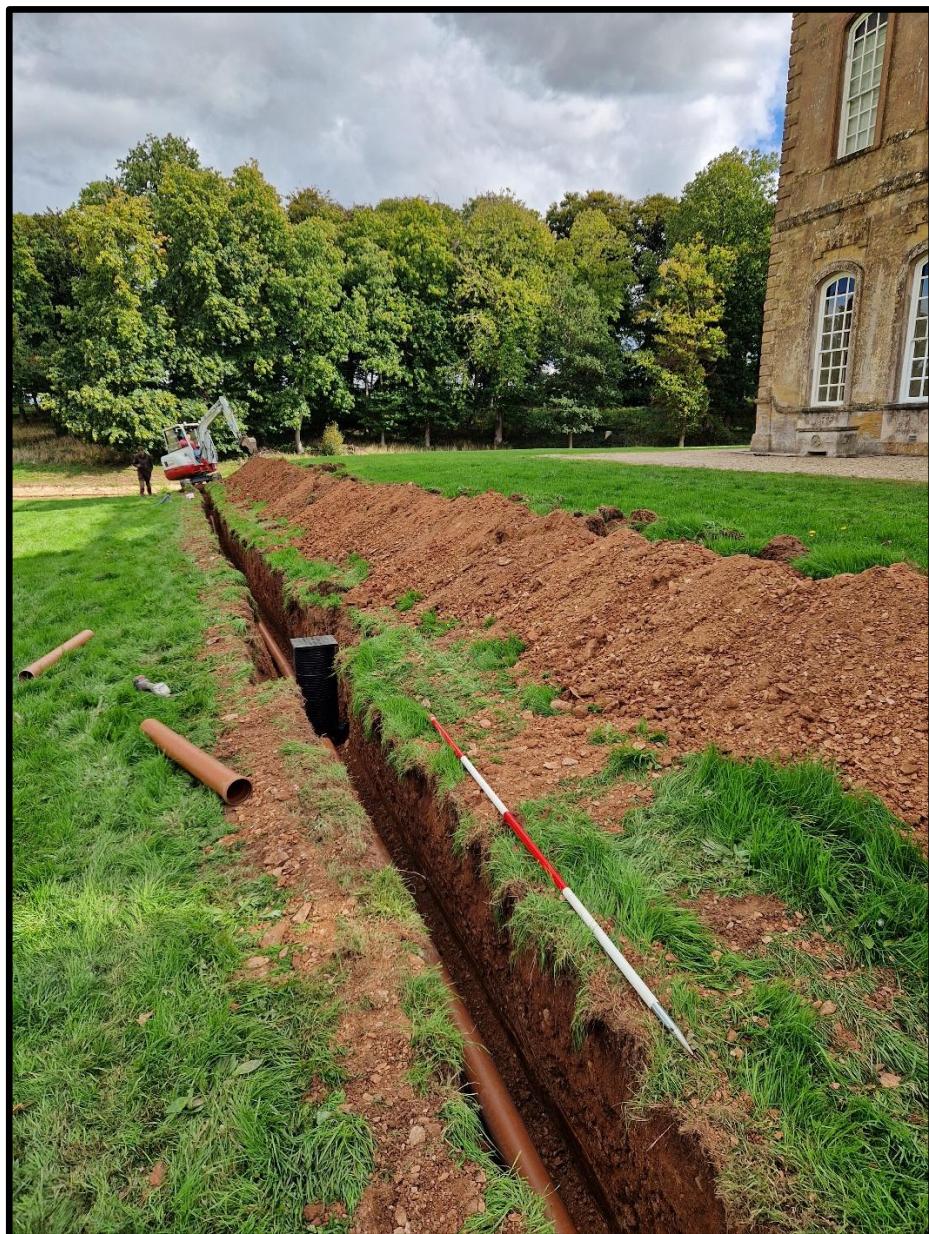
General view of the excavations across The North Lawn. 2m scale. Looking southeast.

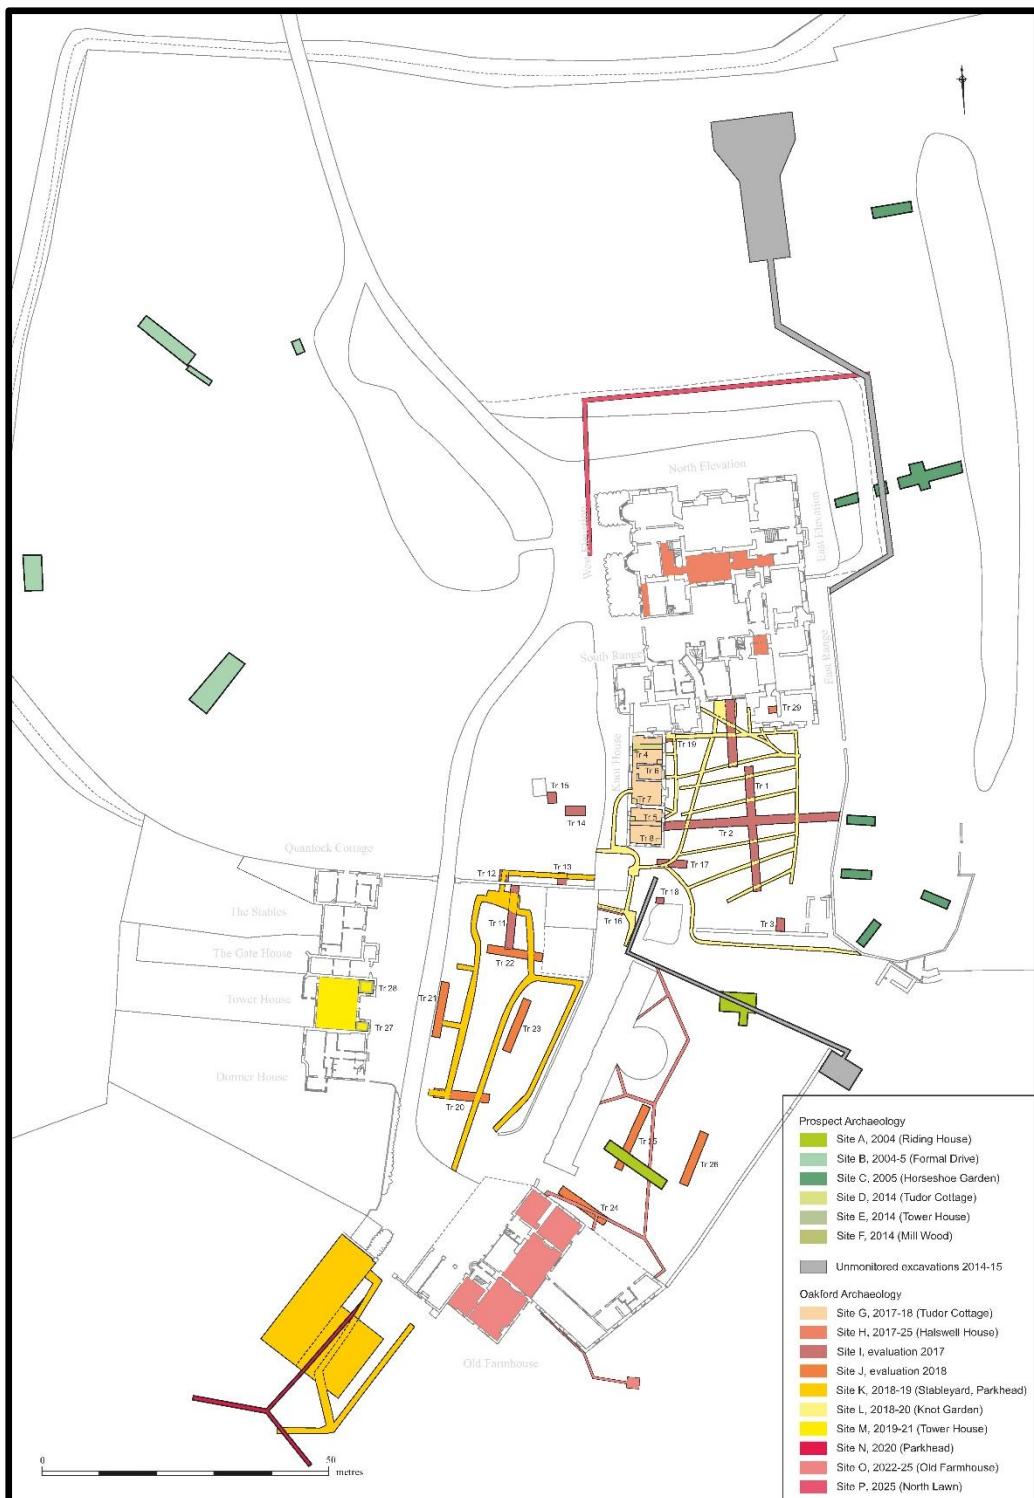
Plan showing location of earlier trenches and recent observations.

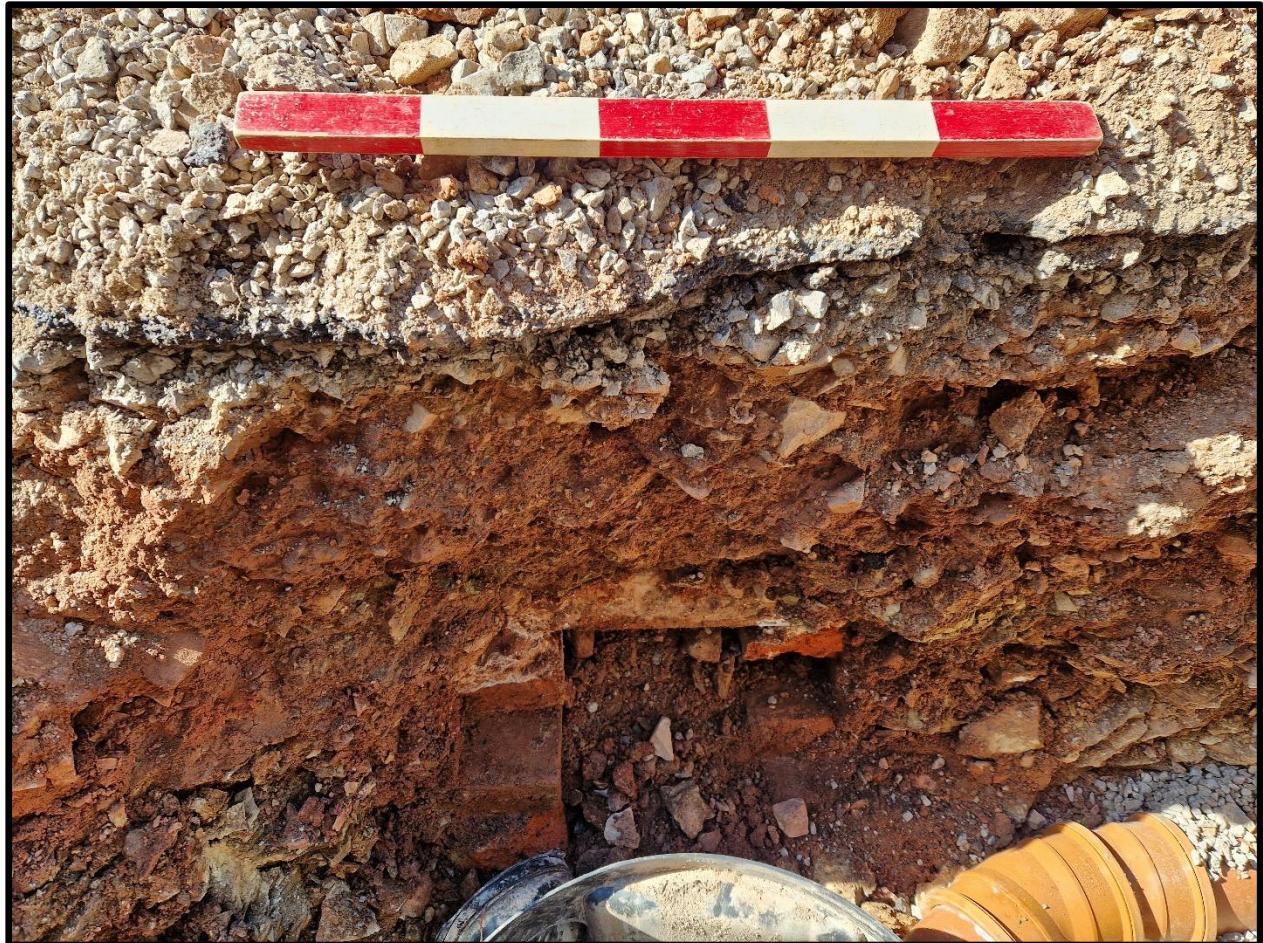
Section through historic made ground deposits to the west of the North Range and 18th century brick culvert (2178). 1m scale. Looking west.

The earliest deposit uncovered by the works to the west and north of the North Range consisted of a number of substantial redeposited natural made ground deposits, likely the result of infilling of the earlier 17th century terraces. Built prior to the laying down of the basal historic made ground deposit were two brick-built 18th century culverts and intended to drain both the new approaches to the recently rebuilt West elevation of the house and redirect the large quantities of water that often runs down the prevailing slope at the rear of Halswell House. These were buried underneath the second historic made ground deposit which was in turn sealed underneath an extensive imported sub- and topsoil associated with the creation of the current North Lawn in the period 1740-50.

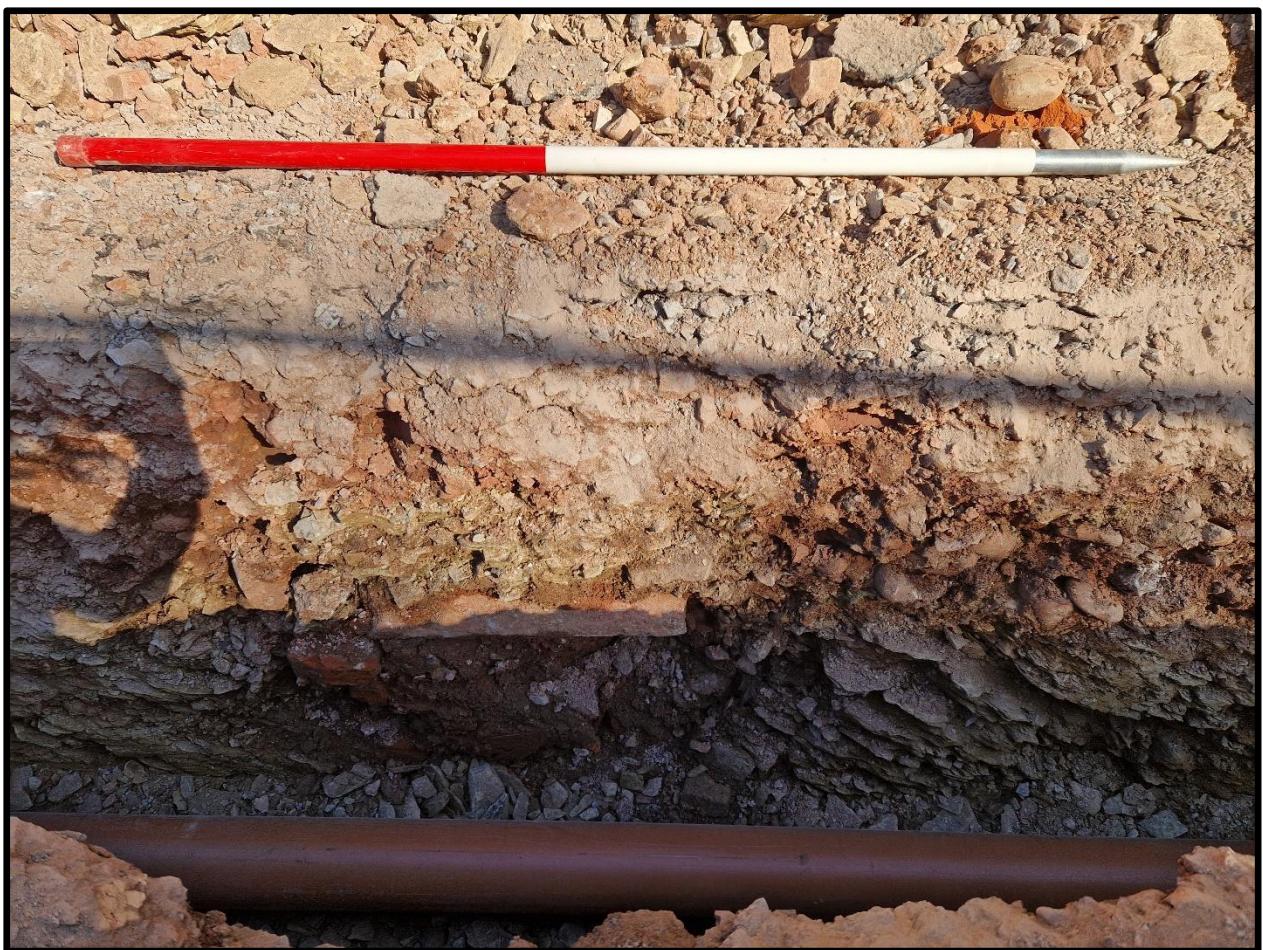
Section through historic made ground deposits to the west of the North Range and 18th century brick culvert (2180). 1m scale. Looking west.
