**Halswell Park, Goathurst Somerset  
The Deer Park Ha Ha (Areas 1 & 2)**

**The Results of an Archaeological Evaluation**

**Halswell Park  
GOATHURST, SOMERSET**

**THE DEER PARK HA HA, HALSWELL PARK, GOATHURST, SOMERSET. THE RESULTS OF AN  
ARCHAEOLOGICAL EVALUATION**

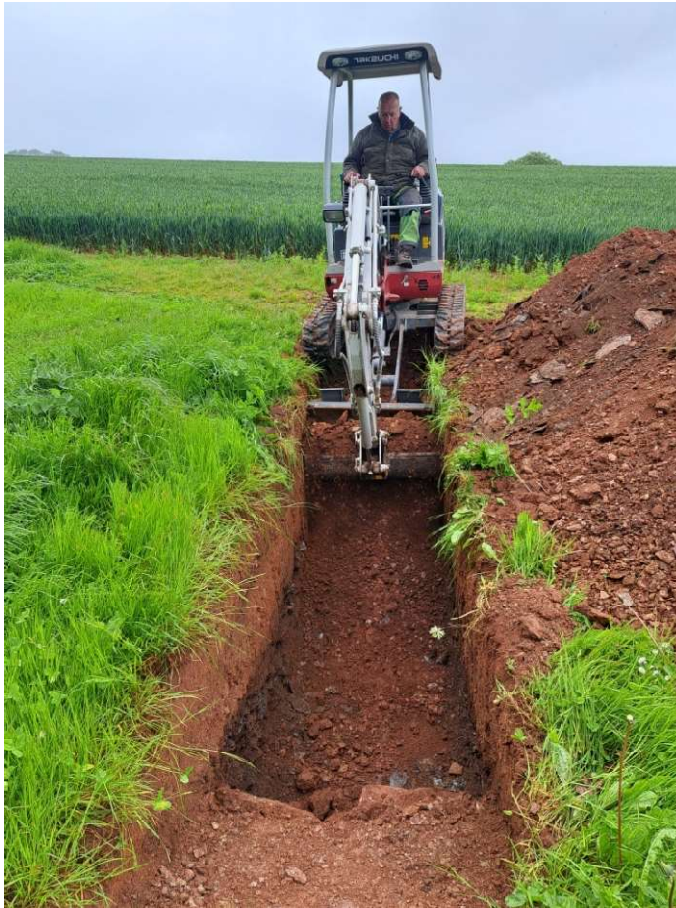
**Pl. 1: Commencement of excavation in Trench 1 to the west of the site (view from E)**

2.1.3 The trenches were initially opened through the use of a machine fitted with a toothless grading bucket under constant archaeological supervision with the process being occasionally halted or paused to allow the collection of artefacts and the examination of exposed deposits. The process of excavation was completed through manual effort and all exposed surfaces were cleaned prior to a photographic record being compiled to include detailed and wide shots of significant features, at least one trench long section and trench location. At the completion of the excavation at least one long section of each trench was drawn at a scale of 1:50 and annotated to record the characteristics and stratigraphic relationships of each context. Plans were drawn at a scale of 1:50 if deemed appropriate and the trench locations recorded on a final overall plan at a scale of 1:2500.

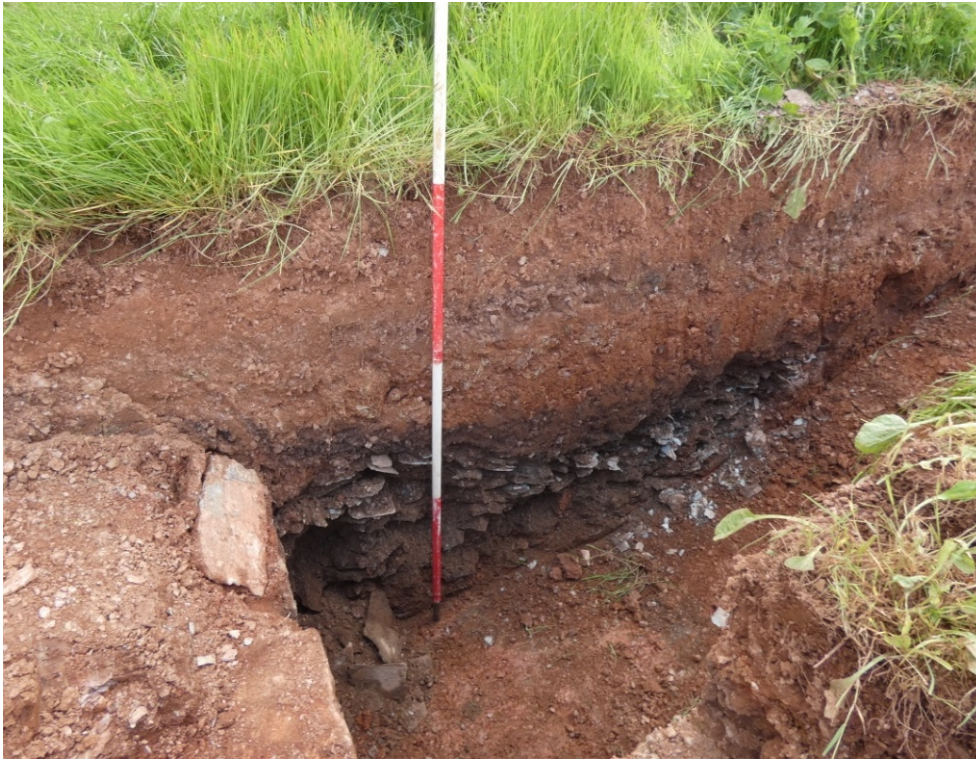
**Pl. 2: North facing section through ditch [107]; Area 1 south (view from N; scale=2m)**

2.3.3 Two 1.00m wide sections of the feature were excavated here in the form of broad ditch [107], 5.00m in width and up to 1.70m in depth with a moderately-sloping west falling to a gentle break at a flat base (figs. 2 & 3; pl. 2 & 4). The east side of the feature was vertical and faced in both excavated locations by a wall (106), 0.40m in thickness and built from the base of the ditch and which survived to maximum height of 1.30m, although the upper courses may have been lost (pl. 3; 5 & 6).

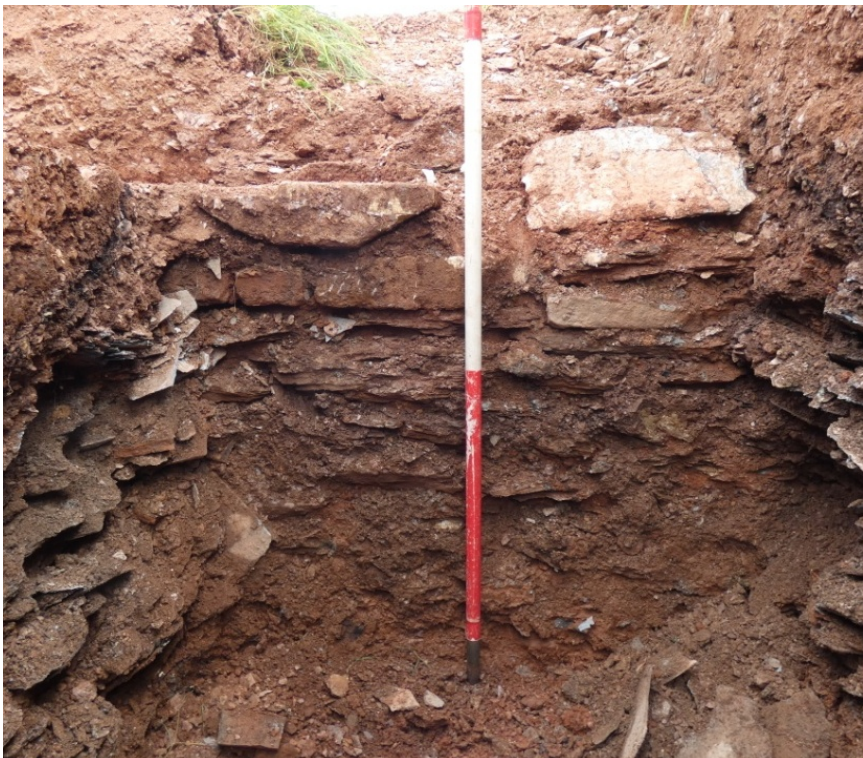
**Pl. 3: Detail exposed elevation of retaining wall (106); Area 1 south (view from W; scale=1m)**

2.3.4 Evidence at both locations suggested that the original wall (106) had been constructed of flat-laid Morte Slate rubble bonded by red-brown sandy lime mortar, although the upper surviving courses to the south included a brick header course which may represent a later repair. Further short lengths of probable repairs, all including brick headers and stretchers, were noted in the centre of the excavated length in the form of (112) & (115), with the former being coincident with a slight deviation in the overall line of the wall, suggestive of a partial failure.

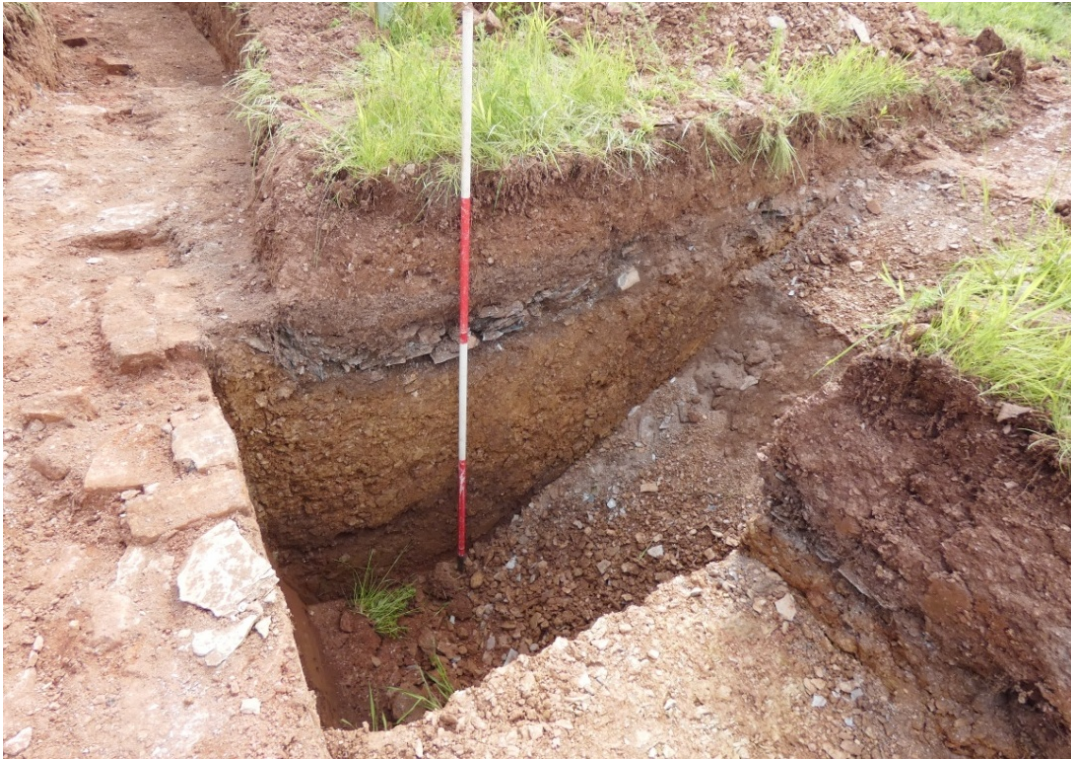
**Fig. 4: North facing section through ditch [107]; Area 1 central (view from N; scale=2m)**

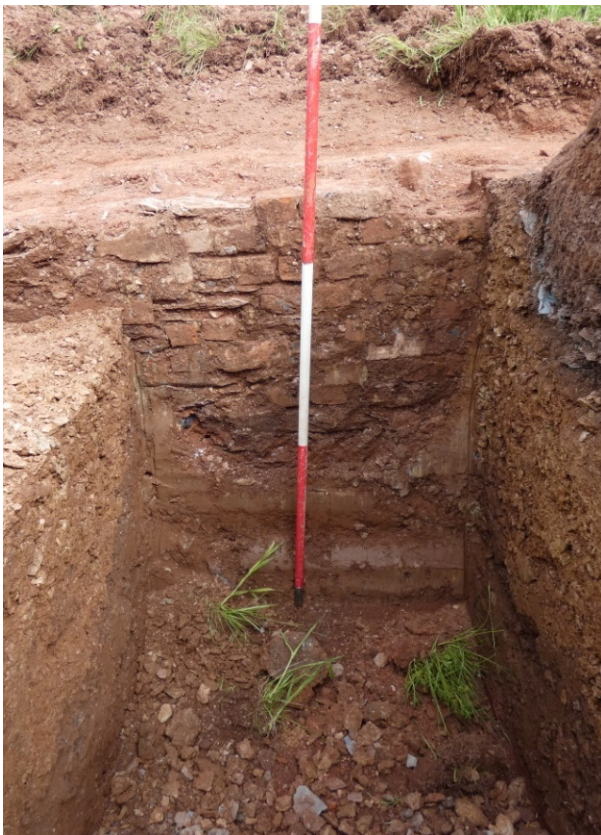
**Fig. 5: Detail exposed elevation of retaining wall (106) & repair (112); Area 1 central (view from W; scale=1.50m)**

| Context No. | Type | Interp. Type | Description | Period | Same as/Part of | Strat. Above | Strat. Below |
|---|---|---|---|---|---|---|---|
| 112 | Structure | Wall Repair | Up to 4 courses of brick headers with some MS rubble bonded by hard red-brown lime mortar inserted in top of wall (106) | | - | 106 | 105 |

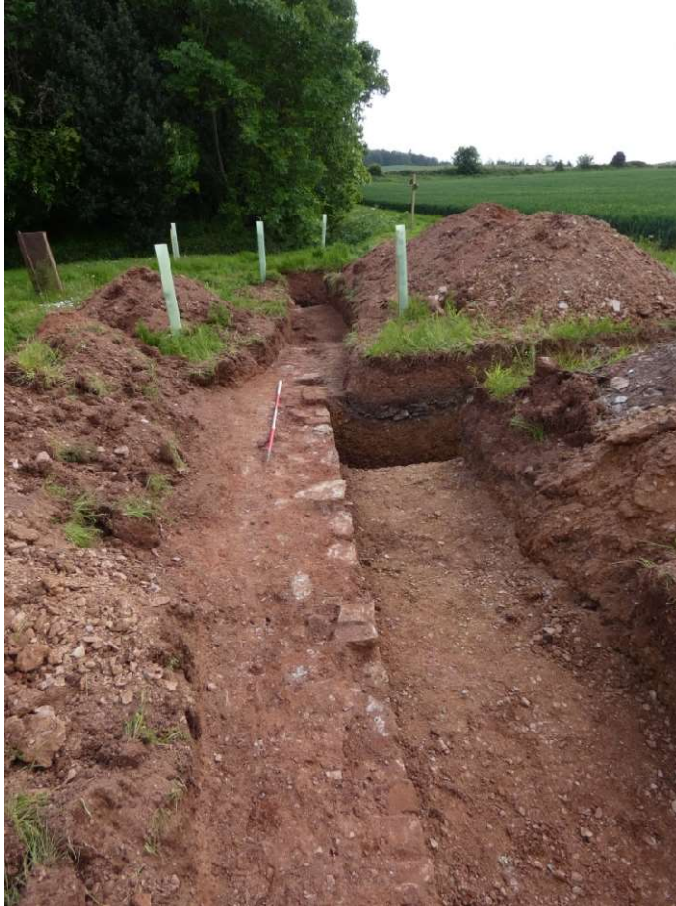
**Pl. 6: General view of Area 1 at close of excavation showing exposed length of wall (106) (view from N; scale=2m)**

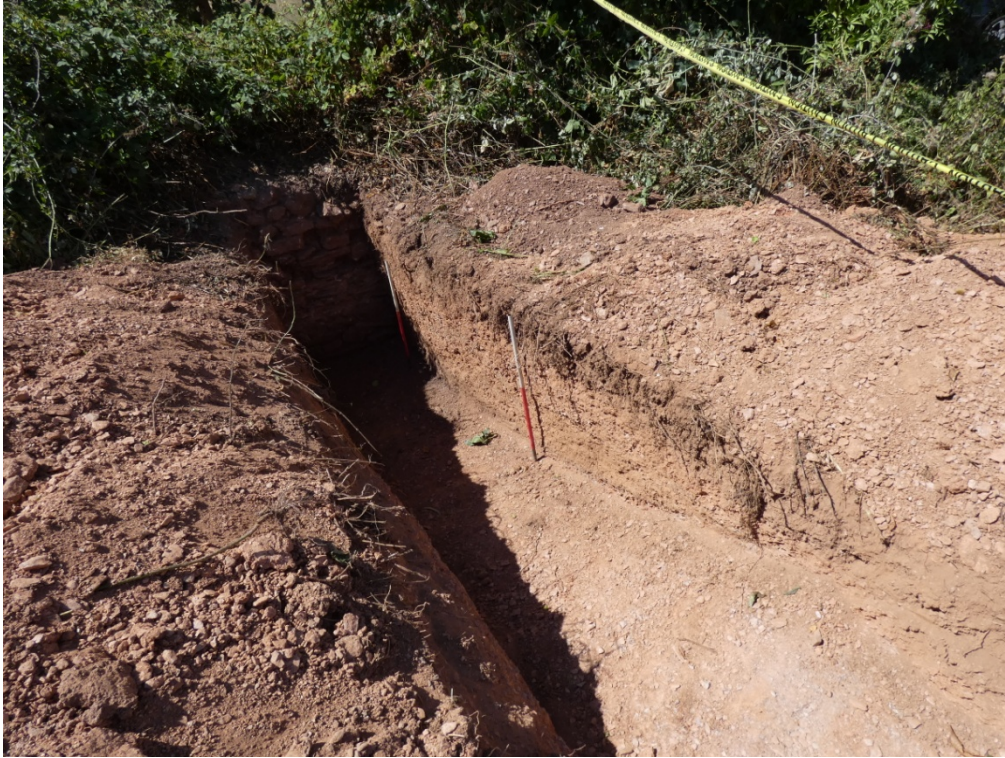
**Pl. 7: General view of south facing section in Trench 2 (view from ESE; scales=1m)**

2.3.8 Within Trenches 3 & 4 to the west, Ditch [305] was found to be up to 6.00m in width and 1.80m in depth with a moderately-sloping eastern side falling to a gentle break at a flat base (fig. 4; pl. 7 & 9). In Trench 3 the assumed vertical western edge was faced by wall (305), consisting predominantly of un-coursed red sandstone rubble from which the red-brown lime mortar bonding had been largely washed-out from the upper courses. The central part of the exposed elevation at this point was formed of small to medium sized slabby Morte Slate, quite haphazardly laid and pointed bonded by pale red-brown lime mortar with little finesse (pl. 8). The character of the Morte Slate courses here does not match the quality of the workmanship observed elsewhere and it may be suggested that this represents a later repair to what may have been wall entirely constructed of red sandstone rubble.

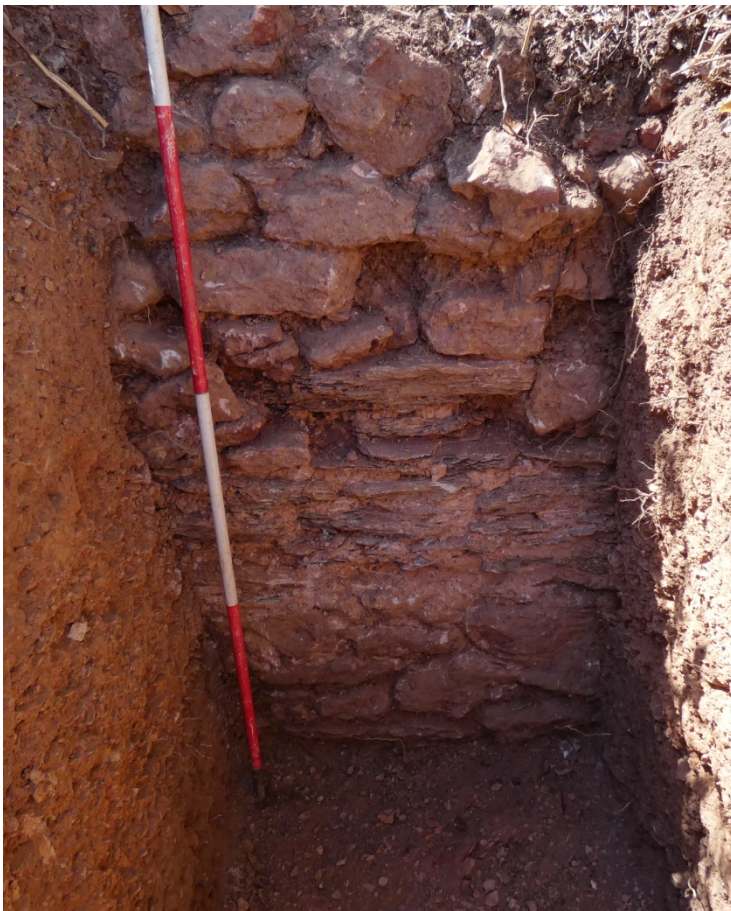
**Pl. 8: East facing elevation of wall (304) in Trench 3 (view from E; scale=2m)**

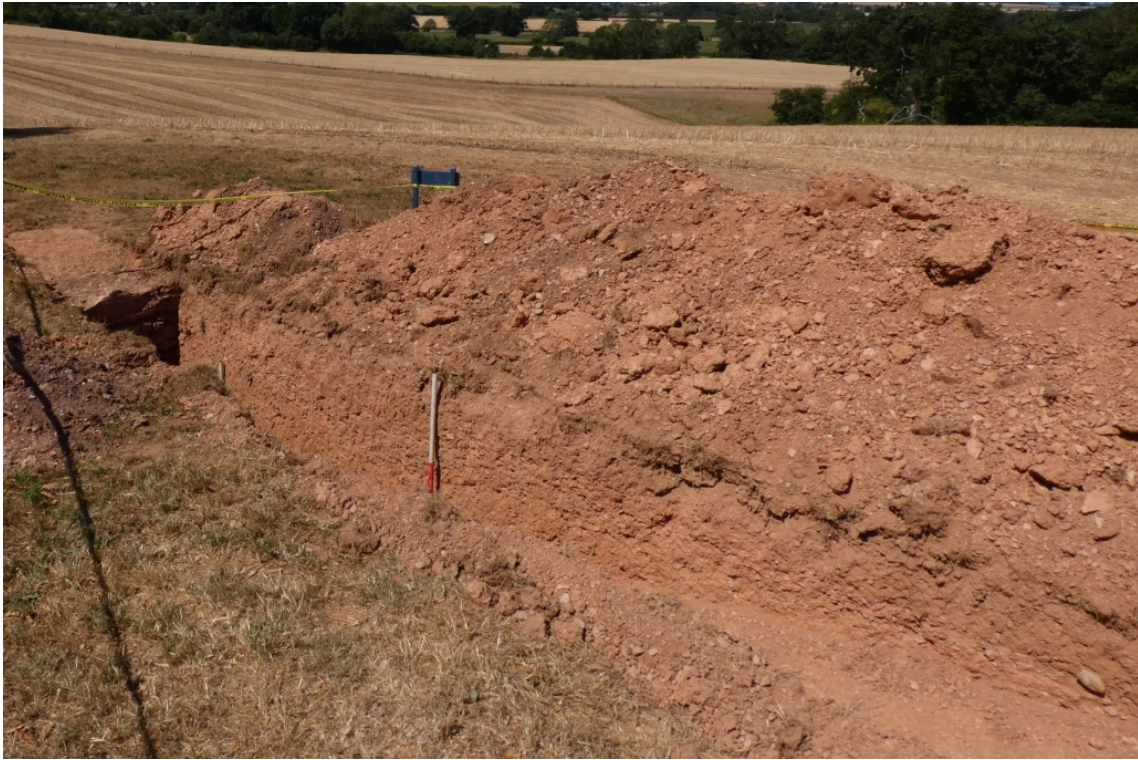
**Pl. 9: South facing section in Trench 4 (view from SE; scale=1m)**

2.3.10 The primary fill of the ditch in Trench 4 consisted of compact dark grey-brown gritty silt (404) likely to be the product of prolonged silting which included quantities of red-brown mortar fragments, some grey mortar along with small red sandstone and Morte Slate, pan tile fragments and bottle glass of mid to late 19<sup>th</sup> century date. It is worth noting here that (404) only sealed the retaining wall to the level of lower part (406) and it may be suggested that this material was already deposited when the later phase of the structure (405) was built, which would possibly explain the significant offset.

2.3.11 The eventual in-filling of the ditch at the location of Trench 4 continued with the deposition of clean red-brown clay-loam (403) which does not appear to be deliberate and may represent an accumulation of material washed off the adjacent field when this was returned to arable use. This was finally sealed by deliberate backfill of compact clay and gravel (402) with all being overlain to level of the existing surface by recent cultivation horizon (401) and top soil and turf (400).

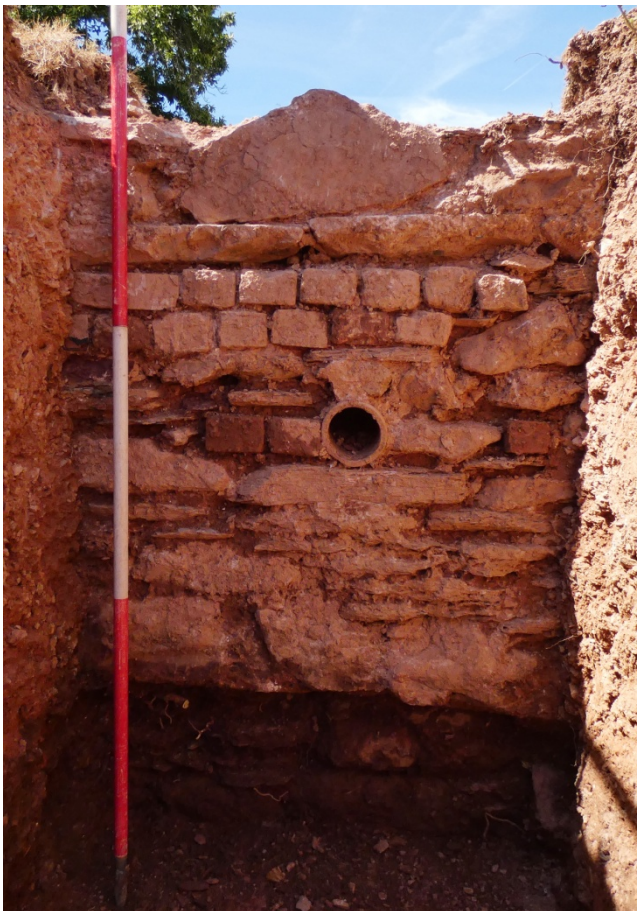
**Pl. 10: East facing elevation of retaining wall (405)/(406) in Trench 4 (view from E; scale=1.50m)**

2.3.9 The wall elevation as exposed in Trench 4 also bore indications of two phases of work. Here the lower part (406) was constructed of red sandstone rubble with occasional components of Morte Slate and bonded by hard dark red lime mortar (pl. 9). The upper and principal part of the elevation (405) was offset from (406) to the east by 0.20m and constructed of Morte Slate rubble with occasional brick, capped by two courses of brick headers, followed by blue lias slabs and finally by large Morte Slate rubble all bonded by pale red-brown lime mortar. This section of wall also contained a ceramic pipe, deliberately built into the structure and running out of the feature to the west.

| Context No. | Type | Interp. Type | Description | Period | Same as/Part of | Strat. Above | Strat. Below |
|---|---|---|---|---|---|---|---|
| 405 | Structure | Wall | NNE-SSW aligned; 5 courses of MS rubble lower sealed by mixed brick and MS rubble including deliberately set E-W aligned ceramic drain pipe; sealed by 2 further courses of brick headers sealed by single course of lias slabs under large lias rubble; all bonded by hard red-brown lime mortar with evidence of repair/pointing of mid grey lime mortar | | - | 404; 406 | 403 |

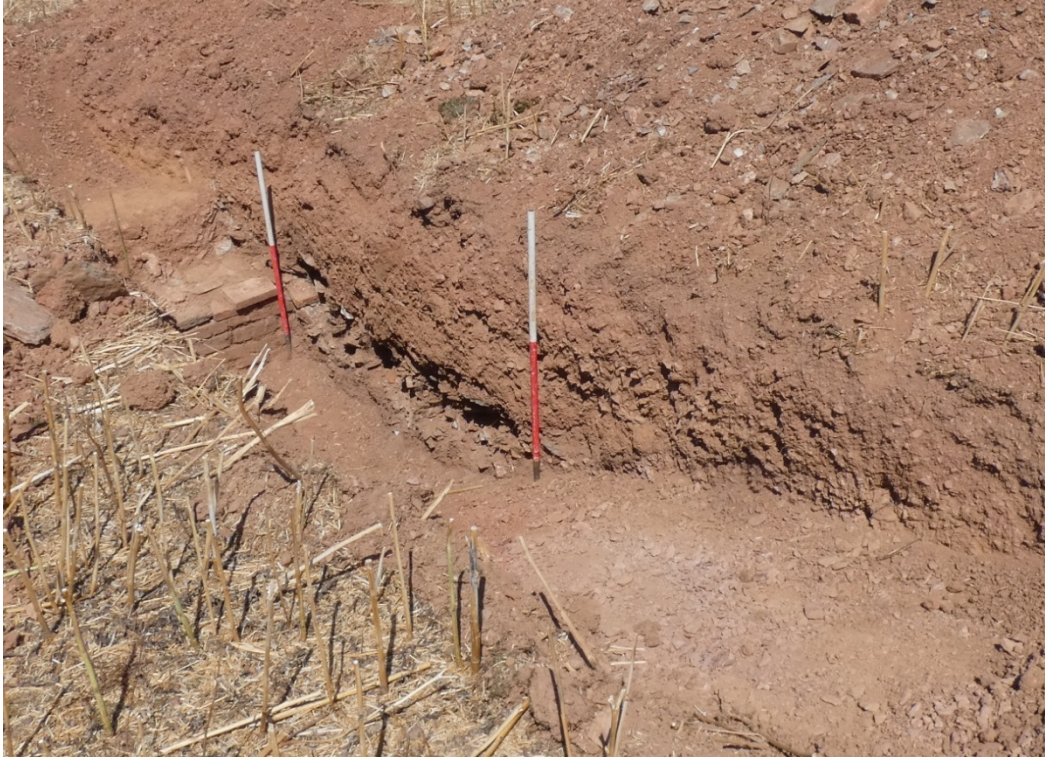
**Pl. 11: West facing section in Trench 5 (view from SW; scales=1m)**

2.3.12 Where located within the centre of the field in Trench 5, ditch [305] was found directly cut a build-up of clean red-brown clay-loam (505), possibly representing the truncated remains of a former cultivation horizon (pl. 13). Here the ditch was less substantial than elsewhere, being 4.75m in width and only 0.90m in depth with a slightly convex and moderately-sloping south side (fig. 4; pl. 11). The retaining wall to the north (503) was found to be severely truncated to a height of 0.40m constructed predominantly of brick with occasional Morte Slate rubble and re-used large square floor tiles of mid 18<sup>th</sup> century date bonded by red-brown lime mortar (pl. 12).

2.3.13 Very little evidence for primary silting was present in Trench 5 and the earliest fill within the ditch consisted of deliberate in-fill of loose Morte Slate rubble and fragmented lime mortar (502) including clay floor tiles and bottle glass and ceramic of the later 18<sup>th</sup> or early 19<sup>th</sup> century. This was sealed by a further deliberate dump of compact coarse gravel and clay (501) and finally by modern cultivation horizon (500) to the level of the existing ground surface.

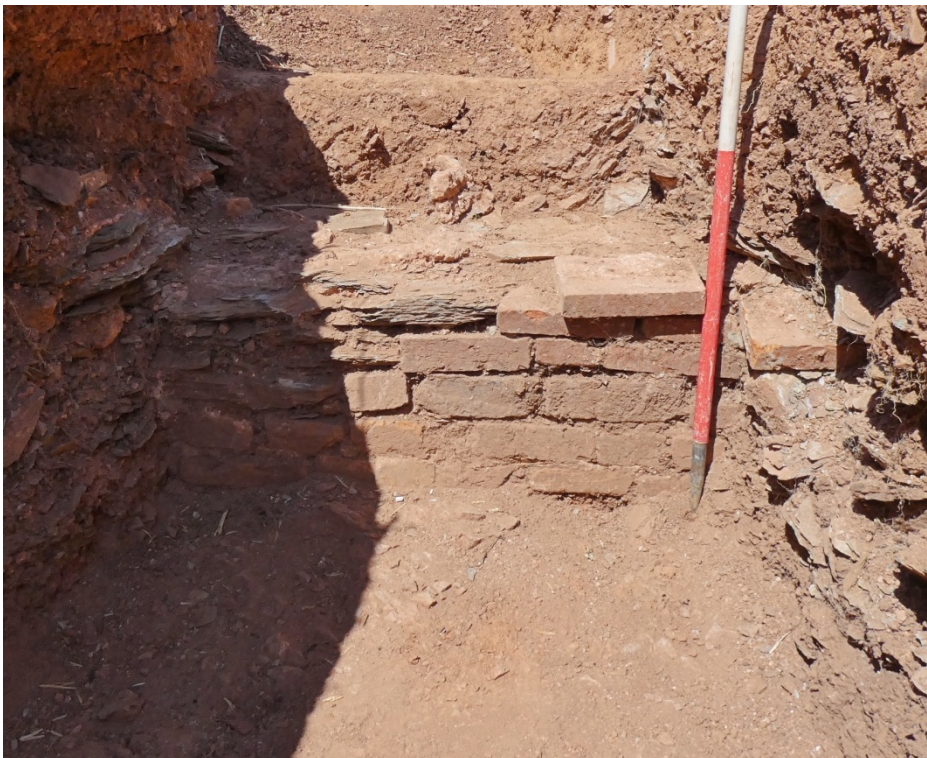
**Pl. 12: South facing elevation of remains of wall (503) in Trench 5 (view from S; scale in 0.50m divisions)**

4.4 The third form of construction was noted in the exposed section in Trench 5 where the remaining section of wall was found to be constructed predominantly of brick with some re-used floor tile. These are components typical of the mid to late 18<sup>th</sup> century and this length may be later than that immediately to the west but broadly contemporary with the feature examined in Area 1.

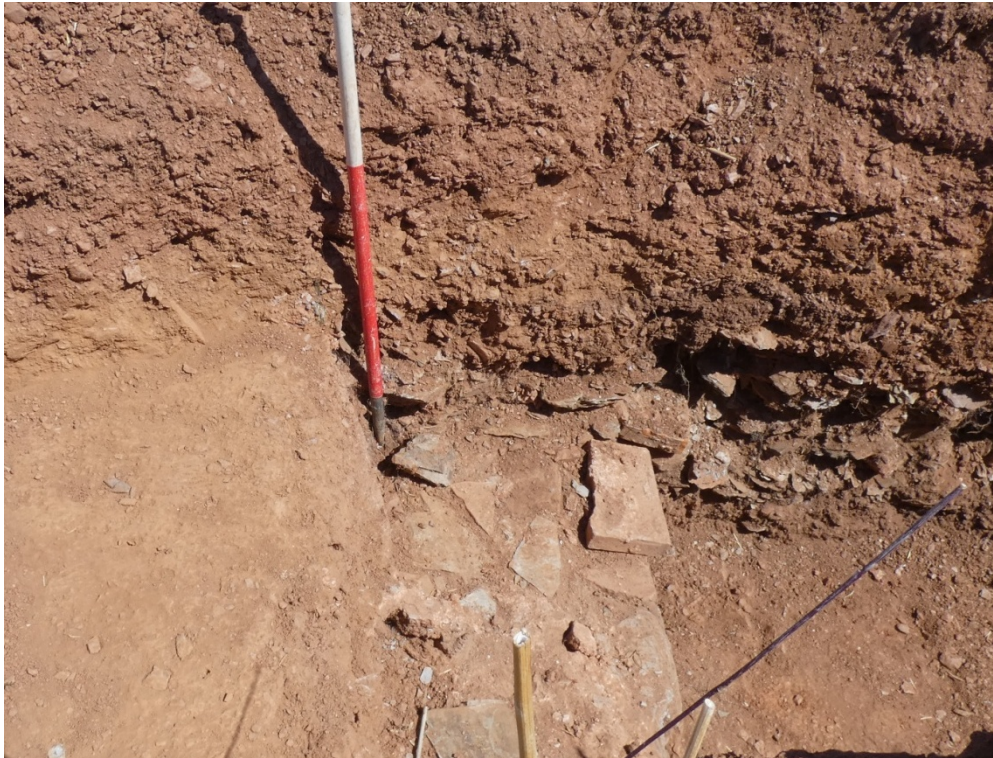
**Pl. 13: Southern edge of ditch cut [305]/[504] in Trench 5 showing earlier cultivation horizon (505) (left) and remains of wall (503) (centre) (view from W; scale=1m)**

2.3.2 Evidence for activity pre-dating the construction of the ha ha was absent, although a buried soil horizon (505) exposed in Trench 5 may represent the truncated remains of a ground surface of medieval or possibly earlier date.

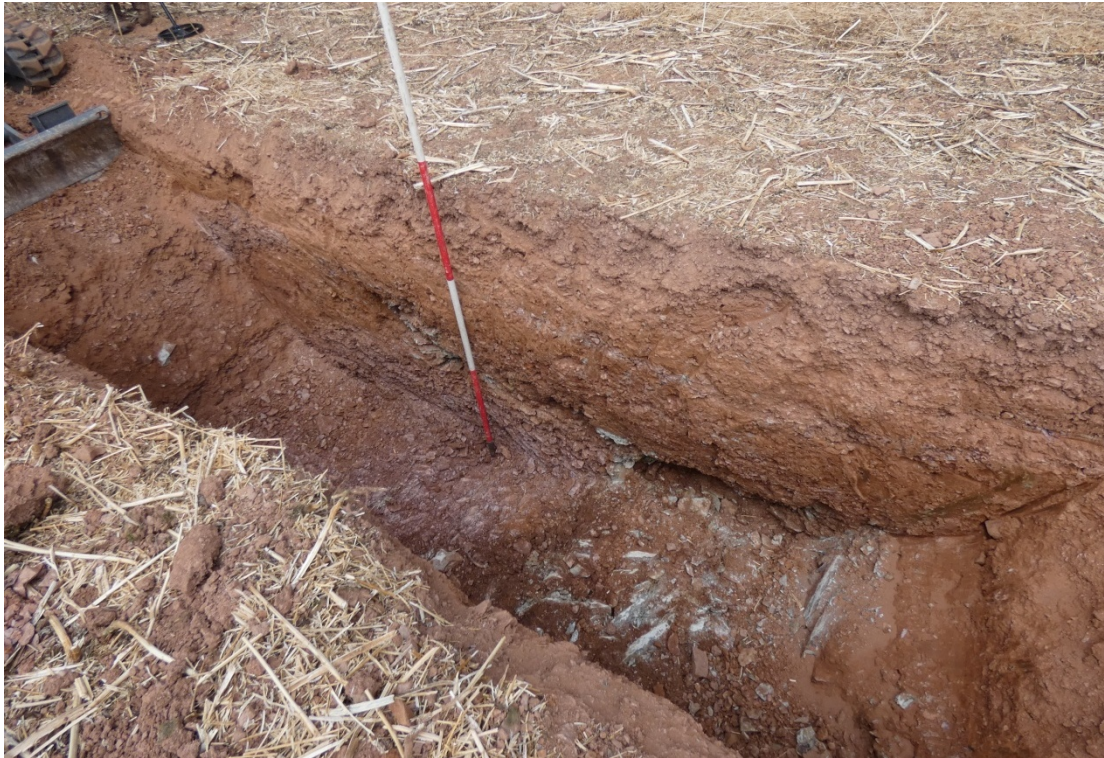
**Pl. 14: West facing section as excavated in Trench 6 (view from SW; scale=2m)**

2.3.14 Within the area investigated by Trench 6, towards the eastern terminus of the feature, ditch [305] was found to survive to a depth of 1.25m in a slightly altered form but its full extent to the south was not determined. No evidence was found for a retaining wall to the north here and it is possible that it had been entirely robbed prior to the backfilling of the ditch (fig. 4; pl. 14).

2.3.15 The remaining feature here was initially filled by loose lias rubble and red-brown lime mortar (604) which included occasional brick. This was sealed by three further episodes of deliberate infill (601); (602); (603) consisting of compacted red-brown clay and gravel and clay-loam of which the upper, (601), contained a glass bottle of the later 19<sup>th</sup> century. These deposits were finally sealed to the level of the modern ground surface by recent cultivation horizon (600).

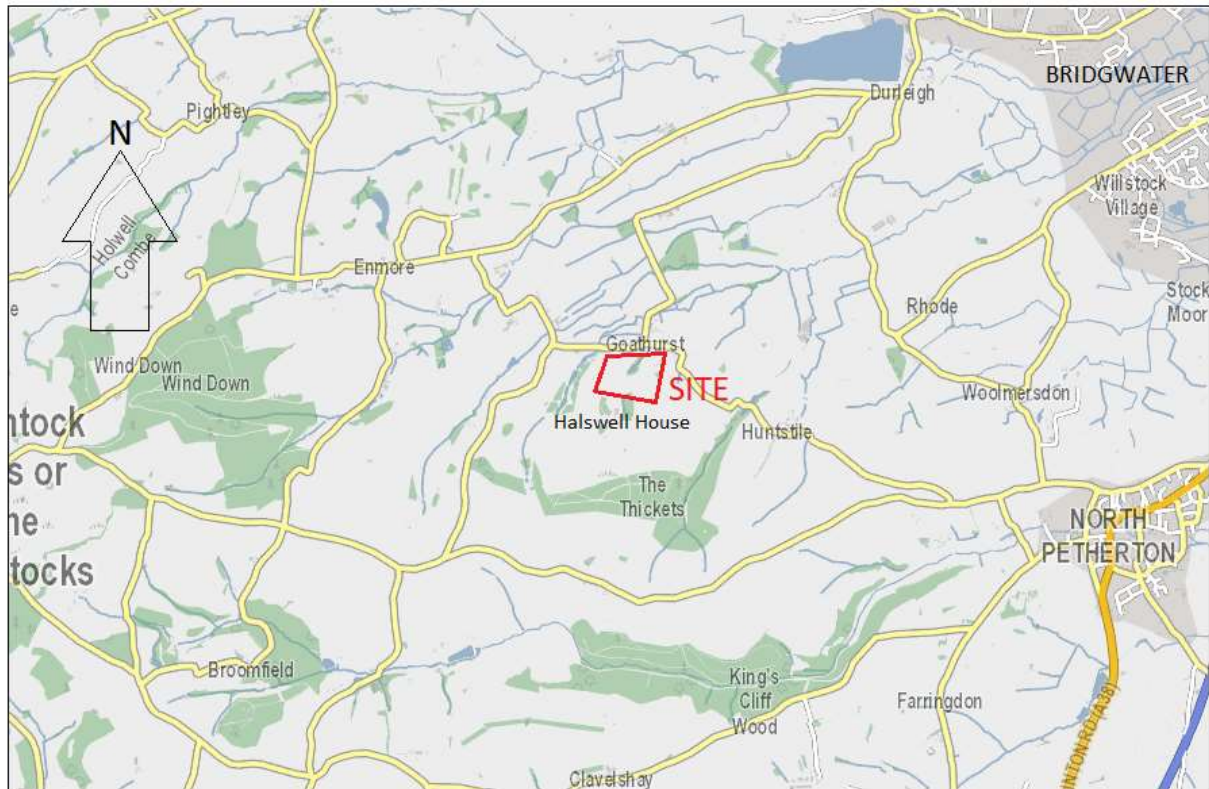
**Fig. 1 (above): Halswell Deer Park, Goathurst. Location of the Site**

**Fig. 2 (below): The Site showing Locations of Proposed Works**

1.1.2 It is proposed that the pond at the entrance to the park (at ST2558 3419) and that to east (Kennel Pond; ST 2578 3383) be opened and restored. Also it is proposed to investigate at points on the line of the former ha ha boundary features (centred at ST 2529 3392 & 2552 3395) in order to establish their condition with a view to their reinstatement in as close to original form as possible.

1.1.3 In addition, planning permission is being sought to allow the installation of a new mains water supply from the northern entrance to the park at ST2559 3426 to a point to the west of the house at ST 2536 2381 and the installation of a ground source heating matrix centred at ST 2524 3400.

4.5.1 **The Ha Ha Boundary Features (Areas 1 & 2):** It is proposed to reinstate the historic deer park boundaries as shown on fig. 2, the position and extent of which are traceable on historic mapping.
